Faculty of Engineering Seismic Retrofitting and Restoration of Historical Buildings Using Innovative Materials: the Case of Carmine's Bell Tower in Naples

PH.D. THESIS

Seismic Retrofitting and Restoration of Historical Buildings Using Innovative Materials: the Case of Carmine's Bell Tower in Naples

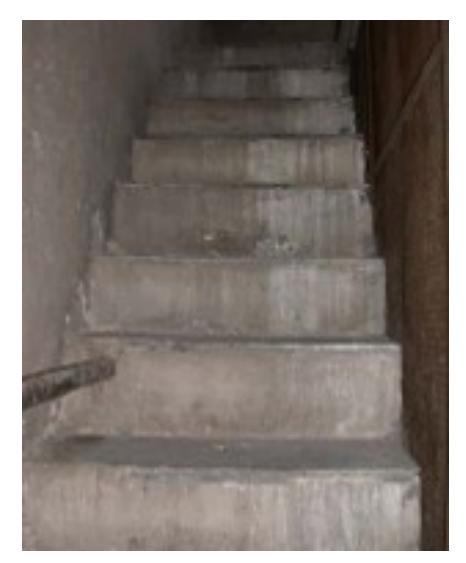
Some recent interventions, at the end of the 1970's and the 1980's, to remedy damages caused by previous seismic actions, consisted in application of steel chains additional to the existing ones. In fact some systems of steel bars at the upper levels go back to the end of the XIX century, while the strands and the bars through the stairs (Fig.17) were located in the 1920's-1930's, before the construction of the RC stair in 1950's and the demolition of existing vaults and wooden floors. For the strand, only the anchoring plates are visible from the outside (Fig.18), since the cables runs through the walls, while the steel bars (diameter 30.0-50.0mm) are visible from the inside of the Bell Tower and their anchoring systems are generally made of vertical bars or outside semi-horizontal bars. A lot of them are ineffective at the anchorage or present a diffuse superficial corrosion and probably are not efficient anymore.

Fig.17. Bars through the stairs

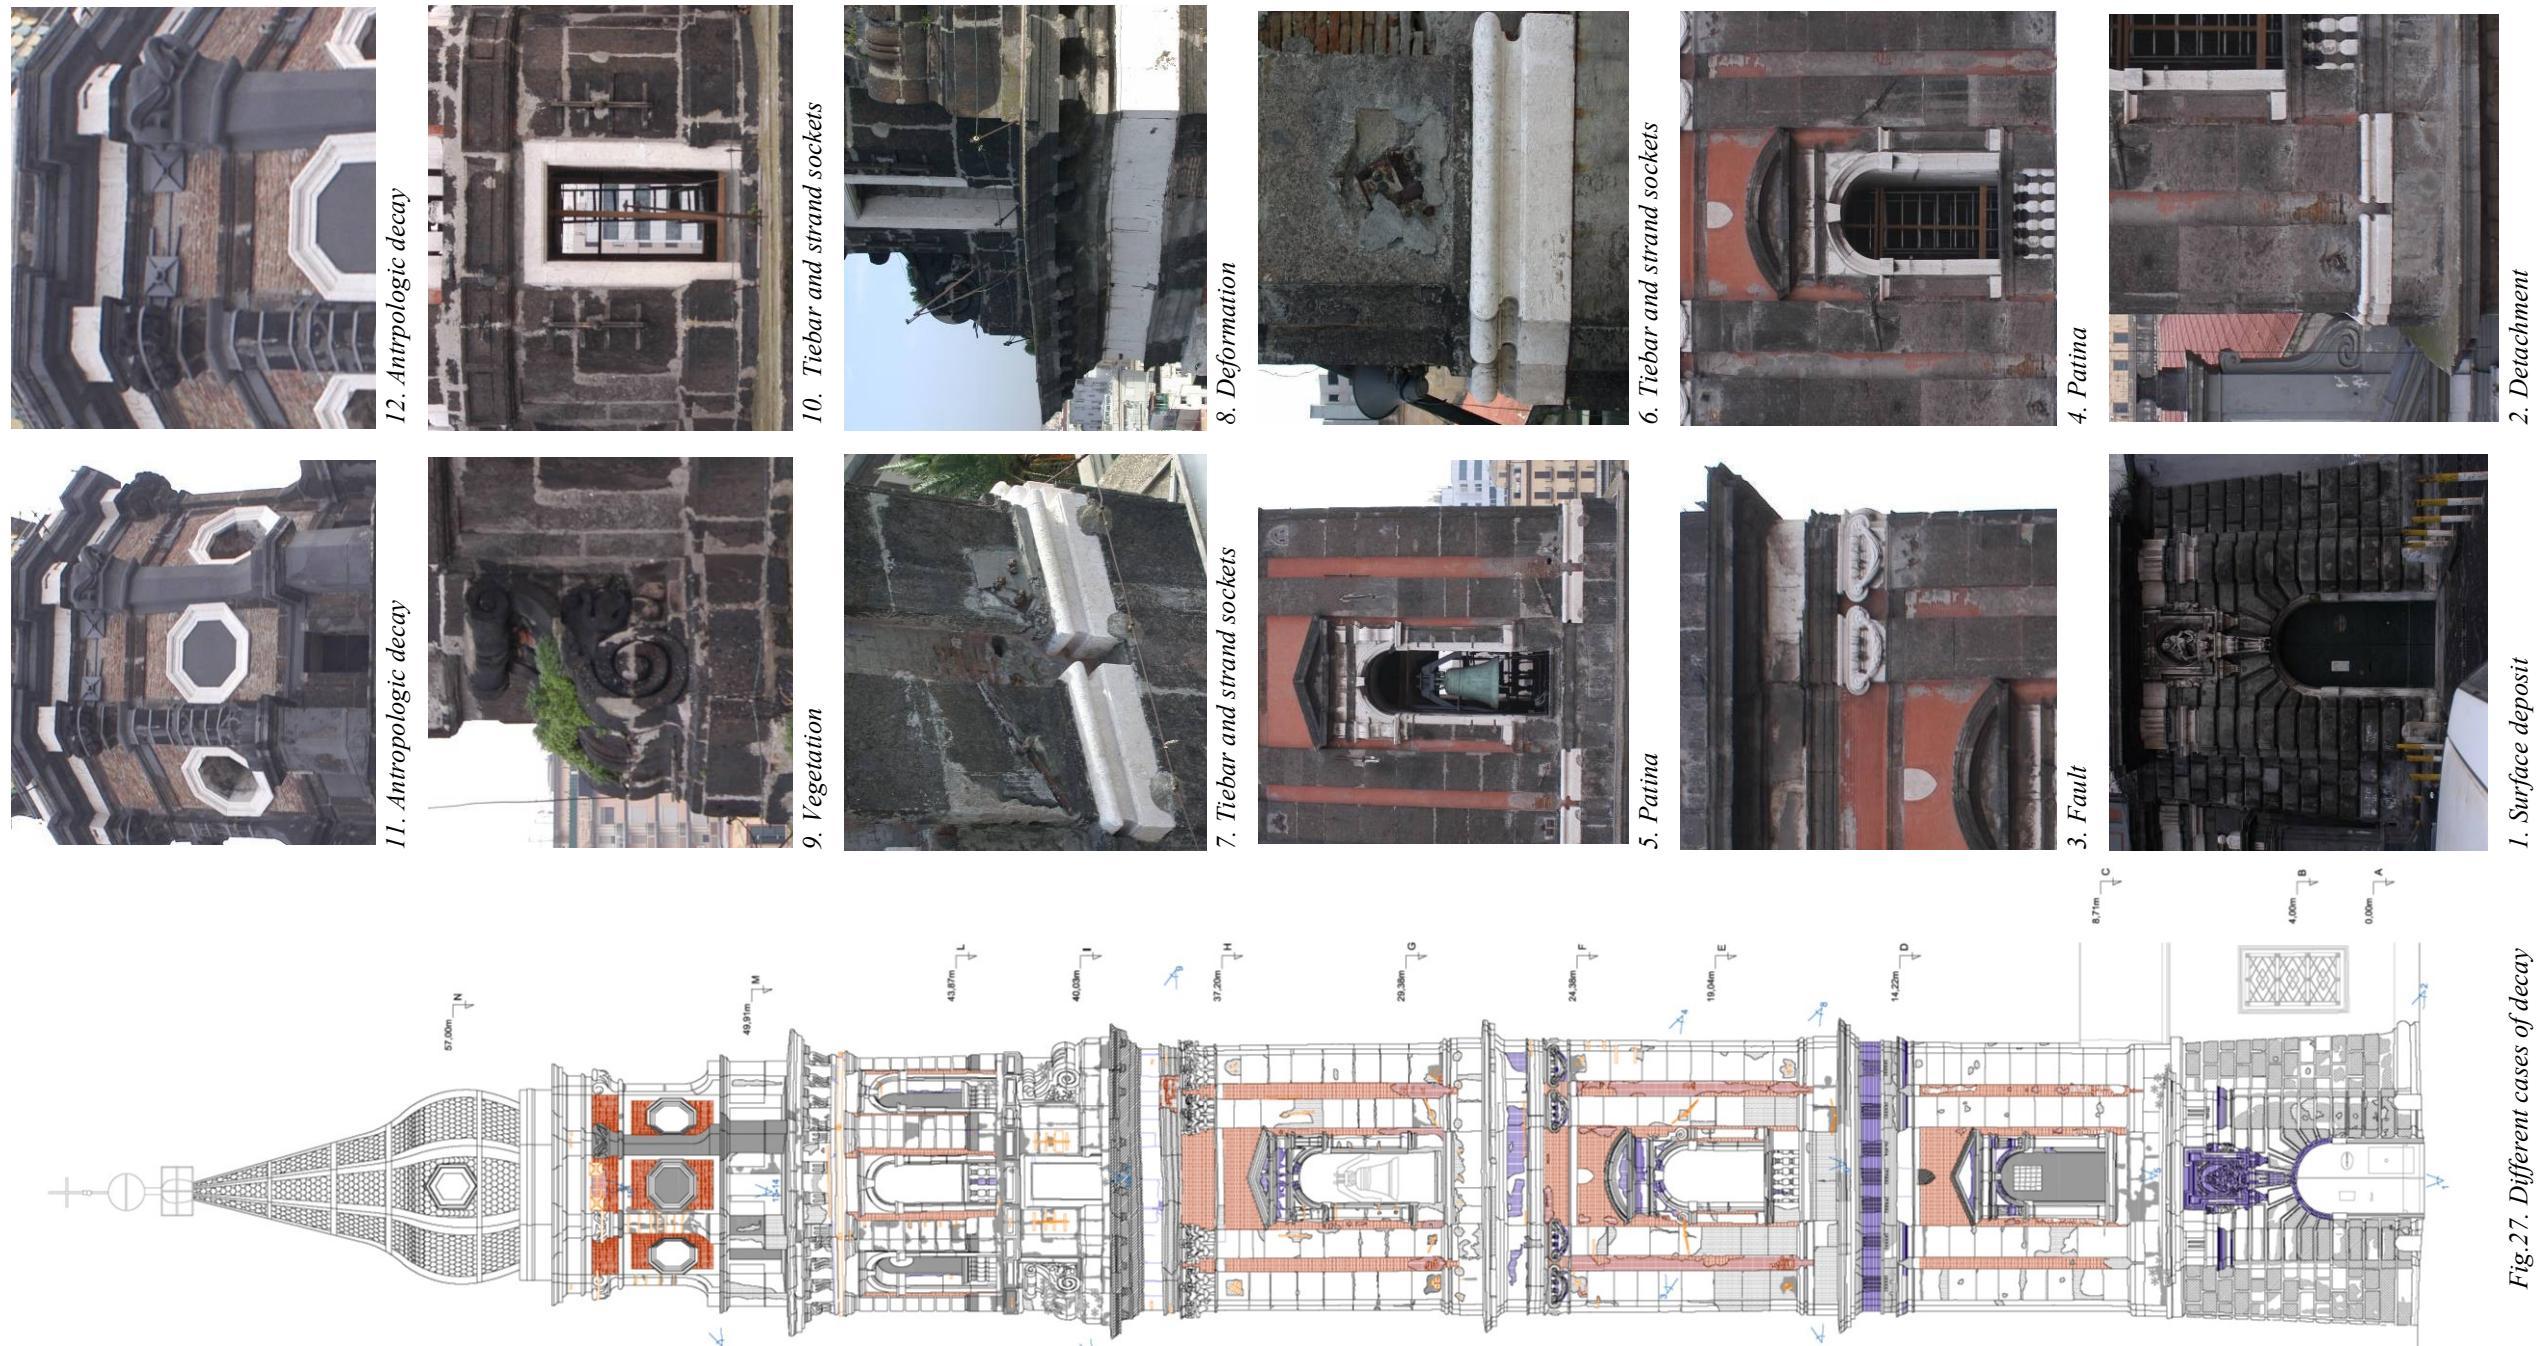
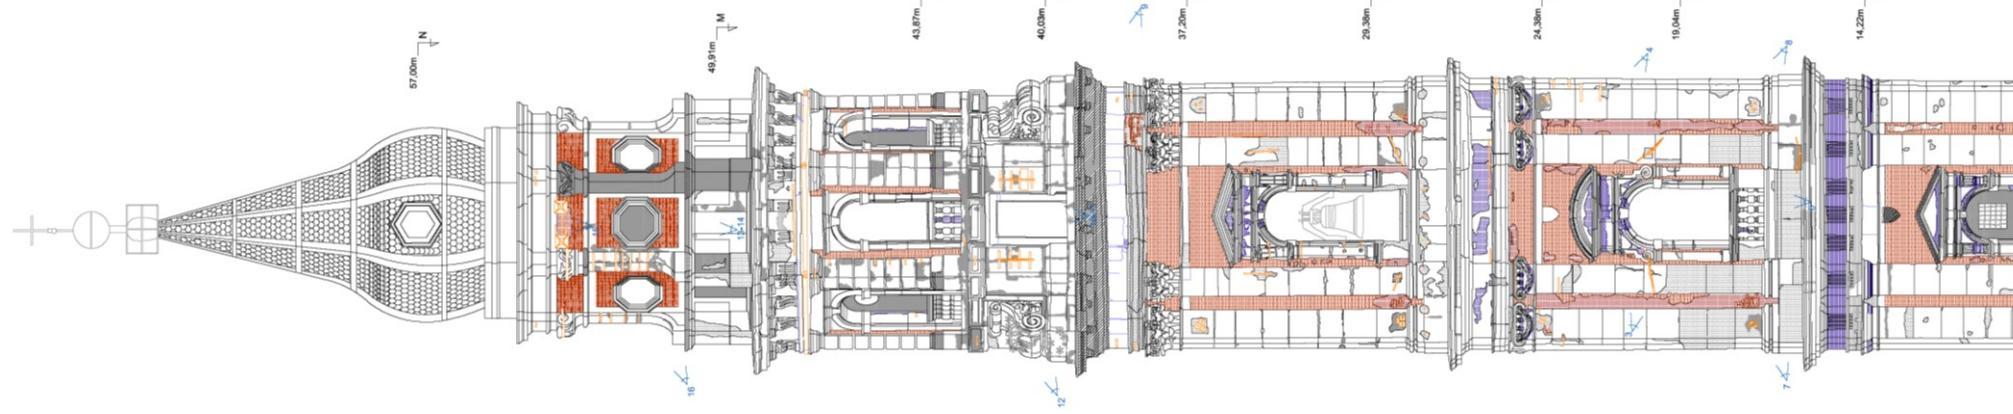
Fig.27. Different cases of decay

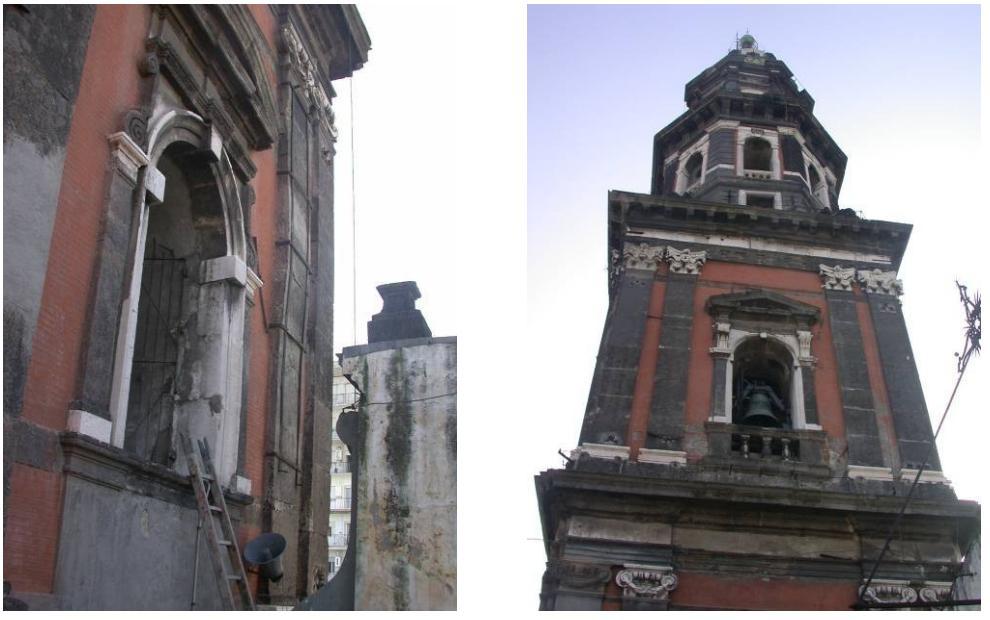
Fig.9. Damage on lateral and main front of the Bell Tower. Stone buckling

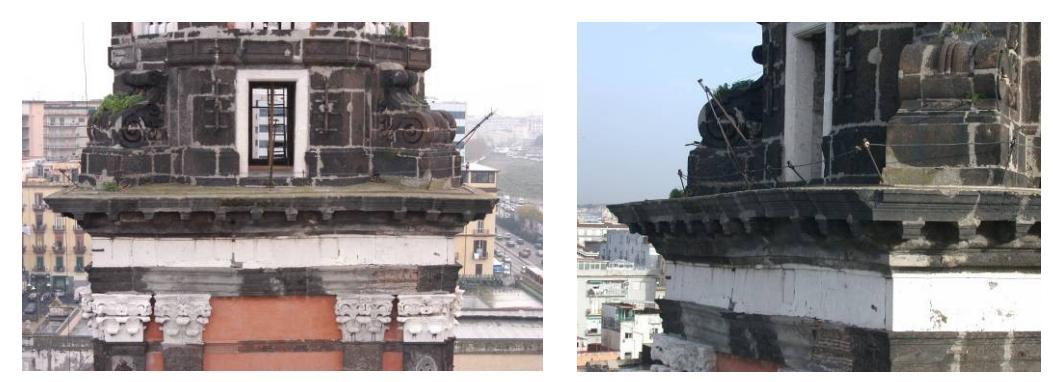
Fig.10. Damage on lateral and main front of the Bell Tower. Frame deformation

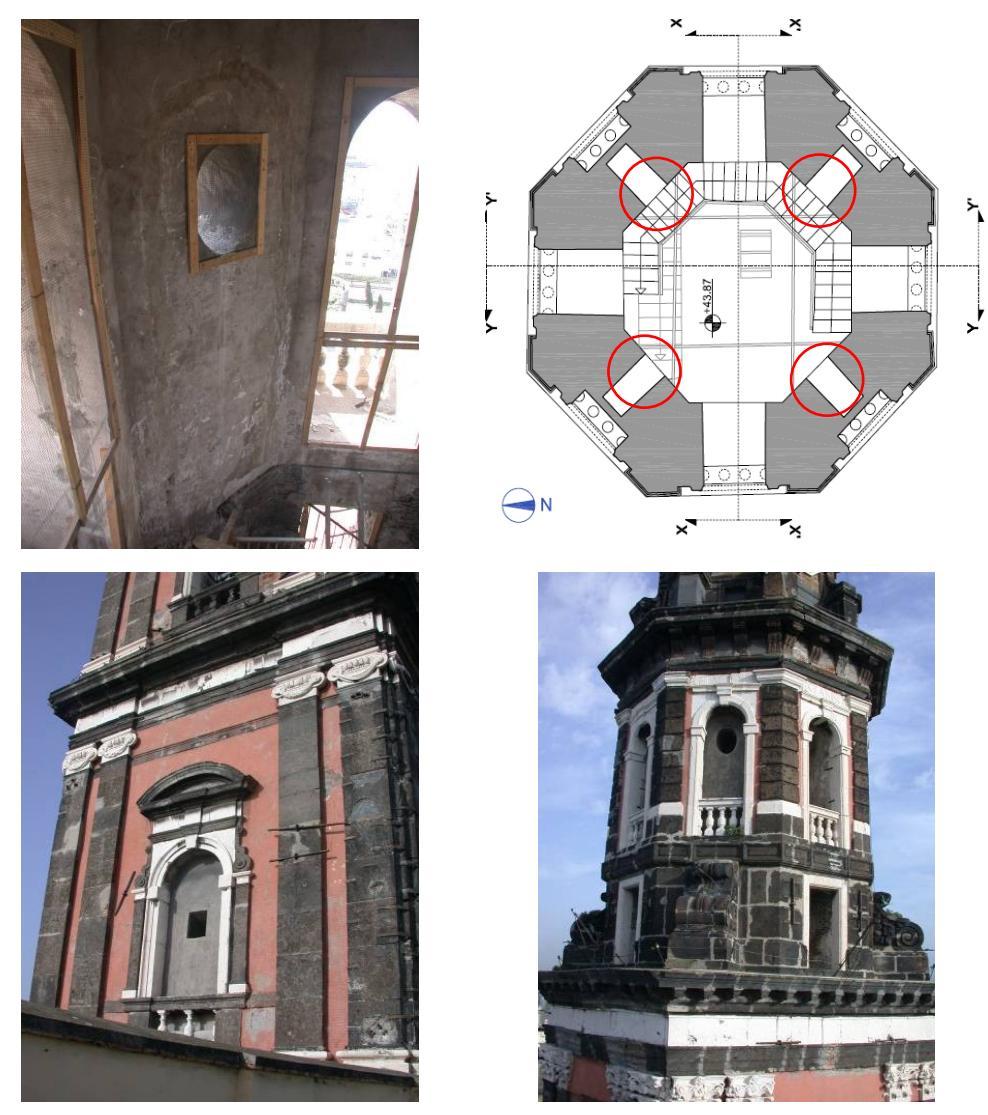
Steel bars are located at the various levels of the Tower, while all along its outside perimeter and for its entire height a series of plates of iron cage are put in place. Their purpose is to tie up the façade piperno lining and to avoid its detaching and falling down. Moreover, almost all ornamental stone parts protruding outside of the Tower have prompted a reinforcement of the constraint, made by means of collars, ties, brackets, etc. The presence of chains and strands, were made also in order to prevent and/or compensate the outside opening of the walls of the Tower and to exercise a kind of containment on the structure favouring the box behaviour. The high numbers of reinforced injections in the angles also appear to reiterate the need for containment and better mutual seam of the walls of the structure. In fact in some parts of the Tower was found as some of the walls actually seem to present a tendency to deflect outward.

Fig.11. Inside and outside view of closet opening

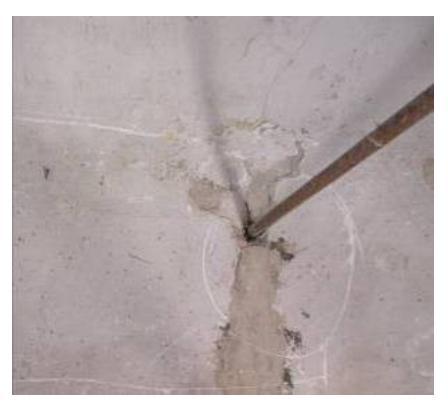
Fig.25. Damage of anchorage of steel chain

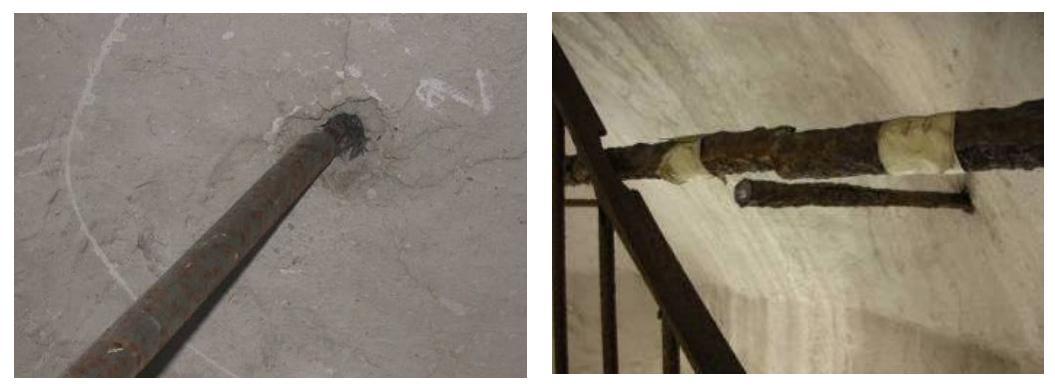
Fig.6. Problems of tie-bars detachment

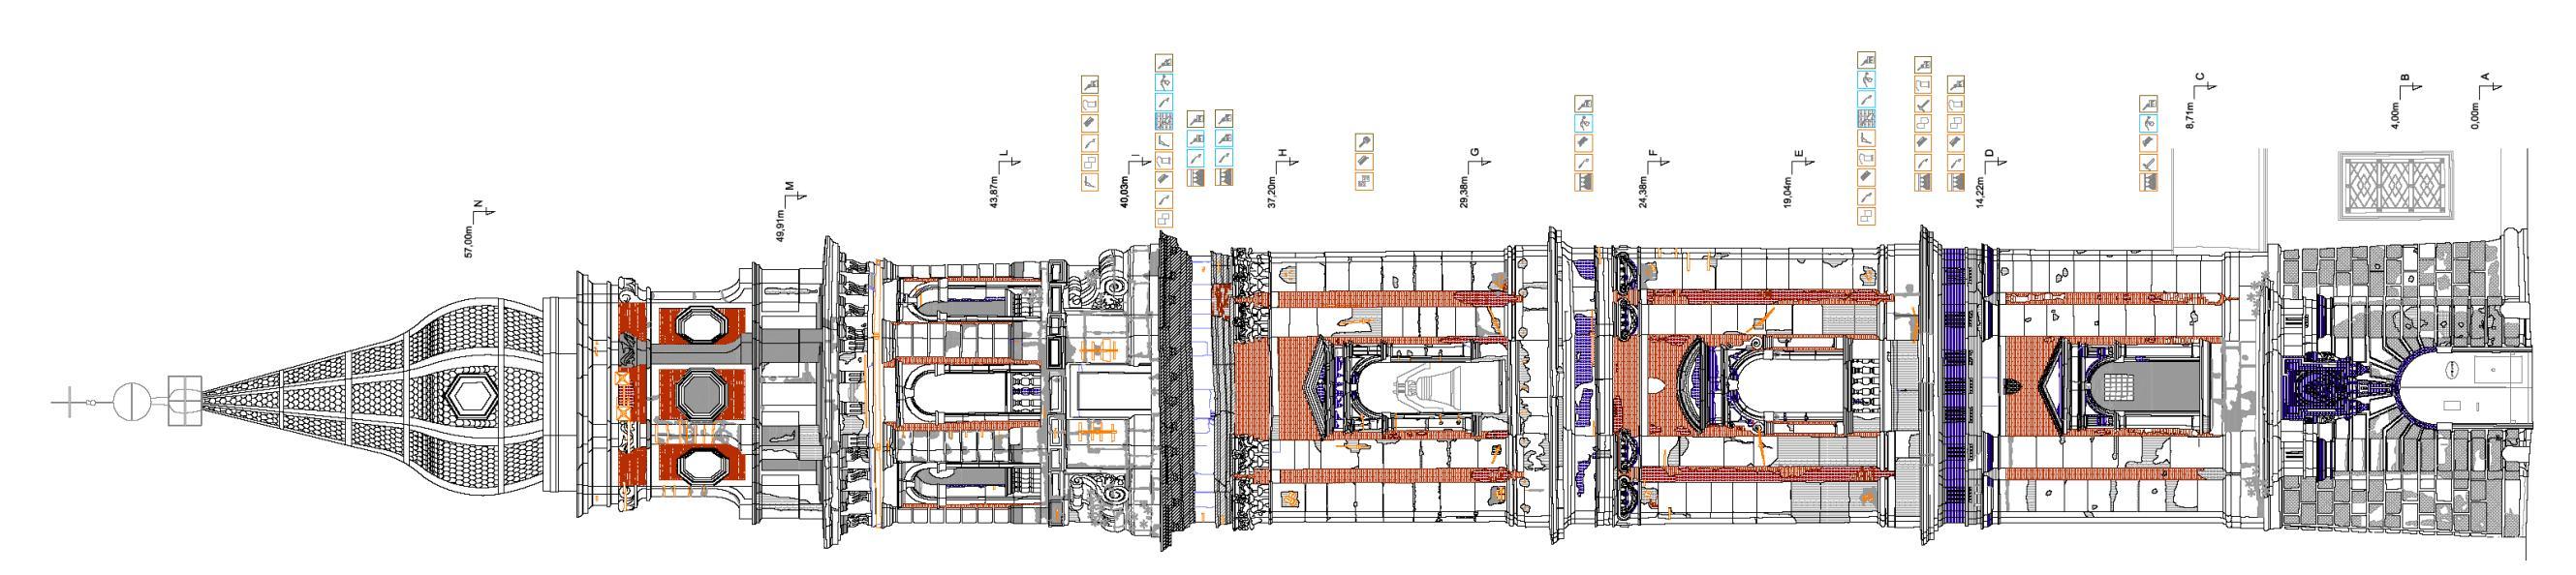
Fig.16. Different cases of decay
