Università degli Studi di Napoli “Federico II”

Dottorato di ricerca in “Trasporti”
XVIII° ciclo

INNOVATIVE METHOD FOR DAMAGE IDENTIFICATION
AND STRUCTURAL HEALTH MONITORING BASED ON
VIBRATION MEASUREMENTS

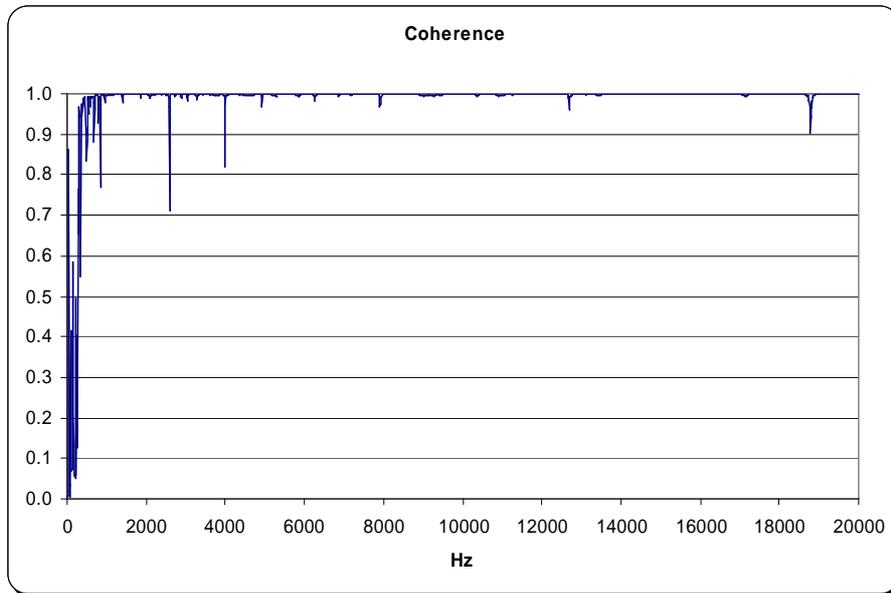
Practically the coherence function is a quality index of the FRF acquired.

Fig. 2.2.1 – Coherence function

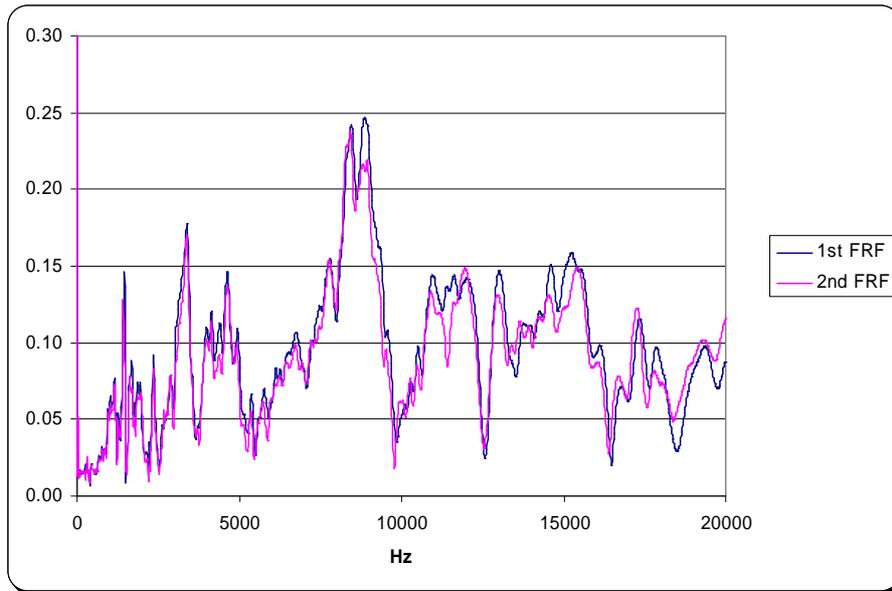
It can be noted that only the FRF amplitude, and not its phase, is used to calculate the Damage Indexes.

Fig. 2.3.1 – FRFs deviation – linear

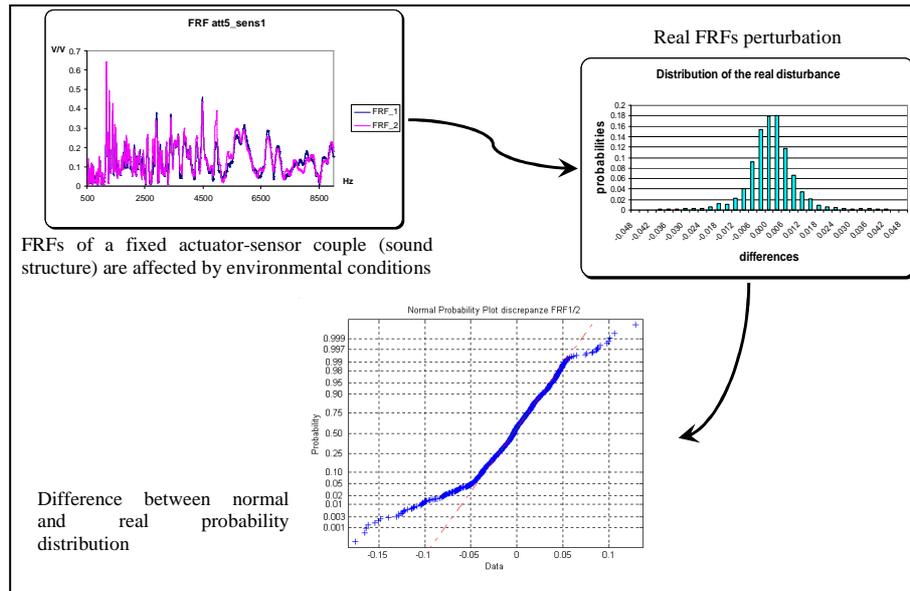
is normal with a variable mean and standard deviation, form the vector. Those random values have the same order of magnitude as FRF; to make the number of generated negative values negligible, since FRFs magnitudes are positive quantities, the mean has been restricted to be greater or, at least, equal to the standard deviation. The measurement noise modifies the probability distribution (as well the FRFs). Therefore the real probability distribution does not agree with the common normal distribution.

Fig. 3.2.6 – FRFs perturbation

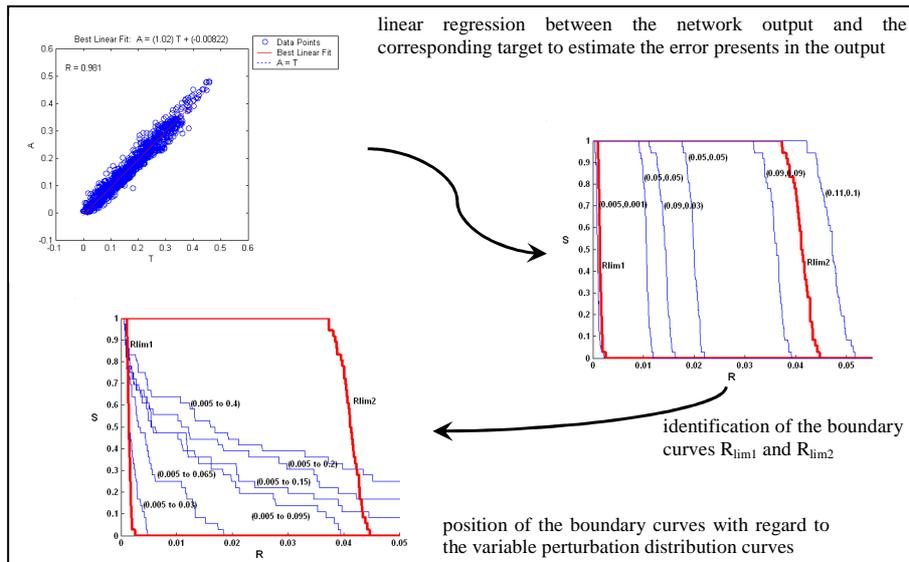
Between R_{lim1} and R_{lim2} there are all the other estimator curves whose position, with regard to the threshold, need to rate for estimating the state of health of the monitored panel. As regards the panel we have considered, the boundary curve R_{lim1} is the estimator curve of the reference FRFs which have been perturbed using the disturbance (0,0099 ; 0,0099), while the boundary curve R_{lim2} is the estimator curve of the reference FRFs which have been perturbed using the disturbance (0,1;0,1). Therefore it is possible to identify two bound values of the reconstruction index R which practically coincide with the values of R which are determined by the intersection between R_{lim1} , R_{lim2} and the x axes. The lower value is equal to 0,0025.

Fig. 3.2.9 – Boundary curves of R index

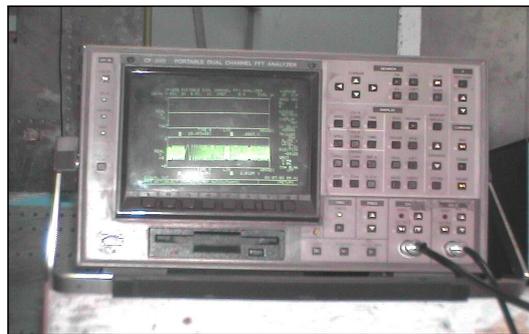
Fig. 4.1.1 – ONO SOKKI CF-350

The ONO SOKKI CF-350 has two input channels, one output channel and an input and output frequency range up to 40 kHz.

Two generators and spectrum analyser made by the ONO SOKKI company have been used. The models are the CF-350 and the DS-2100.

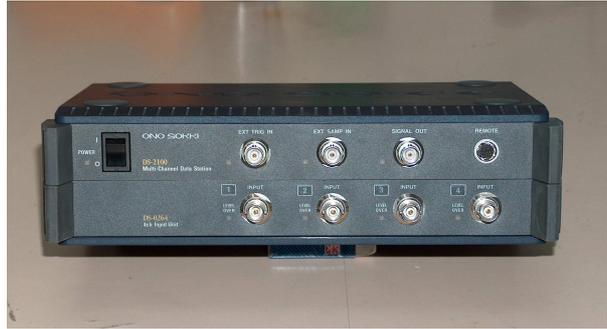
Fig. 4.1.2 – ONO SOKKI DS-2100

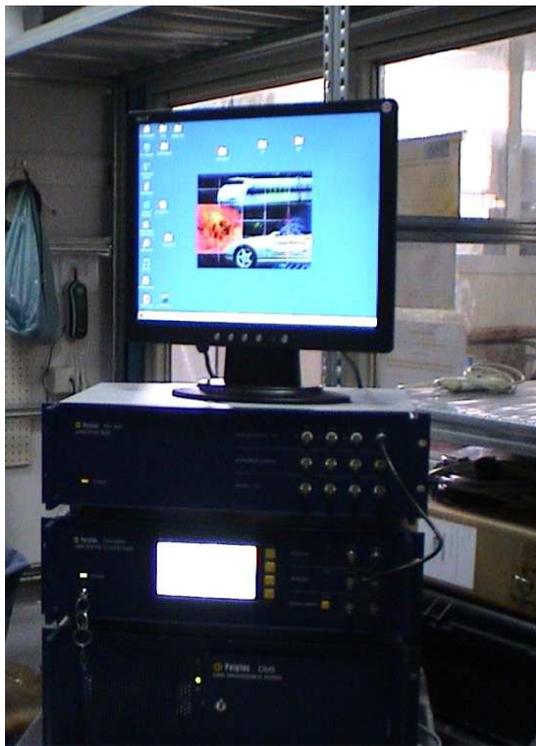
The Scanning Laser Vibrometer is a velocity sensor system. It is able to measure the distribution of vibration velocities of an object, on the basis of laser interferometry, orthogonally to the laser beam. It can quickly acquire from a large number of points of the object, since it is able to deflect the direction of the beam by means of two mirrors driven by fast piezoelectrical motors.

Fig. 4.1.3 – Polytec PSV-400

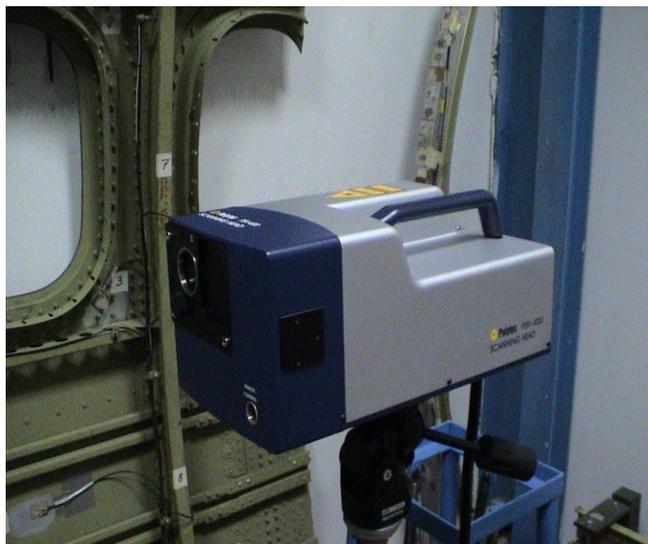
The light source of the vibrometer is a helium neon laser. It is a Class 2 product.

Fig. 4.1.4 – Laser head

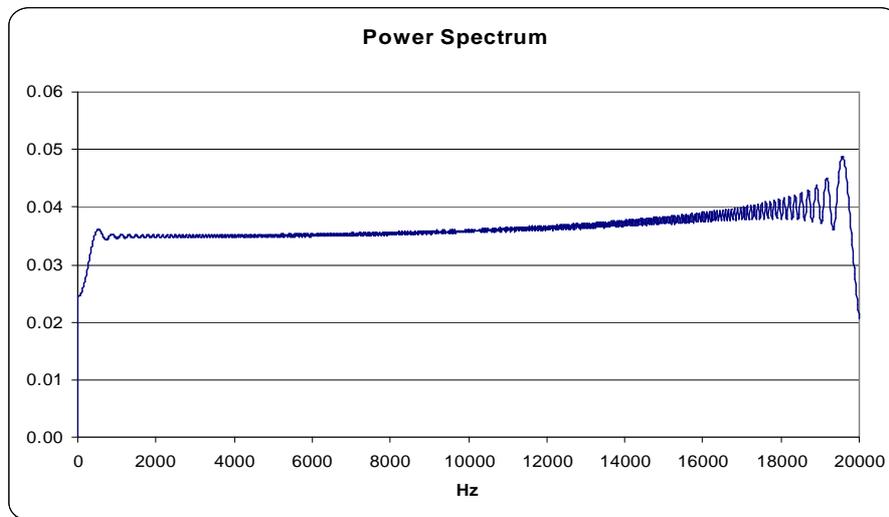
The following graph represents a swept sine signal generated from 0 Hz to 20 kHz. It can be observed that at the highest frequencies the spectrum shows an higher amplitude since it is feeling the impedance of a piezoceramic patch which was working, at that time, as actuator, and it was receiving the signal by the generator.

Fig. 4.1.5 – Swept sine signal

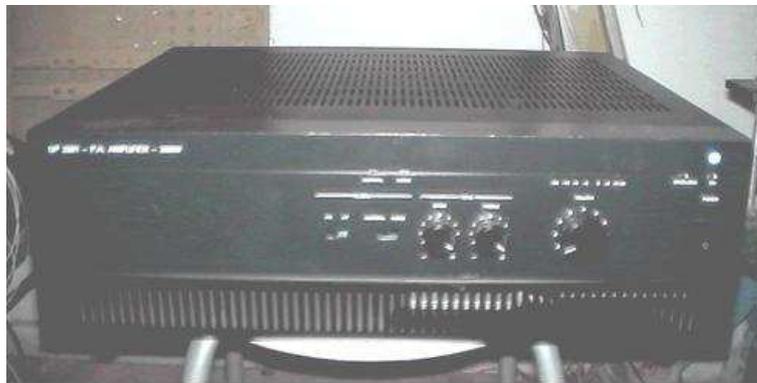
The first one is a current amplifier which has been used to amplify the excitation signal for the magnetostrictive actuators. It has an adjustable gain.

Fig. 4.1.6 – Audio amplifier

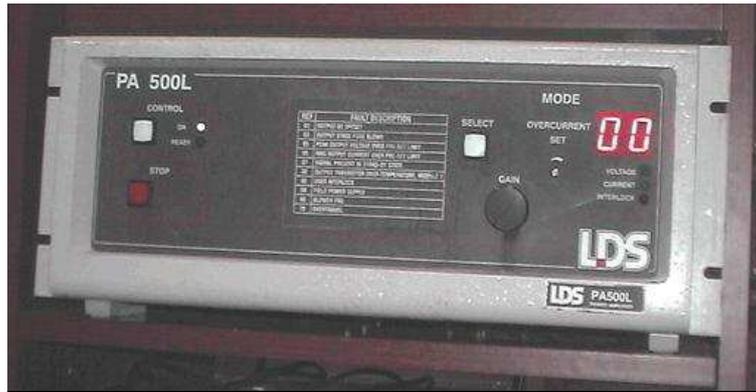
The second one is another current amplifier which has been used to amplify the excitation signal for the magnetostrictive actuators. It also has an adjustable gain.

Fig. 4.1.7 – LDS amplifier

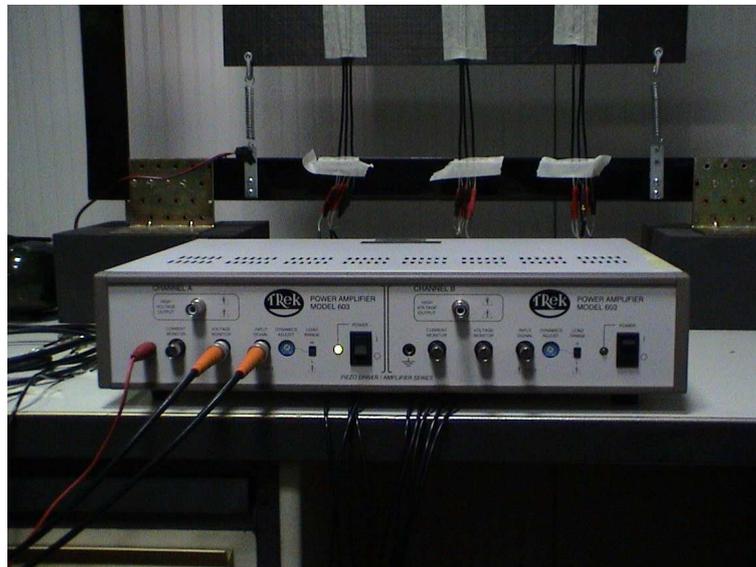
The third one is a voltage amplifier which has been used to amplify the excitation signal for the piezoceramic patches. It has a fixed gain which multiplies the signal voltage amplitude 25 times.

Fig. 4.1.8 – TREK amplifier

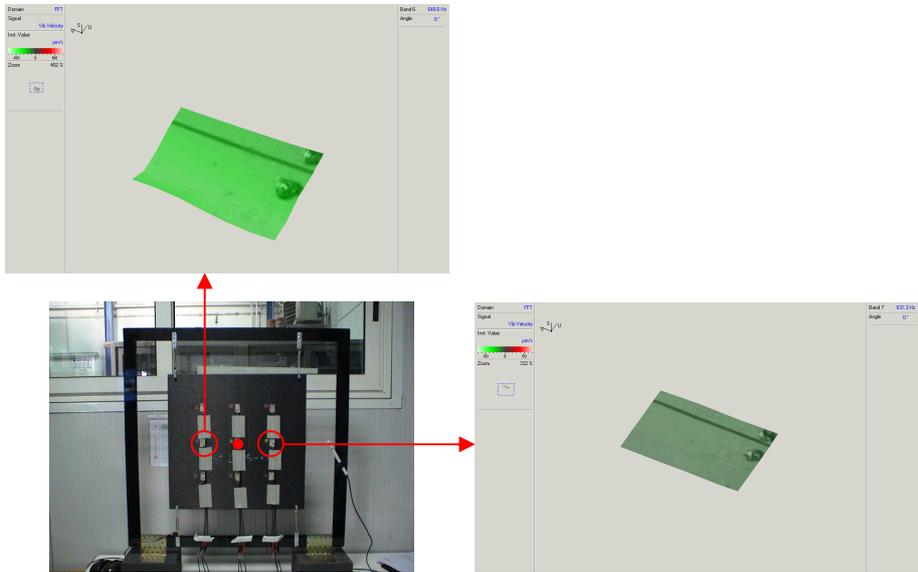
The output of the vibrometer is reported in the next figure:

Fig. 4.1.11 – Piezoceramic patch failure

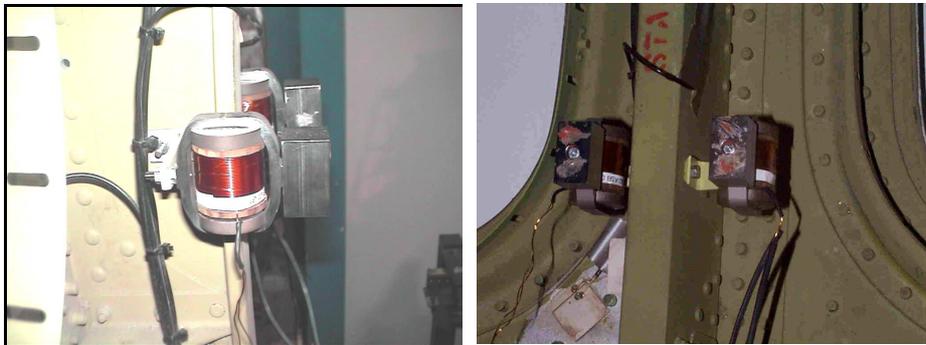
Those actuators are made of magnetostrictive material TERFENOL-D, whose meaning is:

Fig. 4.1.12 – Magnetostrictive actuators

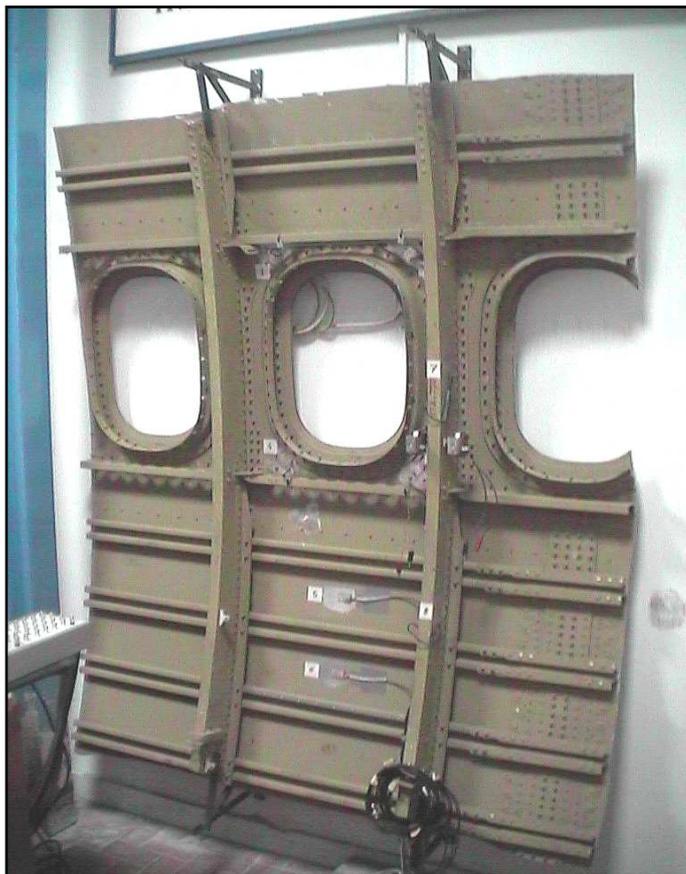
On the test-article eight piezoelectric patches have been bonded in order to create an array of actuators-sensors. Following several tests which have been carried out in order to set up the frequency range, only four piezoelectric patches have been used, since four are enough to demonstrate the capability of the techniques to identify and quantify the damage.

Fig. 4.2.1 – MD-11 fuselage panel

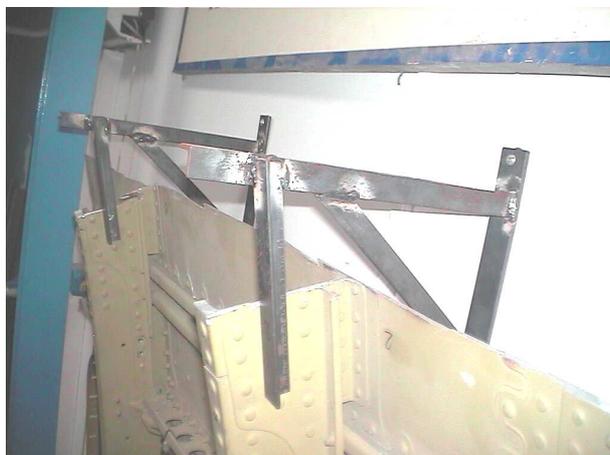
Fig. 4.2.2 – MD-11 Constraint

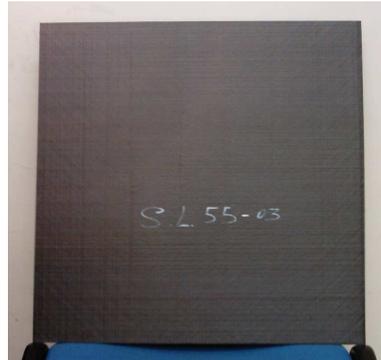
- ✓ 14 plies made of multi-axial HTA 3/6 K (520mm x 520mm x 2mm);
- ✓ panel lay-up: [(90/0/+/-)(+0/-)]s;
- ✓ fibre: multiaxial HTA-6K;
- ✓ resin: epoxy film 977-2 by Cytec;
- ✓ technical data:
 - $E1 = 1.352e11 \text{ N/m}^2$;
 - $E2 = 9.3e9 \text{ N/m}^2$;
 - $\nu12 = 0.34$;
 - $G12 = 4.87e9 \text{ N/m}^2$;
 - $\rho = 1600 \text{ Kg/m}^3$.

Fig. 4.2.3 – Composite panel

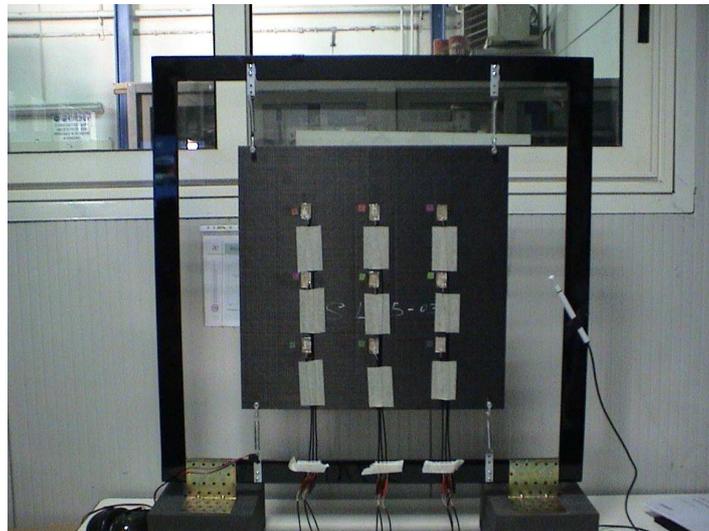
Fig. 4.2.4 – Composite panel set-up

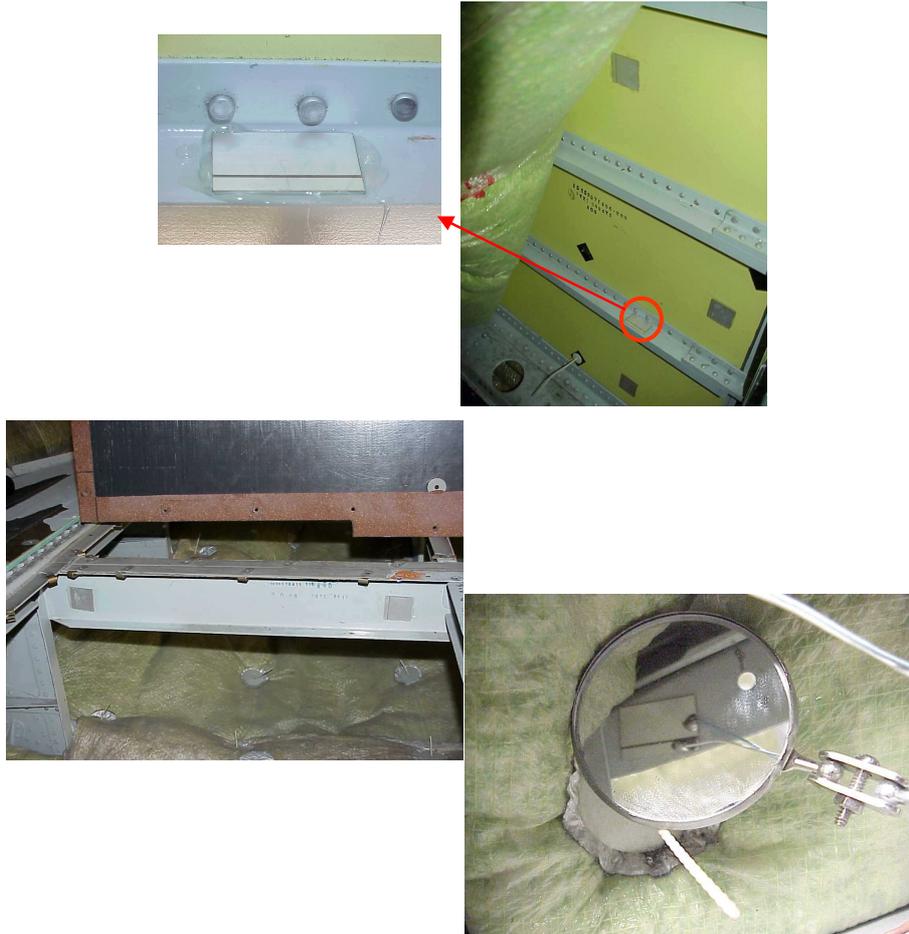
The skin panels of ATR 72 aircraft fuselage are made mainly of 2024 material. They are reinforced by a system of riveted or hot bonded stringers and bonded doublers.

Fig. 4.2.6 – Piezoceramic patches installation examples

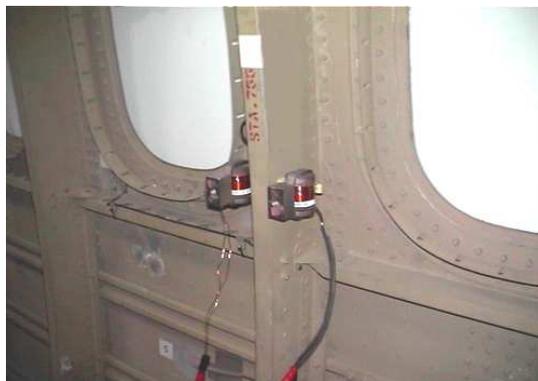
First, it has been used two magnetostrictive actuators, and two different amplifiers: the audio power amplifier and the LDS amplifier. First it has been used the audio one. In order to define their right position on the structure a perturbation has been simulated to not change for ever the structure characteristics, to test several position for the actuators. Firstly, the magnetostrictive actuators have been installed on the right frame of the structure, far from the structure constraints.

Fig. 5.1.1 – Magnetostrictive actuators

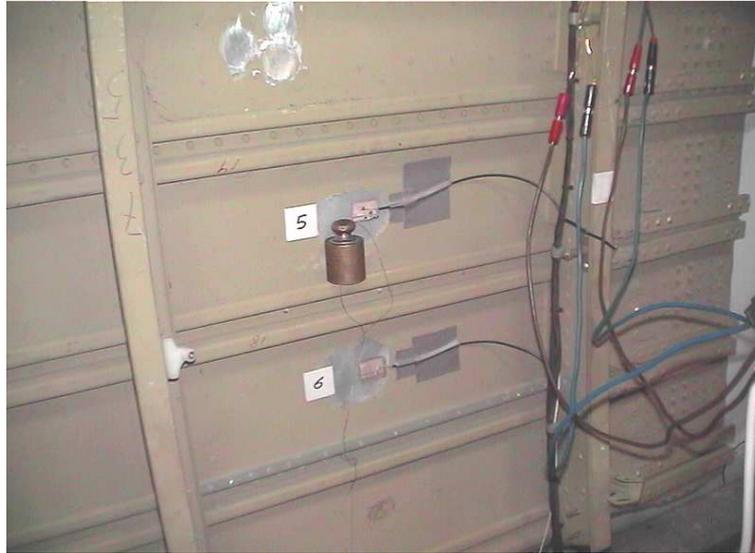
The perturbation has been carried out by means of a mass of gr.500, rested on the structure without fasteners, so that it could be easily moved everyway, with no problem. That kind of perturbation, even if it leads to good damage identifications (see after), is not a real damage simulation, since it is a damage unfaithful to realities. In fact 500 grams added on a structure causes a redistribution of the mass of the structure.

Fig. 5.1.2 – 500 grams mass

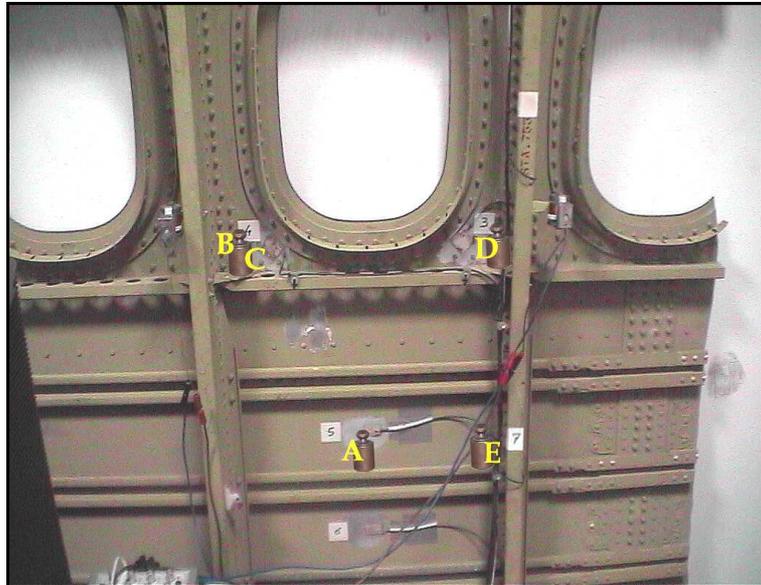
Once the actuators configuration has been fixed, the capability of the Damage Index method in localize the presence of a damage has been tested. So, the mass of gr.500 has been put on different positions on the structure.

Fig. 5.1.17 – Masses locations

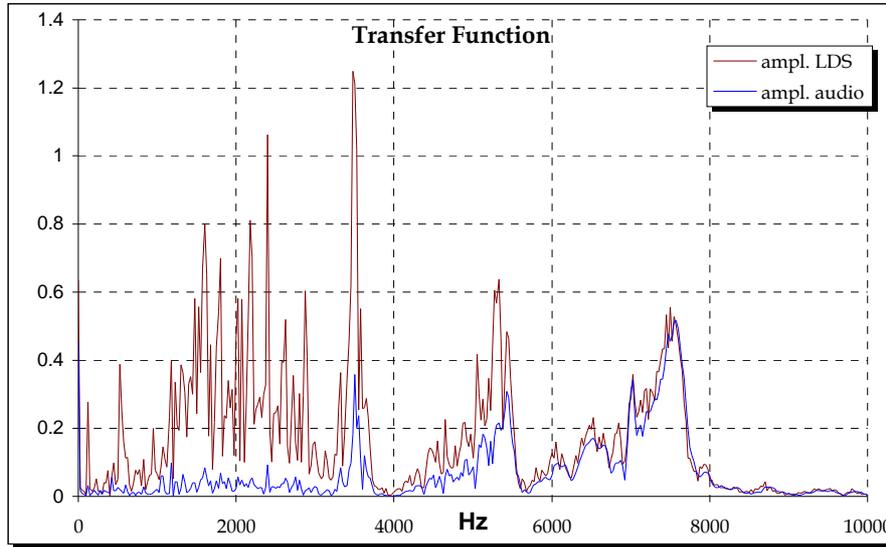
In order to use the magnetostrictive actuators at their peak the LDS power amplifier has been used. It can be observed how the increased energy level has modified the transfer function, especially at low frequencies.

Fig. 5.1.22 – FRFs comparison – LDS amplifier – sensor #3

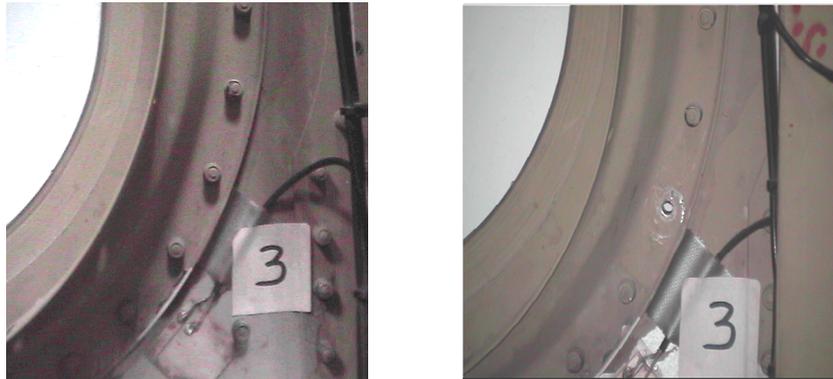
The removal of the first rivet is shown in the next figures:

Fig. 5.1.39 – First rivet removal

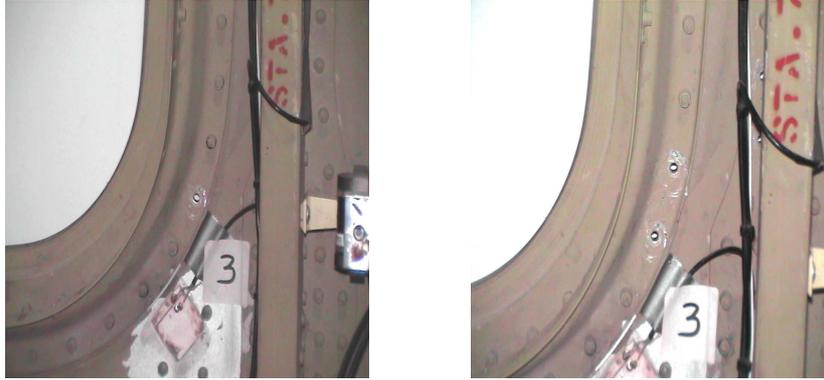
The removal of another rivet, close to the first, has been the following step.

Fig. 5.1.45 – Second rivet removal

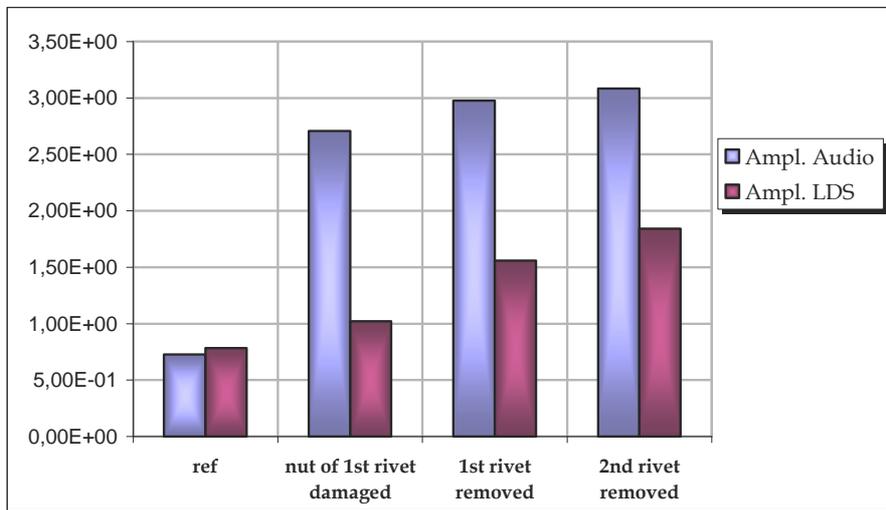
Next figures show all the results obtained by means of the Damage Index “1” only, and both the amplifiers.

Fig. 5.1.46 – Global Damage Index “1” both amplifiers

It can be observed that the damage have been identified, but using a more clean signal, even if the level of the energy is low (using the audio amplifier), the identification is better.

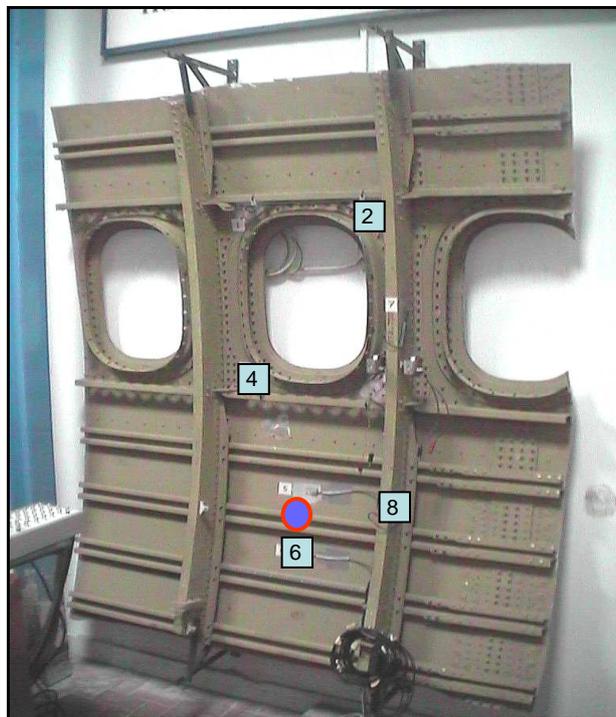
On the test-article 8 piezoelectric patches have been bonded in order to create an array of actuators-sensors. Following several tests which have been carried out in order to set up the frequency range, only 4 piezoelectric patches have been used, since 4 are enough to demonstrate the capability of the techniques to identify and quantify the damage.

Fig. 5.1.61 – Second experimental test set-up

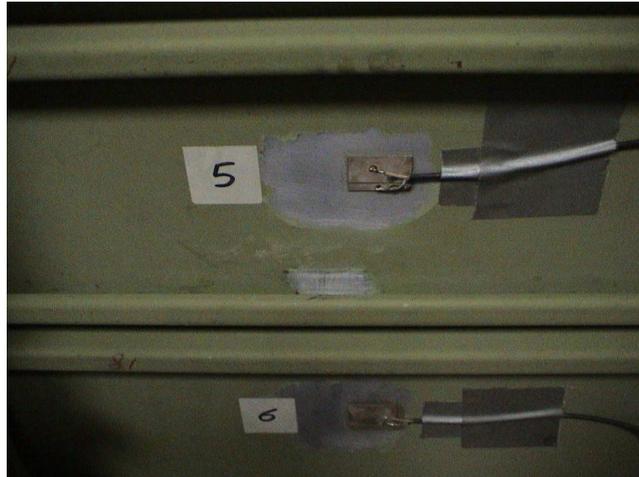
Fig. 5.1.62 – Damage location

The second damage imposed on the test-article has consisted in a chemical corrosion. It was carried out by means of the hydrochloric acid with a 15% title, whose pH is -0,65. The corroded region measures 8,5 cm². The corrosion was carried out two times on that region, removing about 0,67 grams at a time.

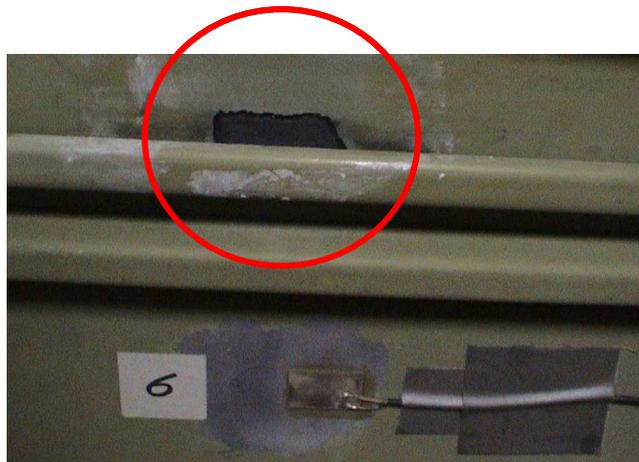
Fig. 5.1.63 – Corrosion detail

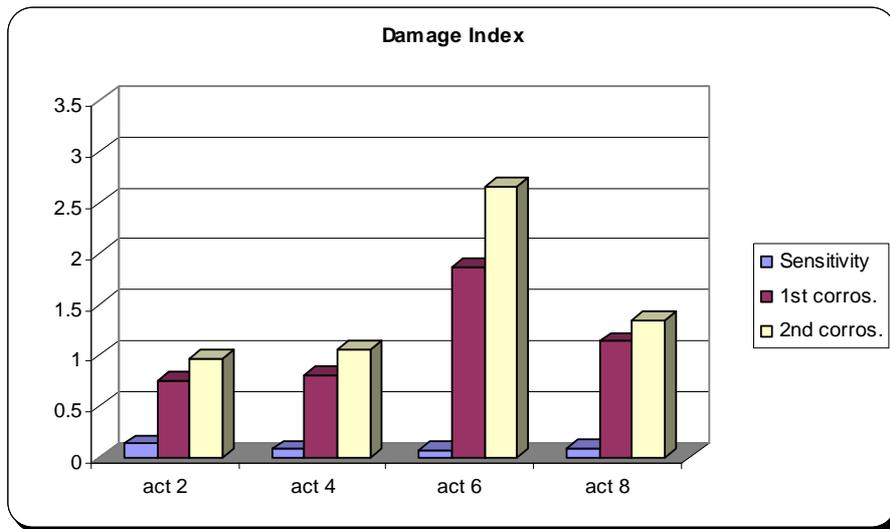
About the Damage Index method, it is possible to show a graph for each couple of actuator-sensor. To sum up the results, they have been gathered in a graph which contains four groups of bars. Every group represents the sum of indexes of the couple actuator-sensor, in which the actuator is fixed. Moreover each group consists of three bars: the first represent the sensitivity index, which is determined using FRFs of the healthy structure acquired at different times to measure the experimental error and the environmental noise and vibrations which can influence the FRFs; the second and third bars are the indexes obtained after the two corrosion steps.

Fig. 5.1.64 – Corrosion Damage Index “2”

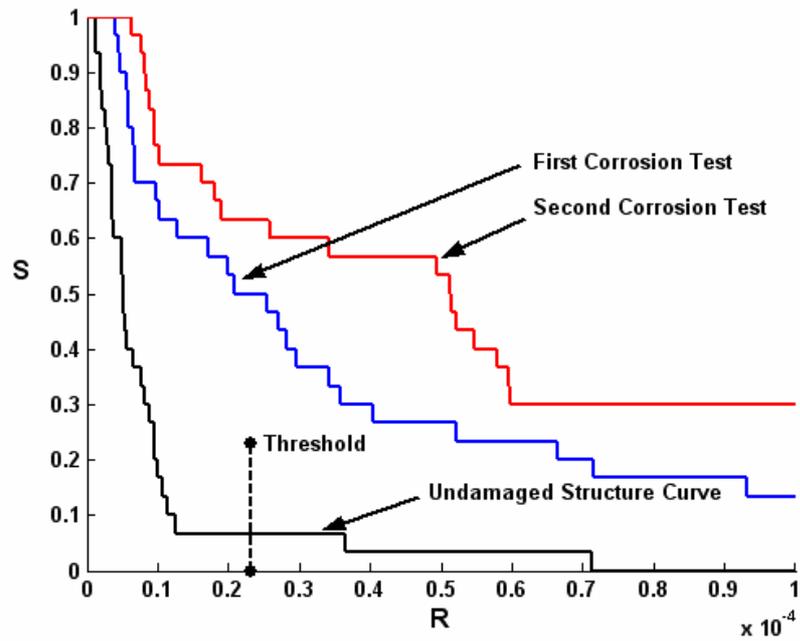
A Neural Network was trained by means of eight FRFs acquisition campaign of the sound structure.

Fig. 5.1.65 – Neural Network output

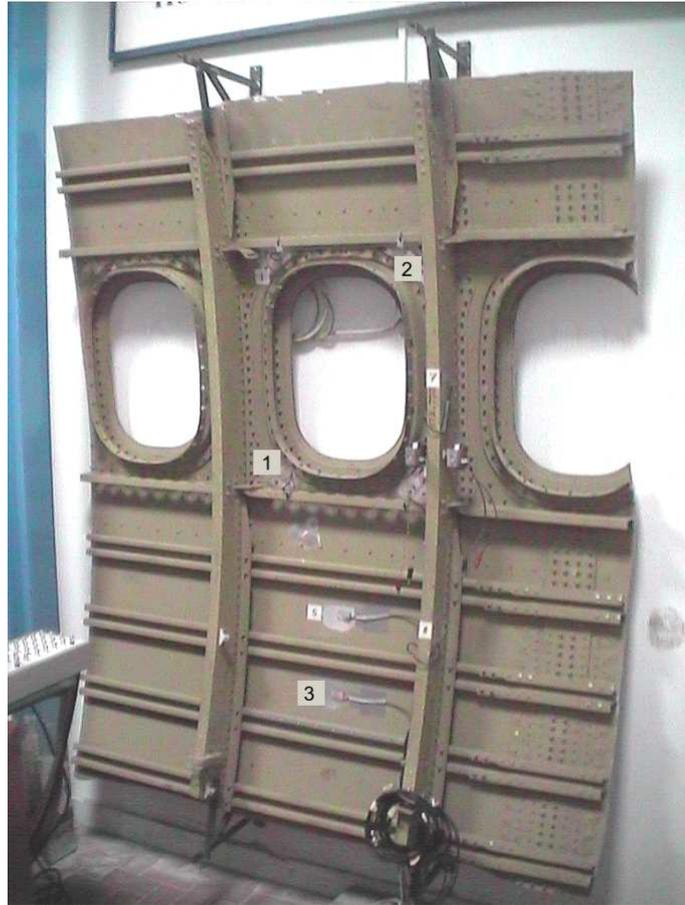
The excitation signal was the swept sine, generated from 0 to 5 kHz. Taking into account the coherence function behaviour, the frequency range was fixed from 1,0 to 5,0 kHz. The excitation voltage was equal to 125 Volt.

Fig. 5.1.66 – Third experimental tests set-up

The piezoceramic patch #1 was used as actuator, while the other two patches as sensors. Furthermore, by means of the Laser Vibrometer, twenty-two acquisition points on the structure have been defined.

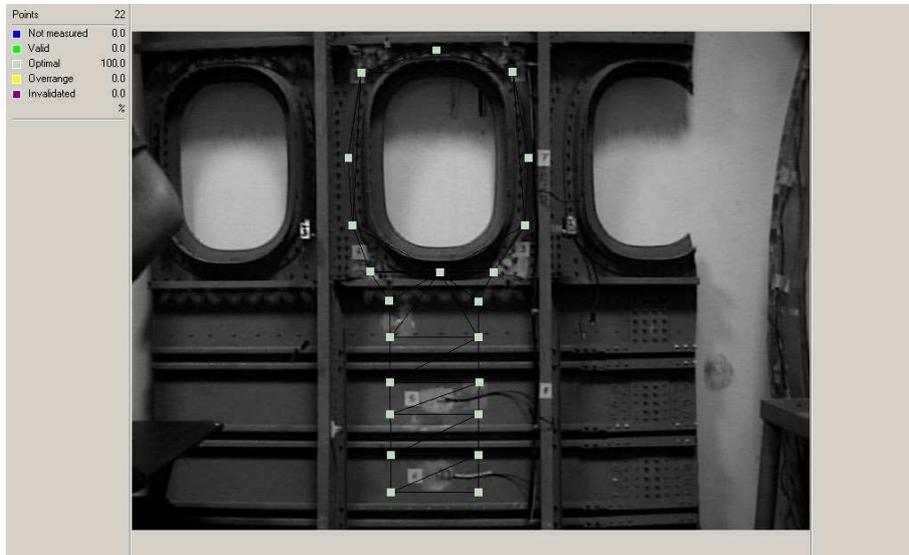
Fig. 5.1.67 – Laser Scanning Vibrometer scan points

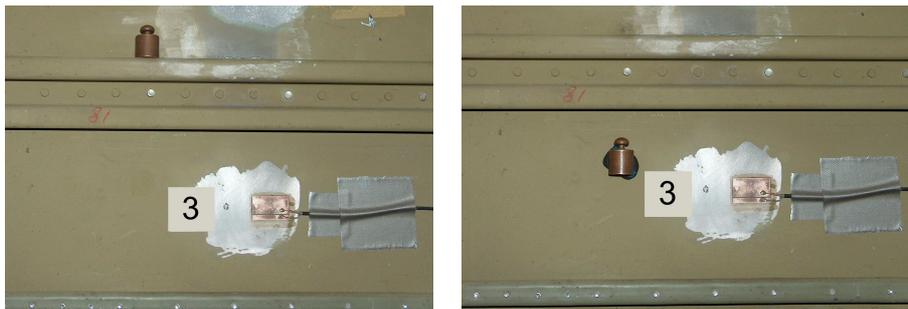
Fig. 5.1.68 – Mass addition

The mass of 50 grams was located in two different positions, a little far and close to the piezoelectric patch #3.

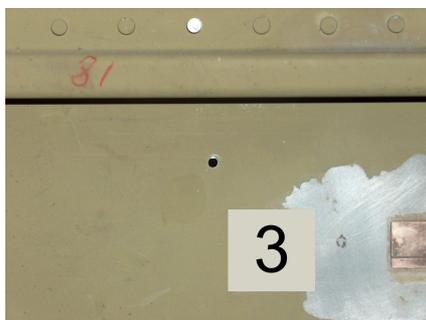
Fig. 5.1.69 – Drilling damage

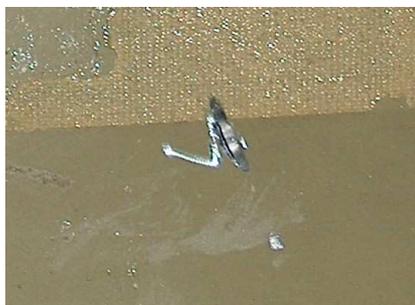
Fig. 5.1.70 – Crack damage

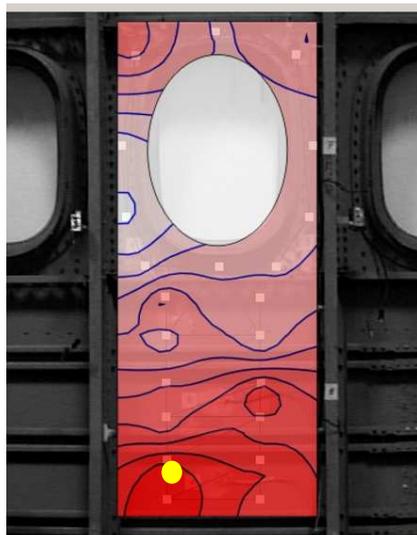
Fig. 5.1.75 – Hole Damage Index – Laser Vibrometer

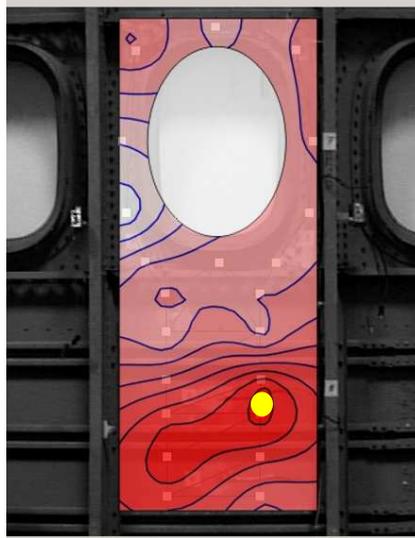
Fig. 5.1.76 – Crack Damage Index – Laser Vibrometer

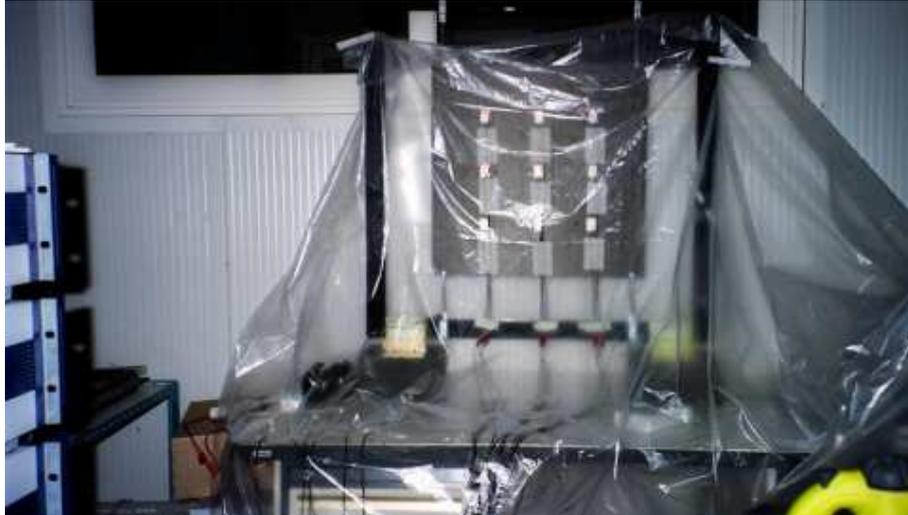
First, the temperature and the humidity were decreased, then increased. It can be observed in the figure 5.2.5, and table 5.2.1, that an equal temperature, but a different relative humidity gives different sensitivity indexes.

Fig. 5.2.4 – Environmental set-up

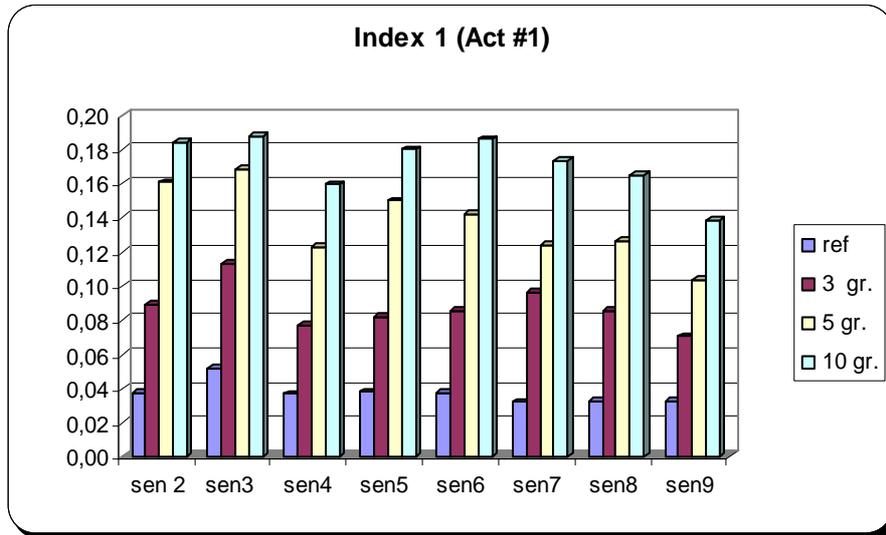
Furthermore, to test the capability of the DI method in quantifying an increasing damage, three masses of 3, 5 and 10 grams have been added close to the piezo patch #1. For that test the piezoceramic patch #1 was the only one which was used as actuator.

Fig. 5.2.10 – Quantification DI

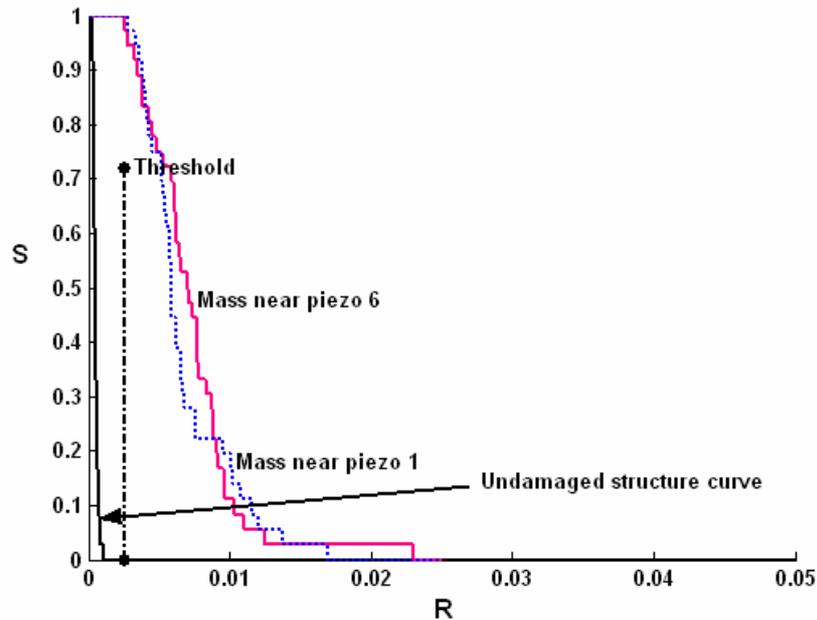
The neural network has been trained making use of the same FRFs of the healthy structure used for the determining of the Damage Index, as positive examples. Owing to reciprocity, since the system is linear, we have now used 36 FRFs only, reducing the redundancy of the information, so the network was lighter.

Fig. 5.2.15 – Neural Network output

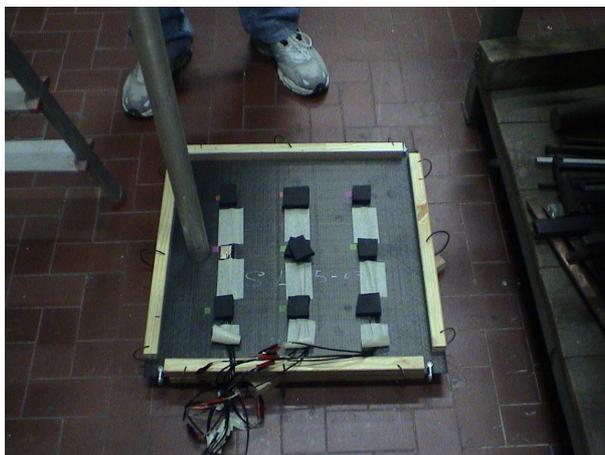
The second experimental test has consisted in three impact tests. A sphere made by steel, whose mass is 146,4 grams and the diameter is equal to 4 centimetres, has been used for the impact. The edges of the composite panel have been stiffened, and the panel has been placed horizontally.

Fig. 5.2.16 – Impact set-up

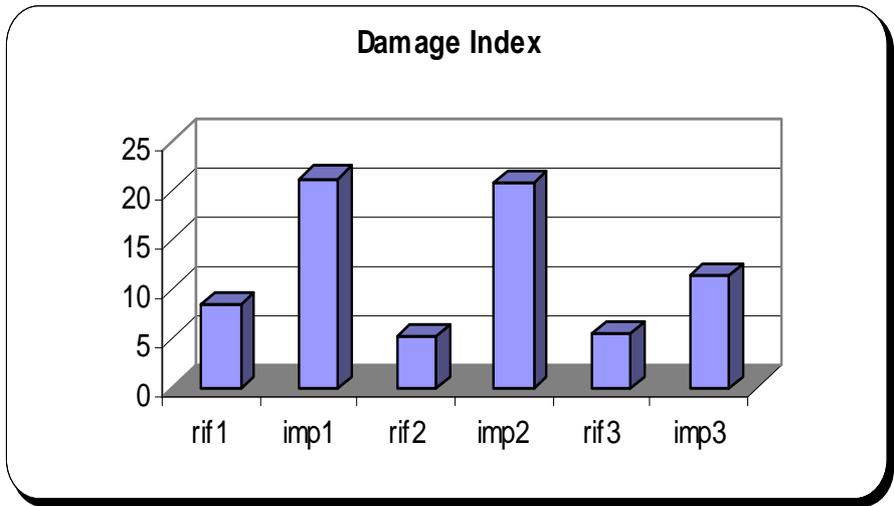
For the first impact test that sphere has been dropped from a height of 2 metres, so the impact energy has been equal to 2,87 Joule, close to the piezoceramic patch #4, outside of the patches array; for the second impact test the sphere has been dropped from a height of 2,80 metres, so the impact energy has been equal to 4,02 Joule, close to the patch #2, and, for the third impact test, the height was equal to 3,30 metres, and the impact energy has been equal to 4,74 Joule, internal to the array. The next chart represents the global index obtained by means of the Vibrometer.

Fig. 5.2.19 – Global impacts indexes

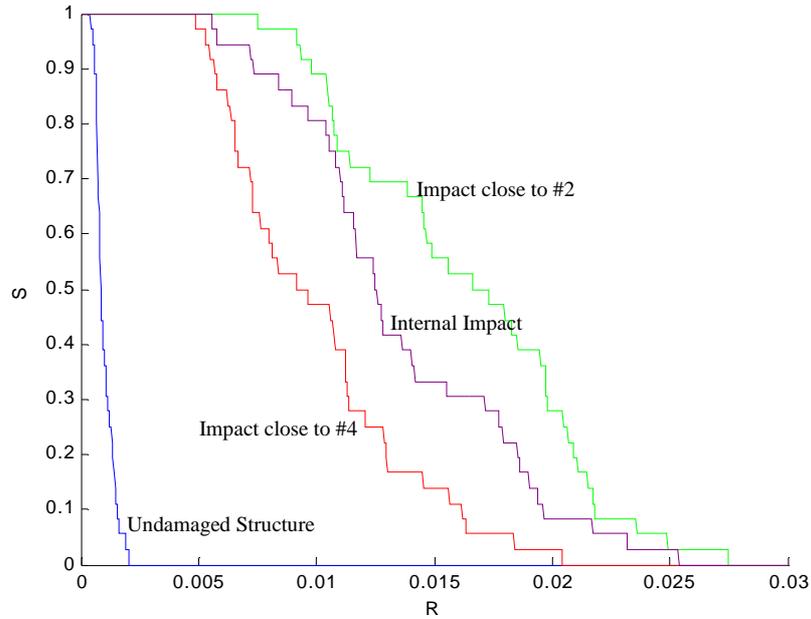
About the Neural Network, as for the second experimental tests, the impacts by means of the iron sphere, probably a damage has occurred. The neural network has confirmed it, in fact its output puts the impact curves far from the undamaged structure curve.

Fig. 5.2.24 – Neural Network impacts output

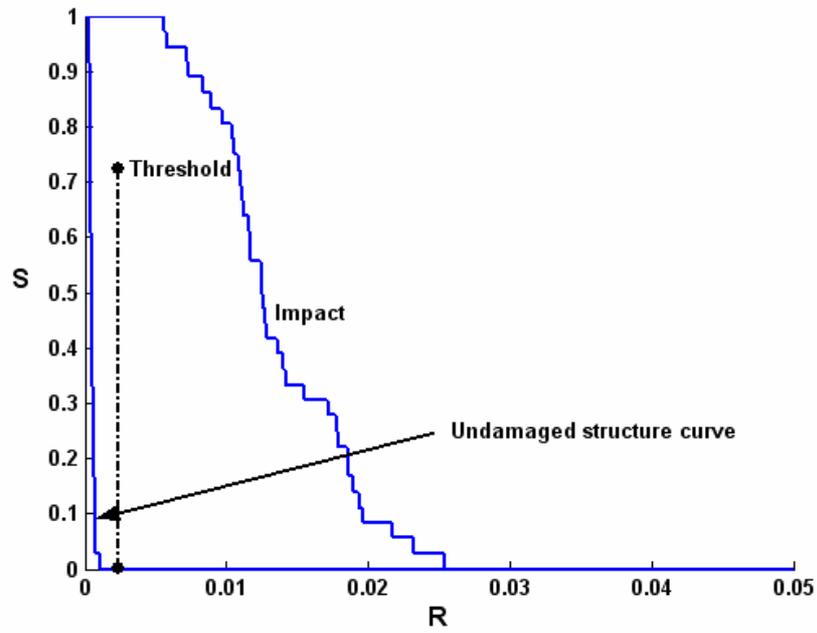
Next graph represents the neural Network output about the second impact, after that the threshold was determined as in Chapter 3.

Fig. 5.2.25 – Neural Network impact #2 output

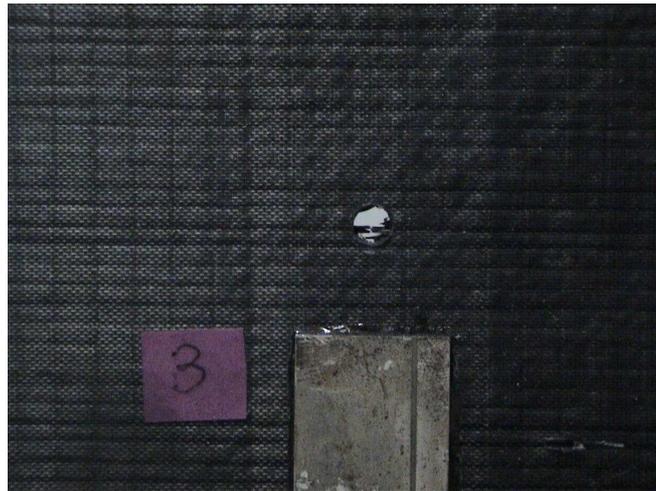
Fig. 5.2.28 – Hole mm.5 location #3

As well as the previous experimental tests, a global Damage Index has been calculated by means of the Vibrometer Scanning Laser for the hole close to the patch #3. The following chart show that result. It can be noted that the hole has been identified.

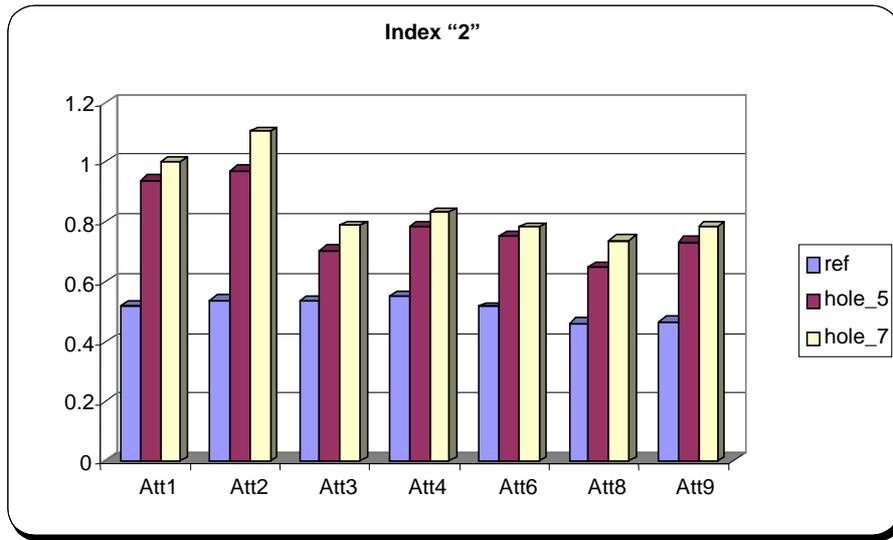
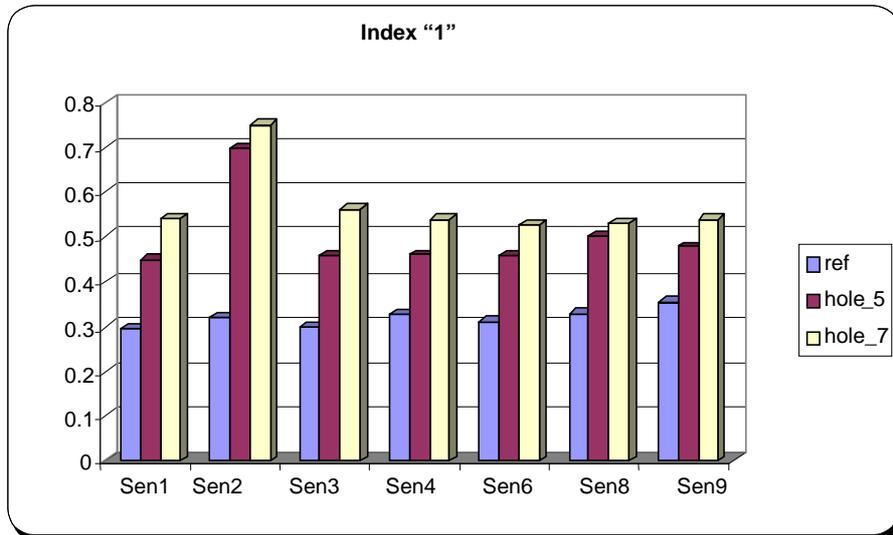
About the hole close to the piezoceramic patch #2, the next charts show the results.

Fig. 5.2.32 – Actuator DI "2"

Fig. 5.2.33 – Sensors DI "1"

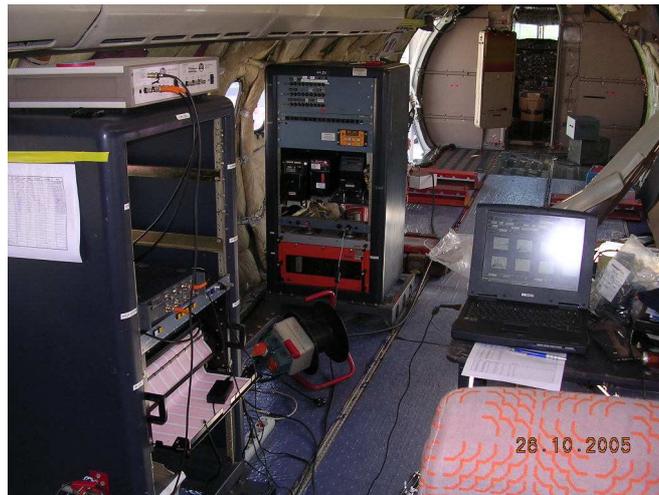
The used instrumentation has been formed by the Ono Sokki DS2100 spectrum analyzer which has generated the excitation signal and acquired the FRFs; the TREK piezoceramic amplifier; a laptop and the interface device to connect the aircraft cables to the instrumentation.

Fig. 5.3.3 – Instrumentation
