Università degli Studi di Napoli “Federico II”

Dottorato di ricerca in “Trasporti”
XVIII° ciclo

INNOVATIVE METHOD FOR DAMAGE IDENTIFICATION
AND STRUCTURAL HEALTH MONITORING BASED ON
VIBRATION MEASUREMENTS

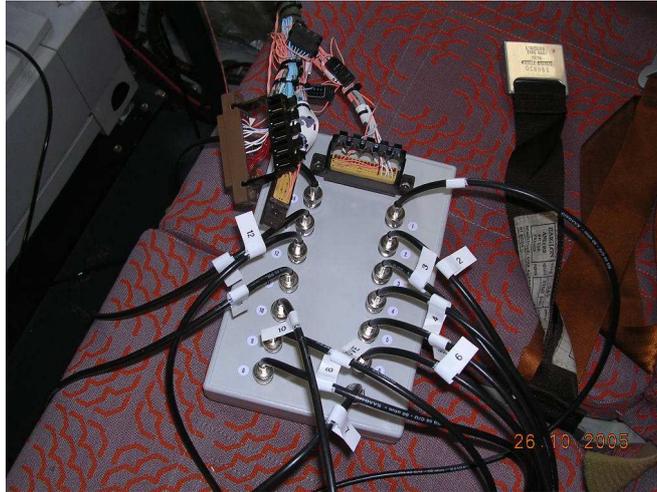
Fig. 5.3.4 – Interface device

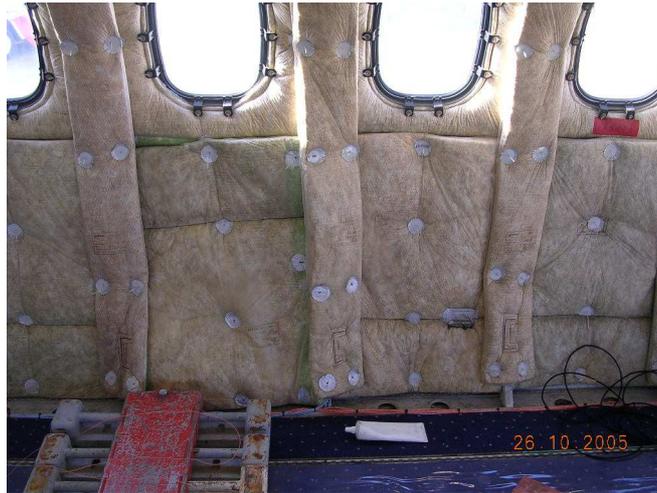
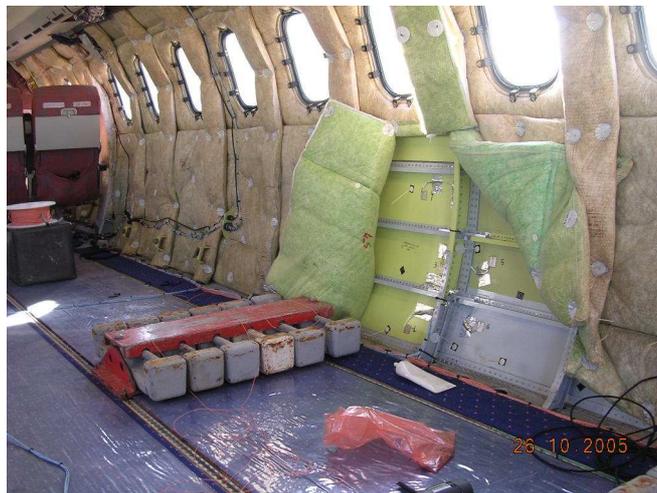
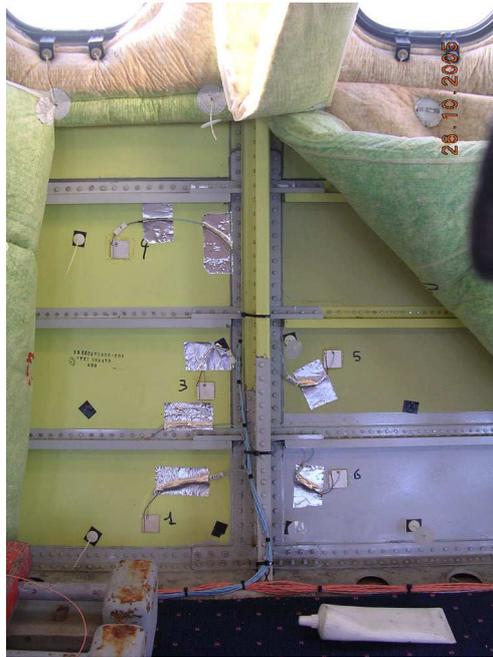
Fig. 5.3.6 – First monitored area

Fig. 5.3.7 – First monitored area

Fig. 5.3.8 – First monitored area (zoom)

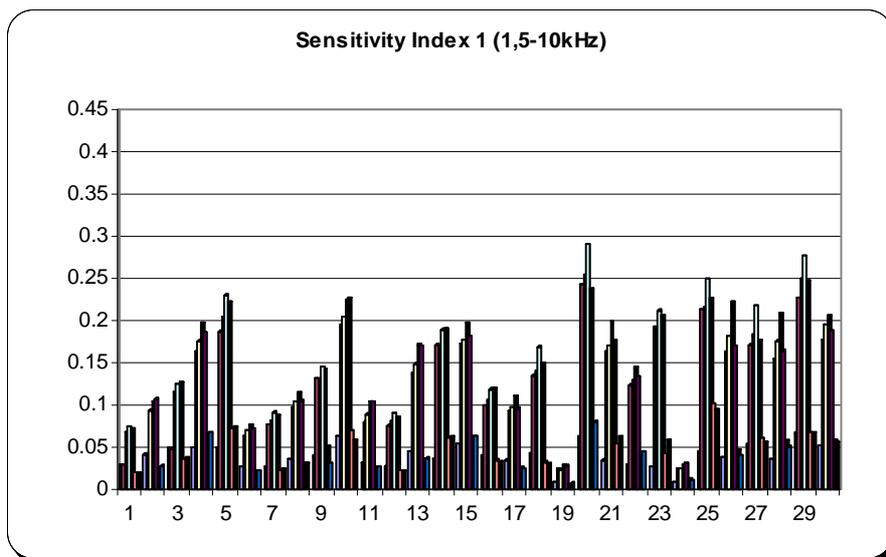
The following step has been a simulation of a damage, consisting of a removal of a rivet connecting the stringer #13 to the joint stringer, which have the Part Number 10S53070210, and it has made of 7075-T73511 aluminium alloy, derived by an extruded piece NTA 44256 (Alenia Technical Standard).

Fig. 5.3.9 – Sensitivity Index

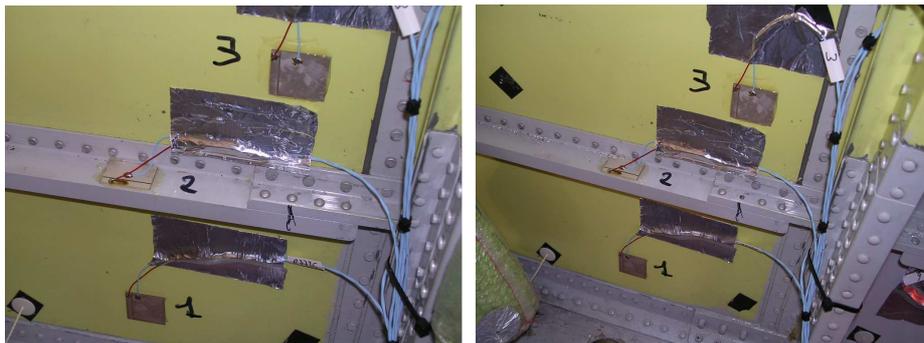
Fig. 5.3.13 – Rivet removal

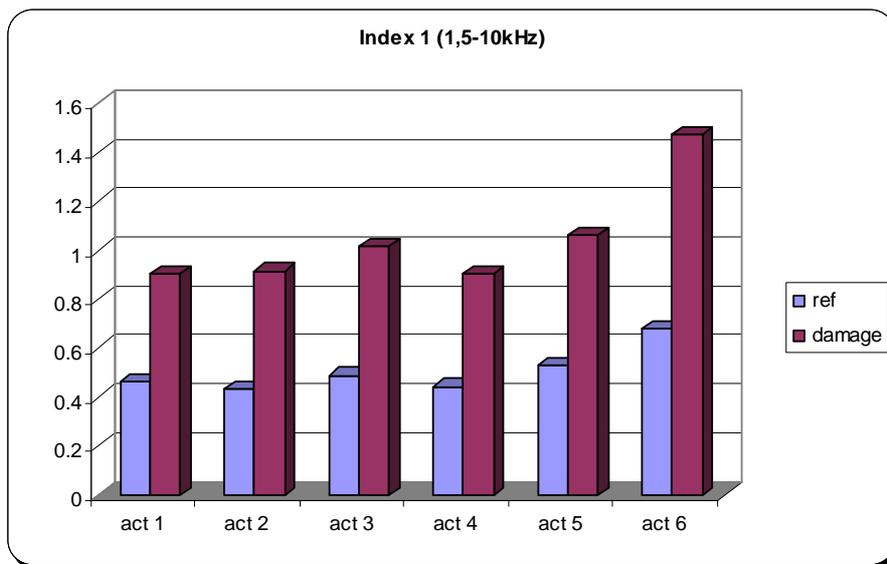
It can be observed that every index has identified the damage. In fact all DIs are higher than the sensitivity indexes. The localization is not so evident: maybe the point is that the system is very sensitive, in fact all the sensors have felt the presence of the damage, and, furthermore, that representation method is not the best. The piezoelectric patch #2, put on the stringer, does not give a good localization of the rivet failure. The Damage Index “2” works better than the Index “1”., and working at the highest range frequency gives the best localization. In fact, to localize the damage, it is necessary to calculate the Index “2” at the high frequency. In that case, the graphs show that the piezoceramic patch #3 localizes the rivet failure, helped by the piezoceramic patch #2.

Fig. 5.3.18 – Actuators DI

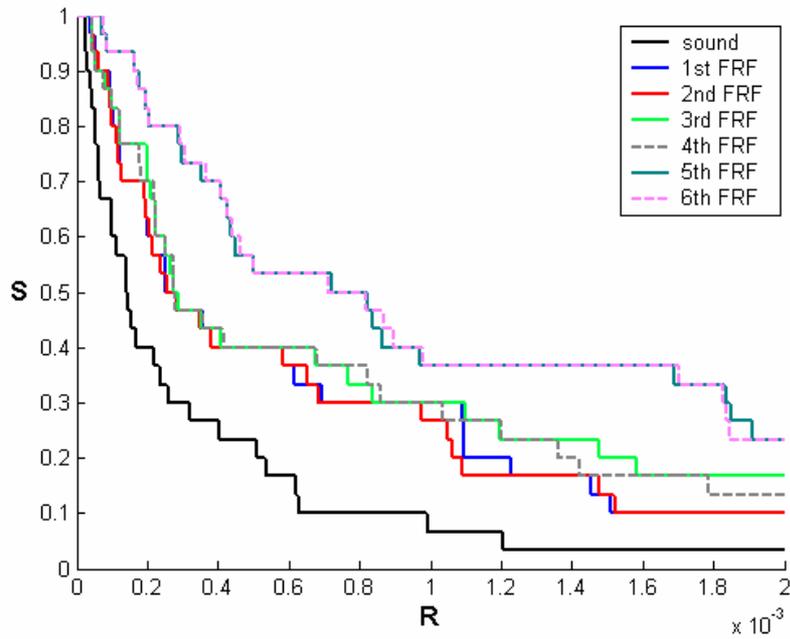
The neural network has been trained making use of the same FRFs of the healthy structure used for the determining of the Damage Index, as positive examples. Training and post-processing algorithms are reported in the chapter 3.

Fig. 5.3.37 – Neural Network output (range 1,5-10kHz)

It can be observed that all the curves obtained by the six acquisition of the FRFs of the damaged structure are located far from the x-axis, and far from the undamaged structure curve. The rivet failure has been identified. In that case the FRFs acquired do not give the same output curves, since the fifth and the sixth curves are located a bit farther.

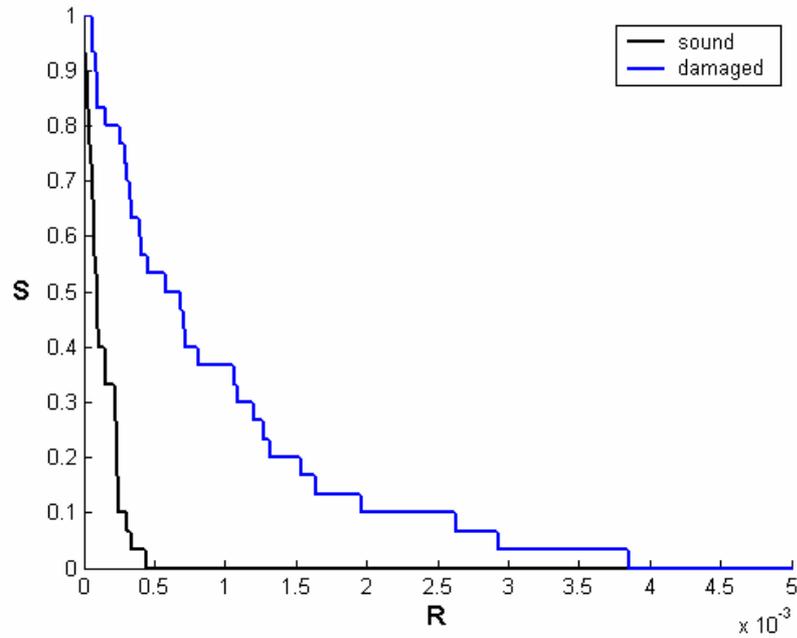
Fig. 5.3.38 – Neural Network output (range 10-18,5kHz)

Considering one only FRFs acquisition of the damaged structure for the neural network, it can be observed that the network, trained with FRFs acquired from 10 to 18,5 kHz, is able to identify better than at the lowest frequency range, since the distance between the undamaged and damaged curves is greater than the respective curves obtained at the lowest frequency range.

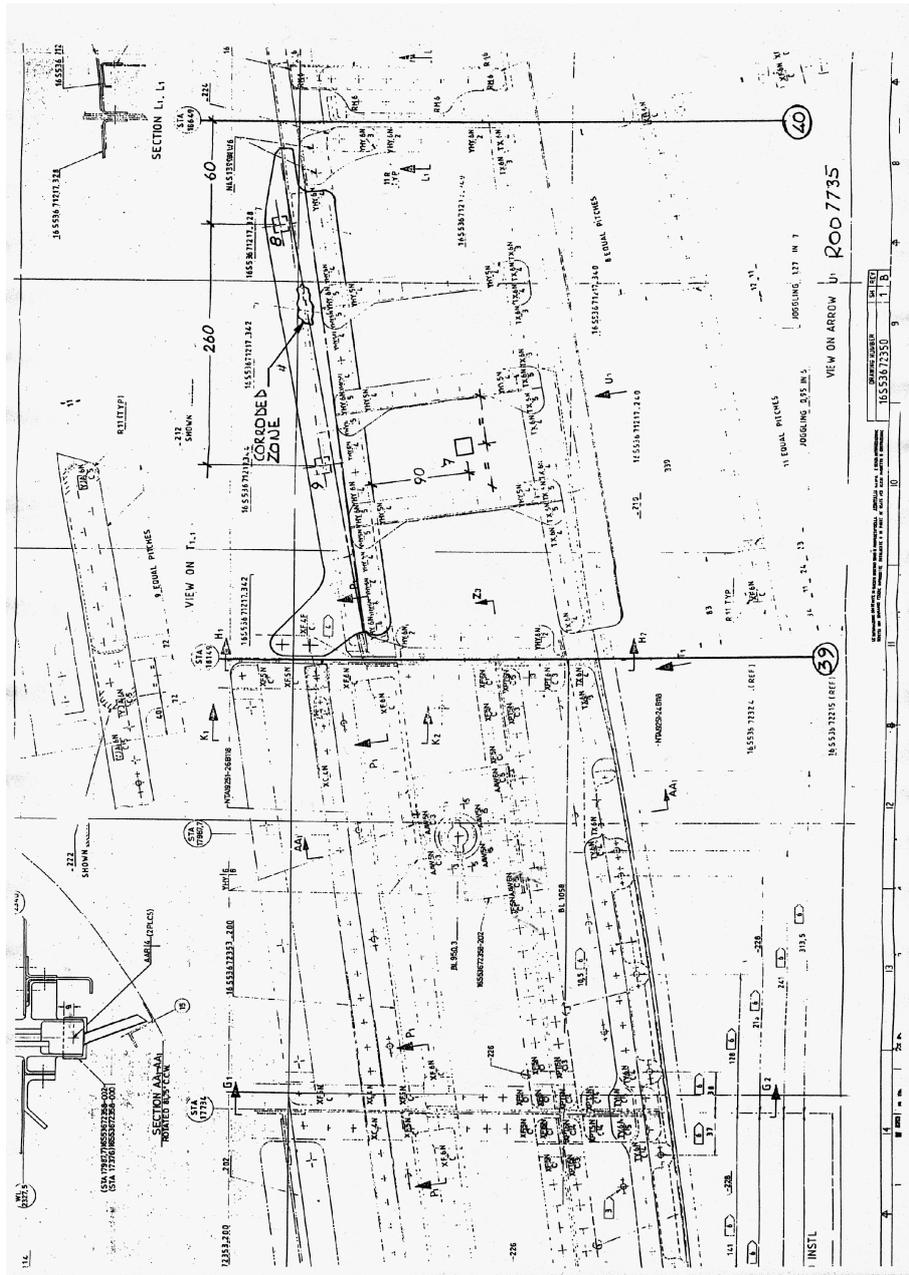
Fig. 5.3.40 – Second monitored area scheme

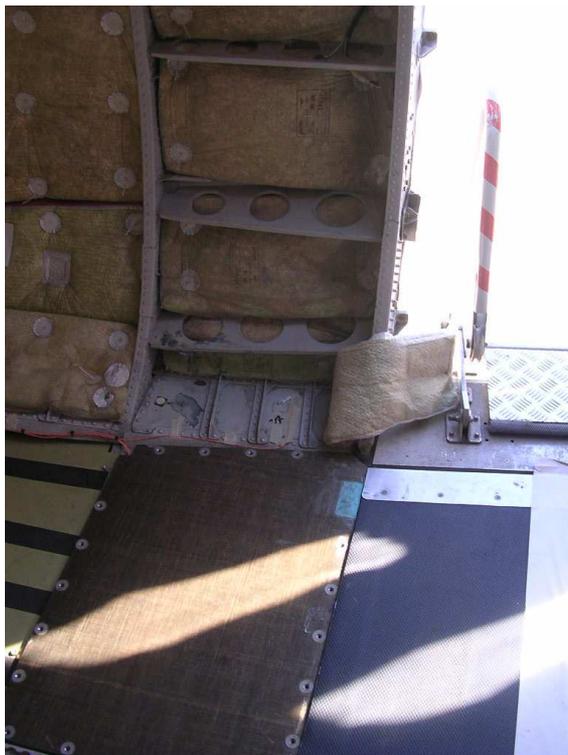
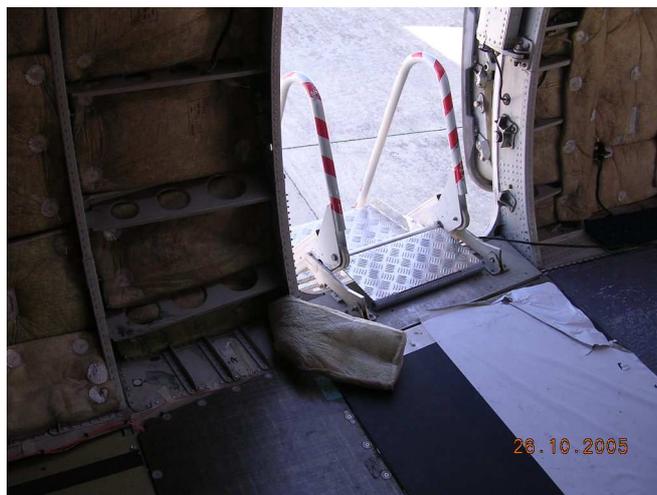
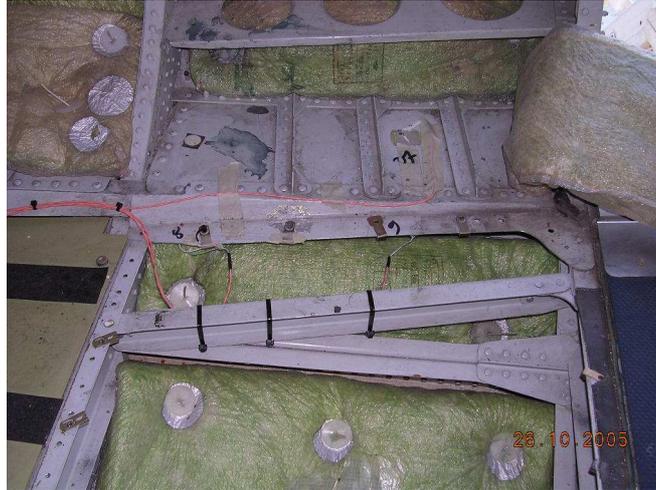
Fig. 5.3.41 – Second monitored area

Fig. 5.3.42 – Second monitored area

Fig. 5.3.43 – Second monitored area (zoom)

Three only piezoceramic patches have been bonded on the floor support zee, so the actuator-sensor couples are only six. An acquisition campaign, similar to that executed for the first area, has been carried out to define the sensitivity threshold of the structure and to train a Neural Network, formed by six FRF' acquisitions.

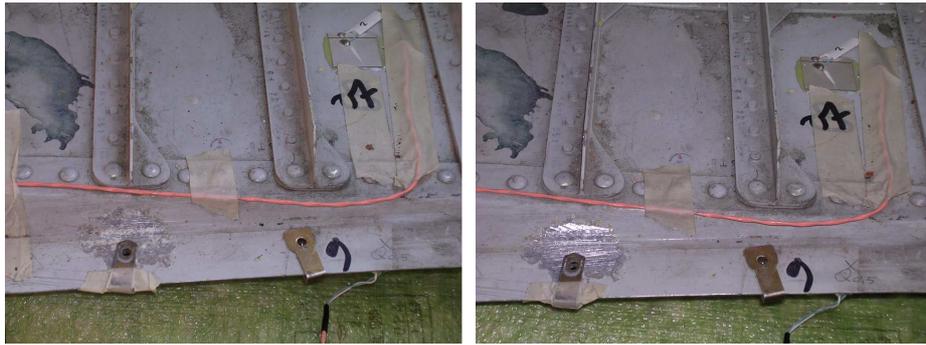
Fig. 5.3.44 – Damage simulated

The pictures show the damage imposed on the floor support zee. It is a light damage located between the piezoceramic patches #8 and #9. A campaign formed by four FRF' acquisitions has been executed. The following charts show an example of both Sensitivity and Damage Indexes obtained.

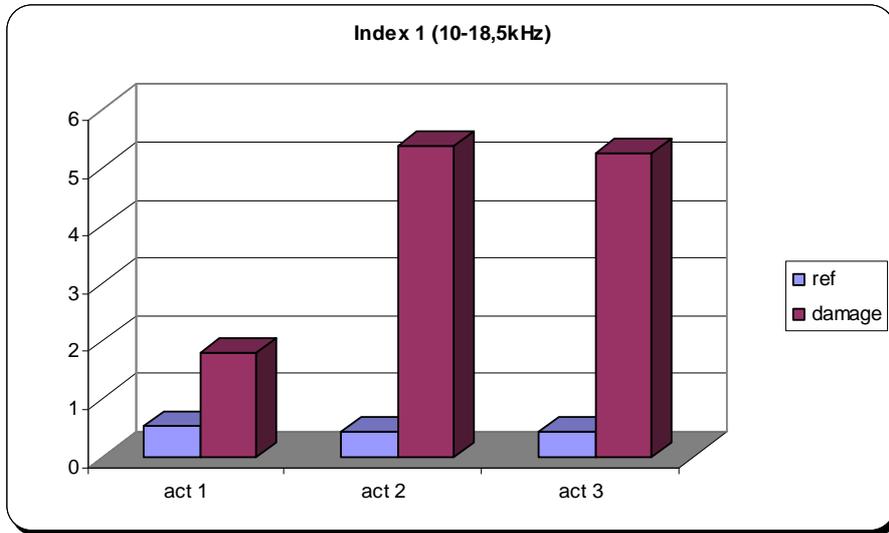
The next graphs summarize the results. The piezo patches #7, #8 and #9 are reported as actuators and sensors #1, #2 and #3 in order to make the explanation of the results clearer. Therefore, the damage is located between #2 and #3.

Fig. 5.3.55 – Actuators DI

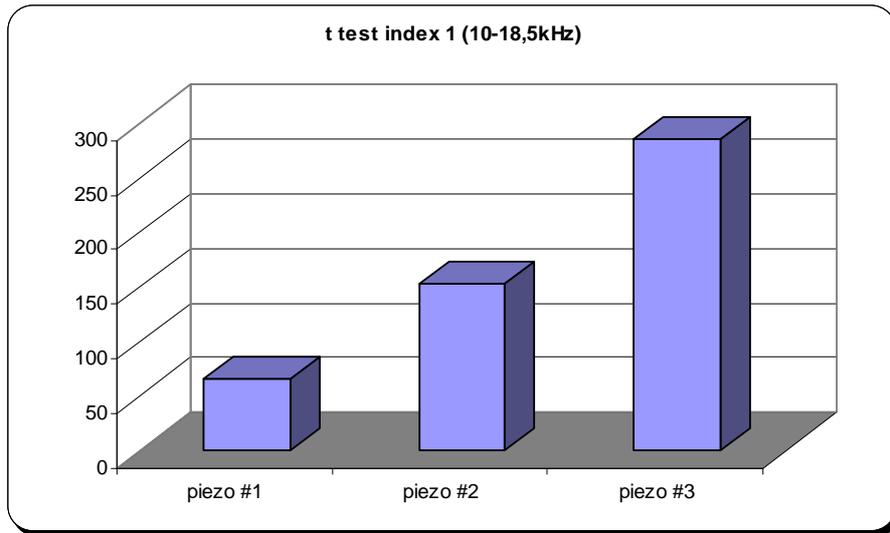
A T_test chart reported in the next page, unfortunately, shows that the Student T_test gives a not so clear localization of the damage, since the bars #2 and #3 have not the same value.

Fig. 5.3.63 – T_test

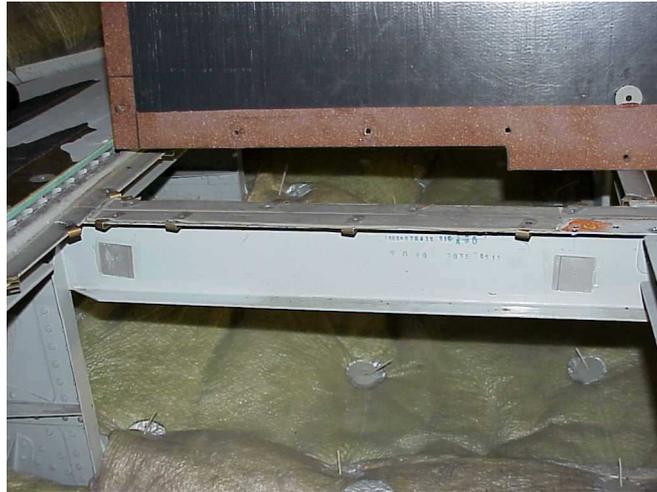
Fig. 5.3.76 – Floor frame

The third area is a floor support where the frame 42 is, on the station 19557, internal to the aircraft, close to the bulkhead. Its P/N is 16S53672412. On that part five piezoceramic patches have been symmetrically bonded. All patches have a square shape; the piezoelectrical patches #10, #12 and #14 have a thickness equal to mm.0,5, while the patches #11 and #13 have a thickness equal to mm.1. In that case the actuator-sensor couples are twenty.

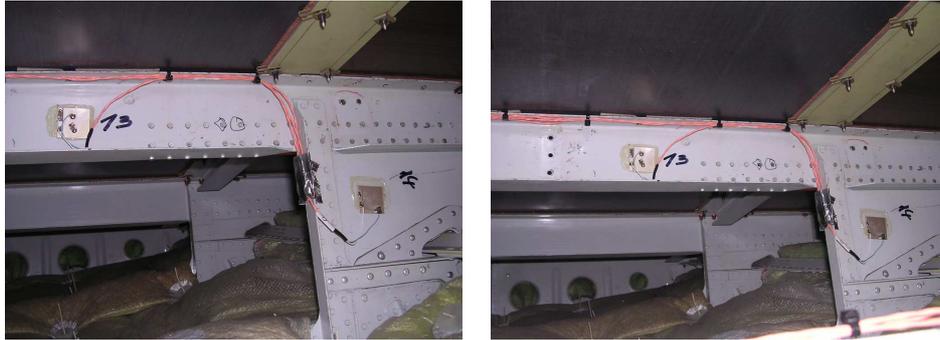
Fig. 5.3.79 – Rivets removed

In order to simulate a damage, two rivets connecting the floor frame to stiffener element have been removed, reducing the stiffness of the region between the piezoceramic patches #13 and #14.

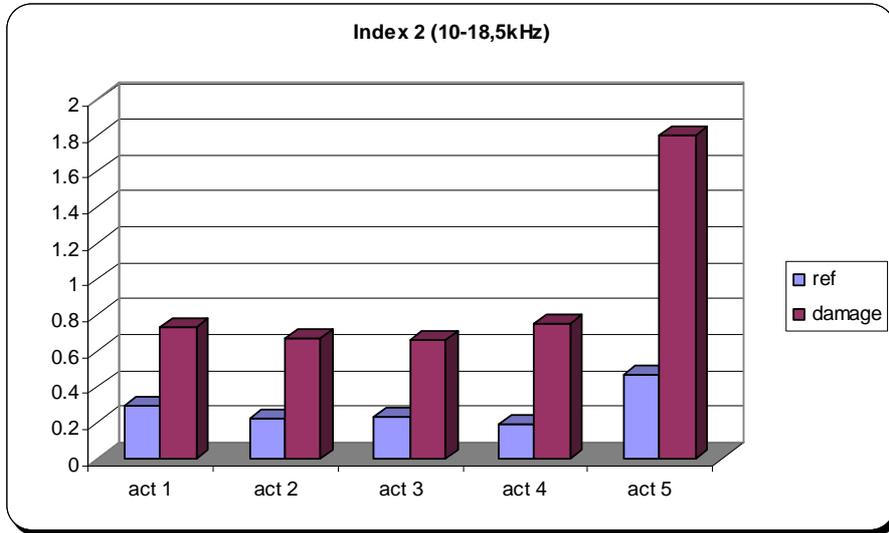
In order to extend the discussion about the damage localization, the following summarizing charts are shown, where the patches from #10 to #14 are reported as #1, #2, #3, #4 and #5. Therefore the damage is now located between the patches #4 and #5.

Fig. 5.3.94 – Actuators DI

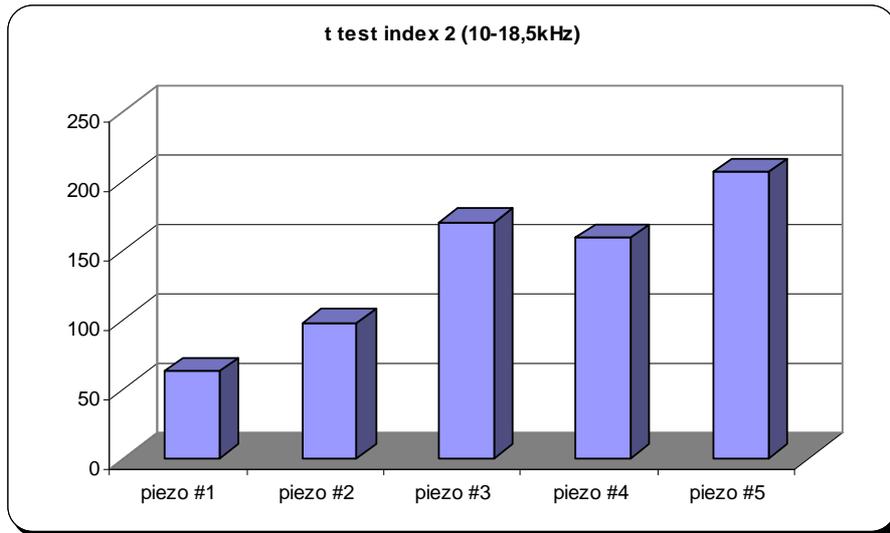
The T_test chart reported in the next page, as well as the Damage Index one, shows a good localization of the damage, even if in a not so evident way.

Fig. 5.3.100 – T_test

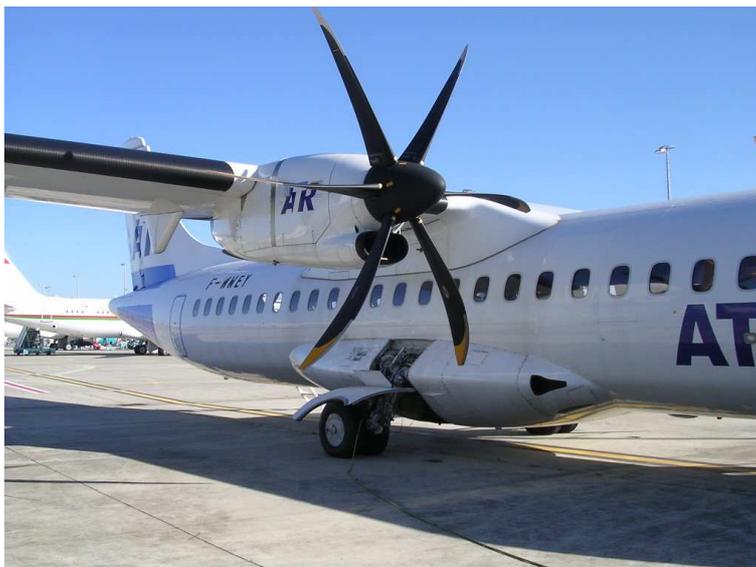
Fig. 5.3.113 – MLG without the fairing

The six piezoceramic patches have been able to monitor both the MLG truss shear and the fairing support. This area is critical because of the very high loads which are transmitted from the landing gear to the aircraft structure during the aircraft landing.

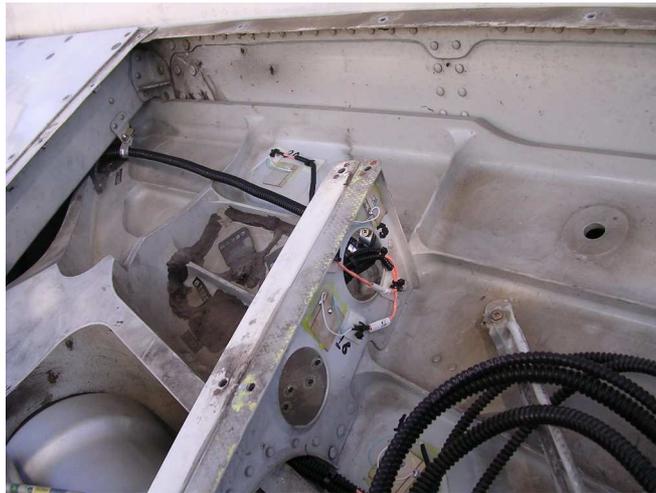
Fig. 5.3.116 – Damaged area

A rivet has been removed to simulate a damage of the conjunction between the MLG truss shear and the fairing support, close to the patches #18 and #19.

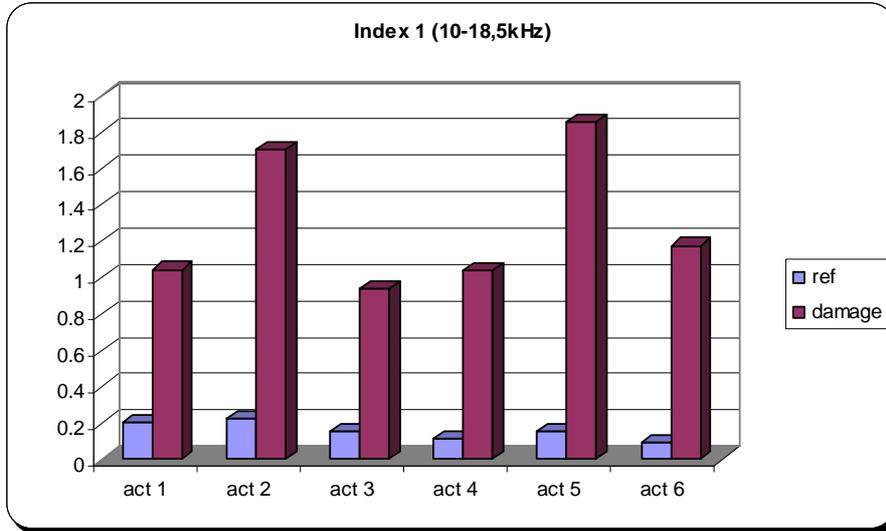
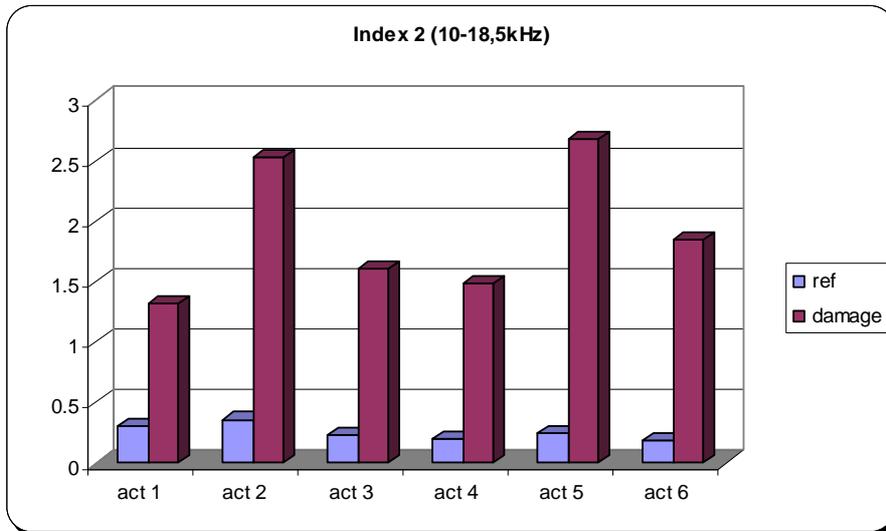
As usual, to better define the localization capabilities of the technique, the following summarizing charts are shown, where the patches from #15 to #20 are reported as #1, #2, #3, #4, #5 and #6. Therefore the damage is located between the piezoceramic patches #4 and #5.

Fig. 5.3.127 – Actuators DI

Fig. 5.3.131 – Actuators DI

From a point of view the indexes have identified the damage, even if the patch #2, identifies the rivet failure too.

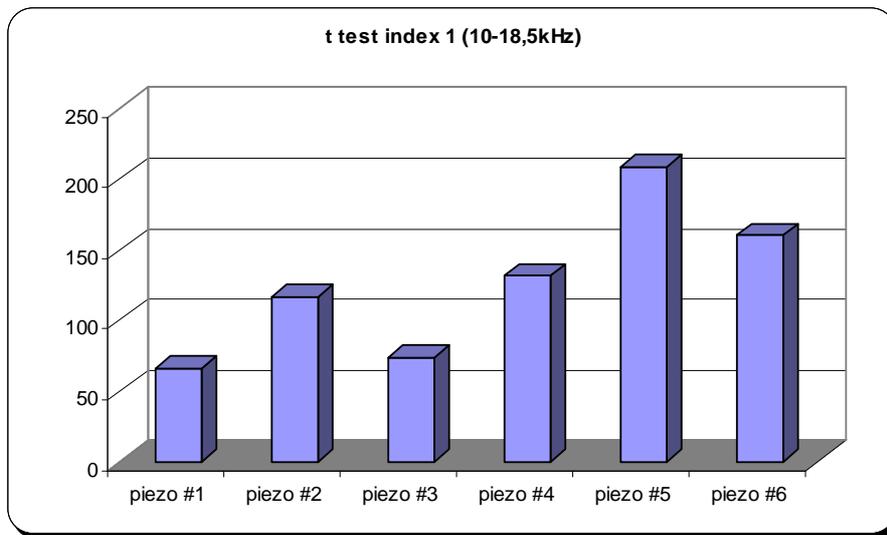
Fig. 5.3.135 – T_test

The T_test indexes have been able to refine the capability of the DI method in localizing the damage, in fact it is clear that the damage is close to the patch #5, i.e. the piezo #19 put on the fairing support.

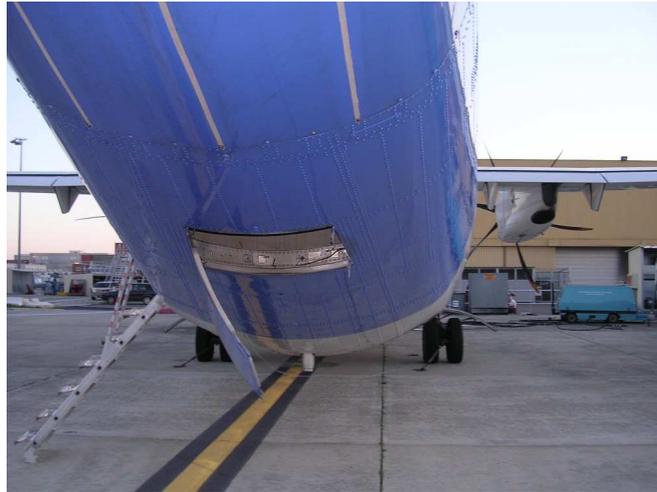
Fig. 5.3.148 – Tail cone

The fifth and last area which has been monitored is located into the tail cone, it is the lowest zone of the frame 45, whose P/N is 18S53871100. On that frame five piezoceramic patches have been glued, from piezo #21 to #25. They have a square shape; the patches #21, #23 and #25 have a thickness equal to mm.1, while the others have a thickness equal to mm.0,5. The patches have been bonded on the lowest part of the frame, therefore, only that region has been monitored.

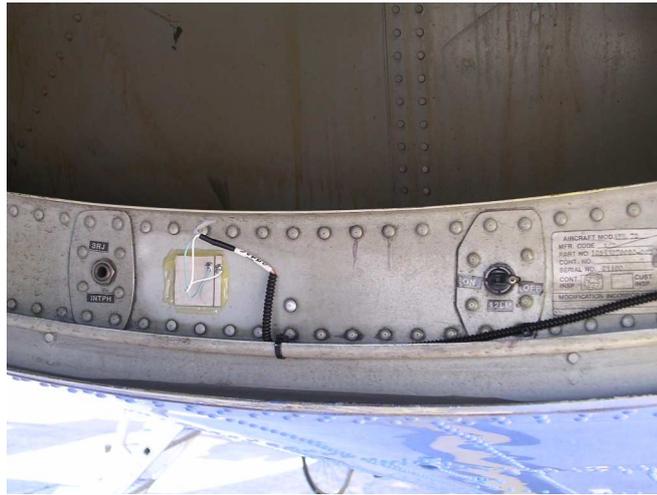
Fig. 5.3.151 – Area damaged

On that area the damage has been executed by means of a removal of two rivets which connect the frame 45 with a stiffener, between the piezoceramic patches #23 and #24.

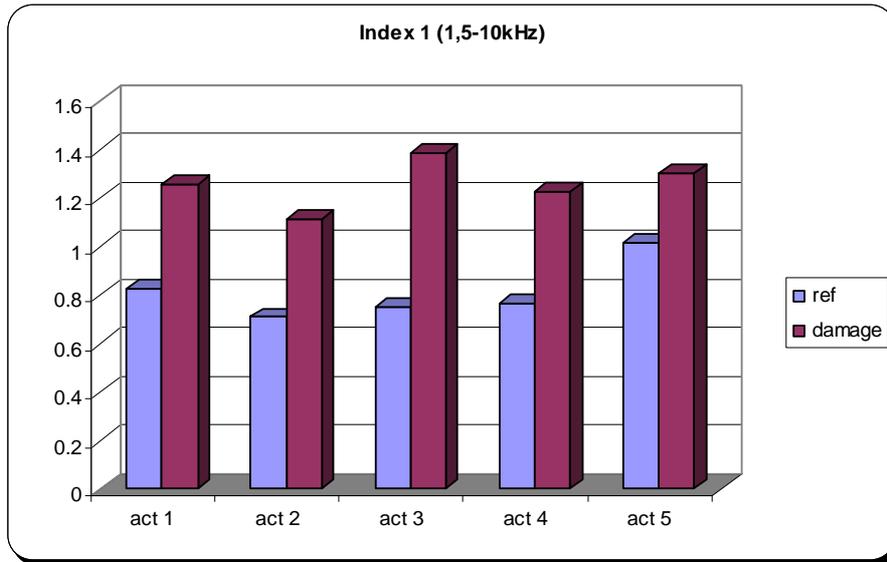
About the following charts, where the indexes are gathered fixing either the actuators or the sensors, the patches from #1 to #5 represent the piezoceramic patches from #21 to #25. Therefore the damage is located between #3 and #4.

Fig. 5.3.161 – Actuators DI

All the piezoceramic patches have identified the rivets failure, but the localization is not so evident.

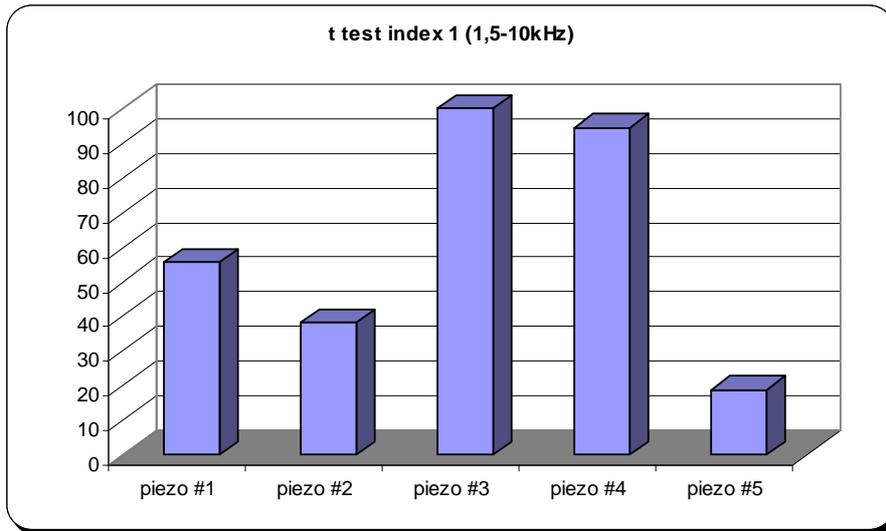
Fig. 5.3.169 – T_test

The T_test indexes localize the presence of the damage as well as in previous areas, since it is able to refine the data.
