**UNIVERSITÀ DEGLI STUDI DI NAPOLI FEDERICO II**  
**DiArc - DIPARTIMENTO DI ARCHITETTURA**

**DOTTORATO DI RICERCA - XXIX CICLO**

Conservation and Restoration of Adobe Architectural Heritage of Bam Citadel (Iran),  
Affected by the 26 December 2003 Bam Earthquake: Problems and Issues

Aprile 2017

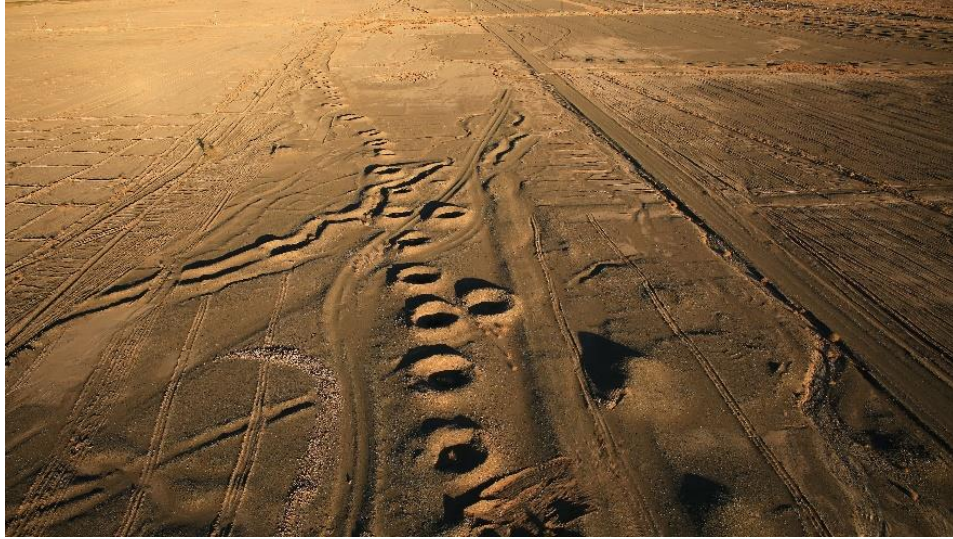
**Figure 1.4-** Aerial photo from Qanat network in Bam region (Photo by Rashedi, 2014. Source: UNESCO-WHC).

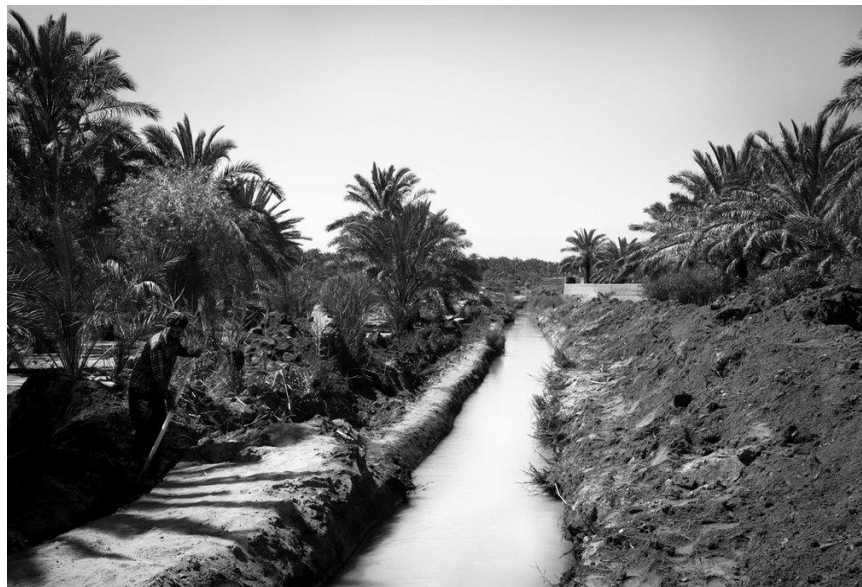
**Figure 1.5-** Subterranean water output in Bam city (Photo by Roghanchi, 2015. Source: <https://www.theguardian.com/world/iran-blog/gallery/2015/oct/20/iran-qanat-ancient-water-system-pakam-pictures>).

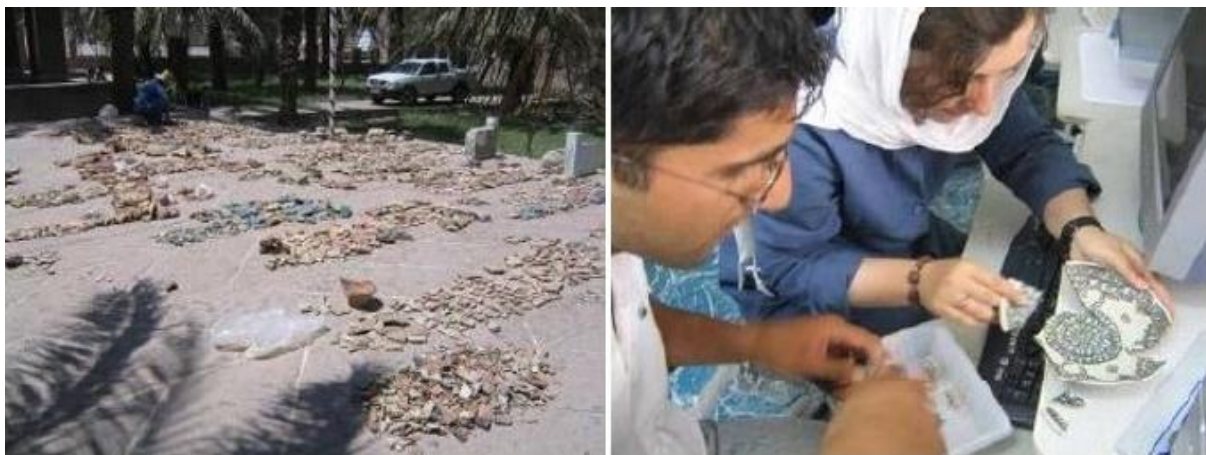
**Figure 1.8-** Some findings in Bam Citadel after the 2003 Bam earthquake (Source: archive of RPBCH).

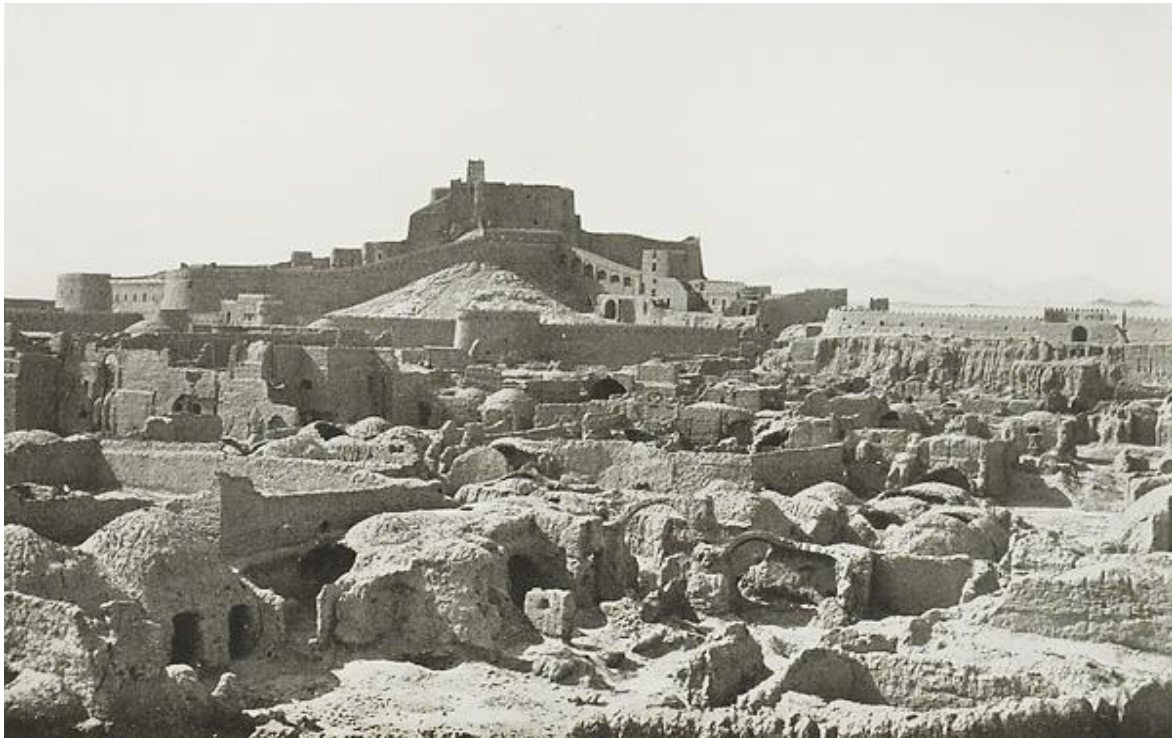
**Figure 1.11-** According to the statement of Sir Aurel Stein, it can be said that the citadel is abandoned at the end of 19th century or sooner in Qajar Period (1795-1925 AD). As it can be seen in this photo, the citadel had suffered from vast destruction. Whether it might have been due to another earthquake, or due to human destruction is a question to be investigated (Photo by Sir Aurel Stein, 1930. Source: Digital Archive of Toyo Bunko Rare Books. Retrieved from <http://dsr.nii.ac.jp/toyobunko/XIII-6-A-4/V-1/page/0025.html.en>).

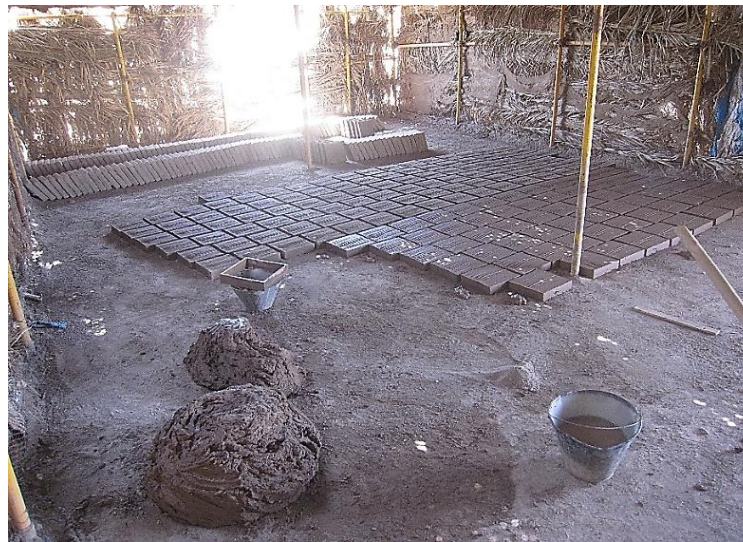
**Figure 2.7-** Adobe-mud brick production at Bam Citadel’s workshop (Photo by Rouhi, 2015).

living spaces. After sunset, when the temperature drops rapidly, the body of massive adobe-mud brick structures will continue to transfer heat to the interior spaces of the house for several hours due to the time-lag effect. Furthermore, this construction material is recognized as one of the sustainable construction materials, meaning that they have little impact on the surrounding environment. Their “embodied costs,” which means the cost to individuals and society overall in its creation, storage, distribution, use and maintenance are very low (Austin & Holmes, 2006). In addition, the construction practice of adobe structure is naturally simple and does not require any special energy resources. Skilled technicians (engineers and architects) are generally not involved in this type of construction, hence the term ‘non-engineered construction’ and ‘informal construction’ (Figure 2.7) have also been used to refer to such constructions (Blondet et al., 2011).

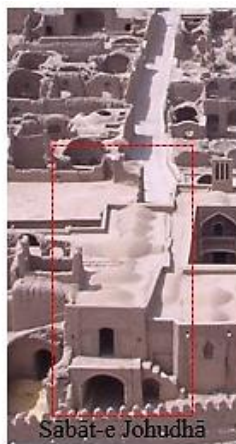
**Figure 2.10-** (Left) roofed allay in Sābāt-e Johudhā (Photo by Ysuda, 2001. Source: archive of Bam3DCG); and (Right) the effects of sun and wind on curved adobe roofs, which are exposed to minimum sunbeam and maximum wind breeze (Designed by Author).

As a consequence of the advantages of curved roofs, a domed roof is always exposed to winds blown in different directions, which is why if an air vent is present at the apex of a domed or cylindrical roof, it takes the favorable wind and conducts airflows from outside into the main rooms (see Figure 2.10 (right)). Furthermore, from pre-historic time, the ceiling light, provided by air vents, is known as an effective tool to sum up a lot of lights for interior space of buildings. Rotation of sunlight from the ceiling light as a channel with circular section where air particles in a thin line is visible gives special glory to the whole area of the buildings. In Bam Citadel, even in streets for providing shadow, there were interlinked arches between two walls of the allays called “Sabat” to make the high temperature of the city tolerable, like “Sābāt-e Johudhā”. In hot and arid areas of Iran, Sabats usually covers Bazaar.

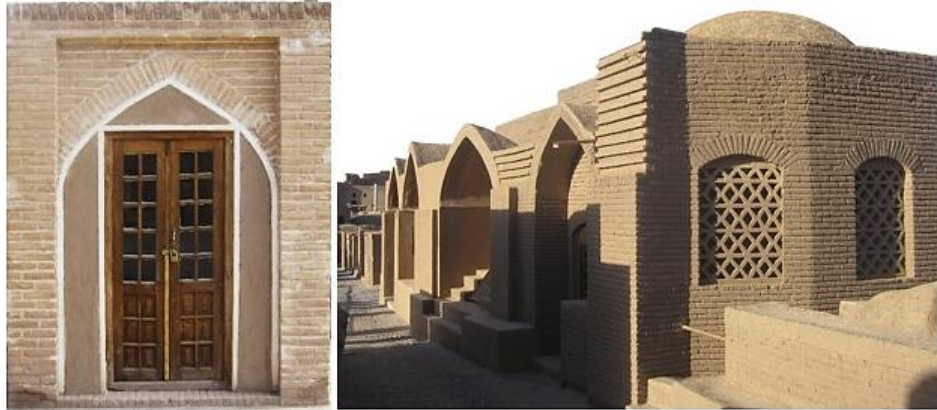
**Figure 2.12-** Samples of windows in Bam Citadel designed with net-like wooden and brick covers (Photos by Rouhi, 2015).

The heat absorbed from windows and doors could be minimized by their installation in exact location, their shape and the way they opened. In Bam Citadel, there were few windows, where most of them faced to the south and located at top of the walls to prevent the heat absorption from the ground. These windows and doors were usually small and sometimes covered by net-like wooden or brick covers.

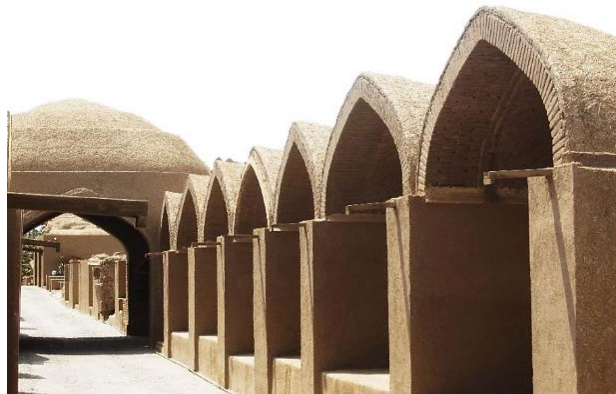
**Figure 2.13-** Downpipes on the ceilings of Bazaar of Bam Citadel (Photo by Rouhi, 2015).

In every structure, whether ancient or new, the first thing that must be considered is conductivity of non-conditioned water like rainfall. In adobe-mud structures, water is known as one of the main causes of deterioration and destruction. In order to prevent accumulation of rainfall in a corner of a building, some downpipes were embedded in different parts of the adobe wall to conduct water to outer side. It should be noted that the length of downpipe is very important in the time of its design since the collected water in the foot of the adobe wall might cause damages.

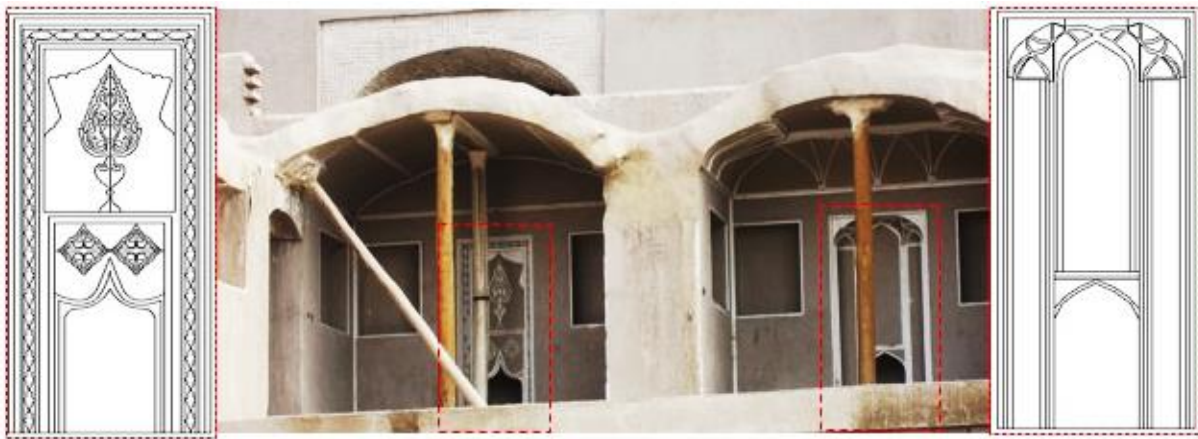
**Figure 2.14-** Samples of architectural form of heaters in the Stable of Bam Citadel (Photo by Rouhi, 2015).

From the caveman era up to now, fire has had an important role in human's life. At first, it was in the form of hole in the ground at the center of a place where they lived. Over time, with the development of civilization, people placed heater inside of the walls. In different parts of Iran, regardless of the type of materials, virtually heaters have the same shape with different materials. In Bam Citadel, the heaters were embedded in the walls. Bam's architects usually followed the conventional architectural styles of their own time for decoration of heaters. There, heaters in both public and governor's district were built of adobe-mud brick and their decoration were usually with chalk trim or brick bumps on the surface of the adobe walls. Meanwhile, there was an architectural compliance between decoration and design of heater with other parts of the rooms like roofs and niches.

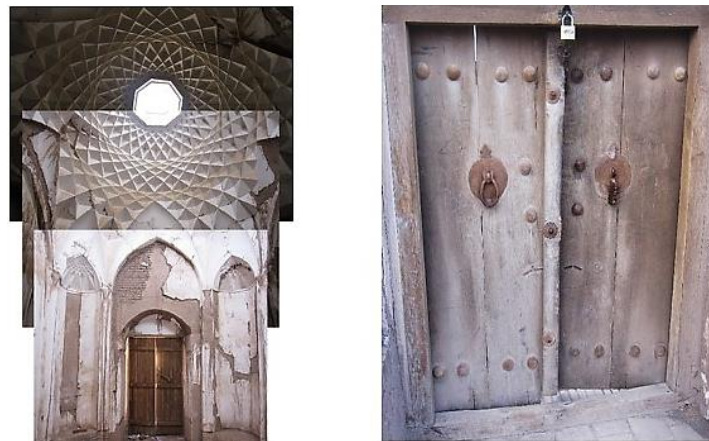
**Figure 2.15-** (Left) the narthex of the Ameri House in the city of Bam (Photo by Rouhi, 2015); and (Right) metal handles of a door opener in the Mirza Naem School of Bam Citadel (Photo by Rouhi, 2015).

Indeed, the influence of Islamic culture on Iranian architecture portrays excellent evidence of how spatial organization in housing is formed by the values of privacy. Optimum visual privacy is a predominant design objective to ensure the safety and privacy of female family members within Muslim homes (Al-Kodmany, 1999). As mentioned by Pirnia (2005b) about the importance of the issue of privacy in Iranian architecture, "one of the most important principles considered in Iranian traditional architecture, especially after Islam, is the principle of privacy." The interior spaces in Iranian Islamic architecture are separated from the exterior space by a wall. Behind the door, there is only a projected part named narthex, where guests wait till the host opens the door. This strategy was used to respect the privacy of males and females in order to avoid unnecessary communication in social relationship. This is the influence of Islamic culture on Iranian architecture. Following the subject of privacy, there is another set of two metal handles on the door: one handle with soft sound is shaped as a ring for use by females and another with rough sound is shaped as a hammer for use by males; through the sound of each handle the residents could easily find out the gender of their guest (see Figure 2.15 (right)).

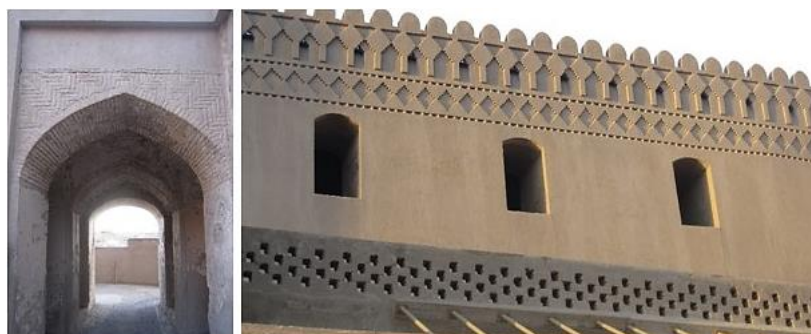
**Figure 2.16-** (Left) bricklaying and thatch coating on the top of the arch shows that change in the height is related to another era (Photo by Rouhi, 2015); and (Right) brick decoration in the south wall of the Barrack of Bam Citadel (Photo by Rouhi, 2015).

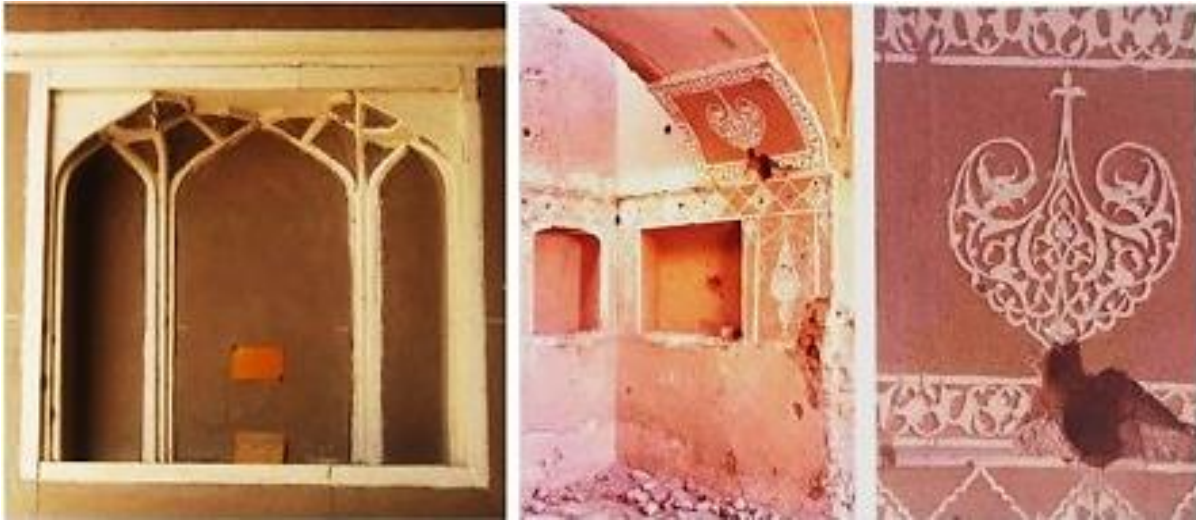
**Figure 2.17-** Decoration of niche in the West of Sabat House (Left), and Governor's House (Right) (Source: archive of RPBCH).

In one of the examples, we can refer to the decoration of niches in Bam Citadel. Iranian architects for setting of decorations and available objects have usually created indentation on the walls. In different structures of Bam Citadel, niches had a very important role. The main reason for creating niches in Bam Citadel was its limited space for setting of luminous objects, and making their availability easier. Furthermore, niches were also embedded on the upper floors of buildings, because they could decrease the dead load of the walls.

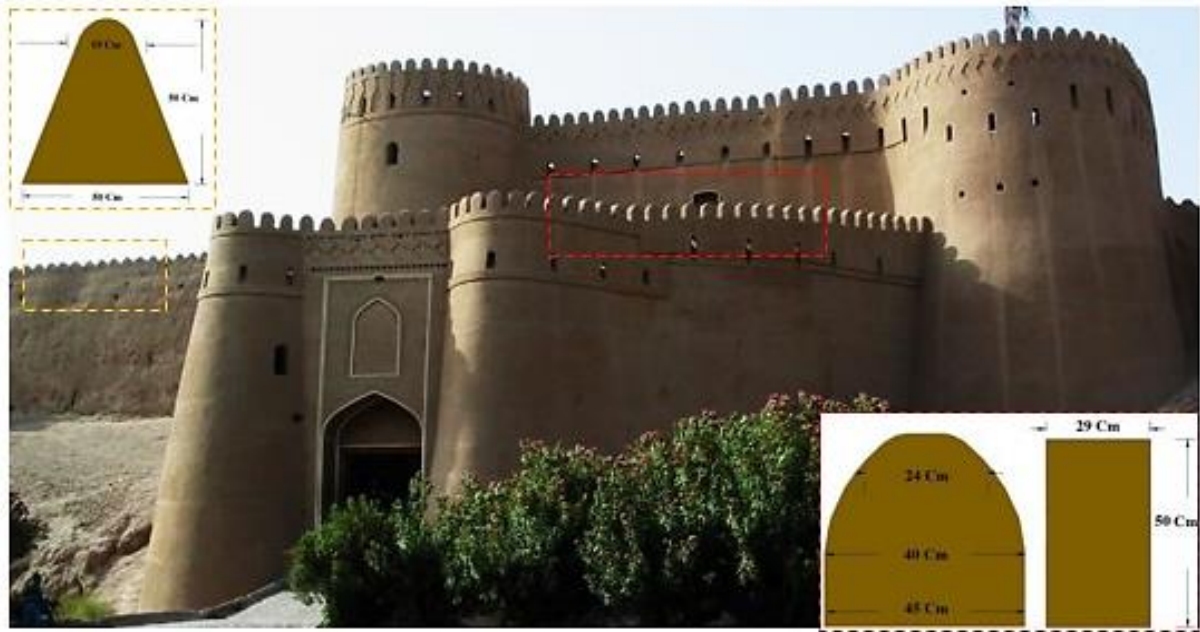
**Figure 2.18-** Variations of the Battlements in the First Gate of Bam Citadel before the 2003 Bam earthquake (Source: archive of RPBCH, designed by Author).

In Bam Citadel, the shape of battlements on city wall and that of the governor's district are the same, but there are some minor differences in their form. Given that Bam Citadel over time have widely been subjected to some changes, these changes in battlements were more obvious than any other parts. By approaching the present time, less accuracy in their conservation and restoration can be seen. The question that may arise here is whether the battlements had the same form in Medes, Sassanid and Achaemenian periods? The answer to this question could be that since the dimension of brick moulds in various periods have been different from one period to another period, if there were any differences in shape (8×32×10 cm, 32× 36×36 cm, 12×42×42 cm, etc.), it could be due to the size of bricks at the desired time. Now archeologists are estimating the age of different parts of Bam Citadel according to this specification.

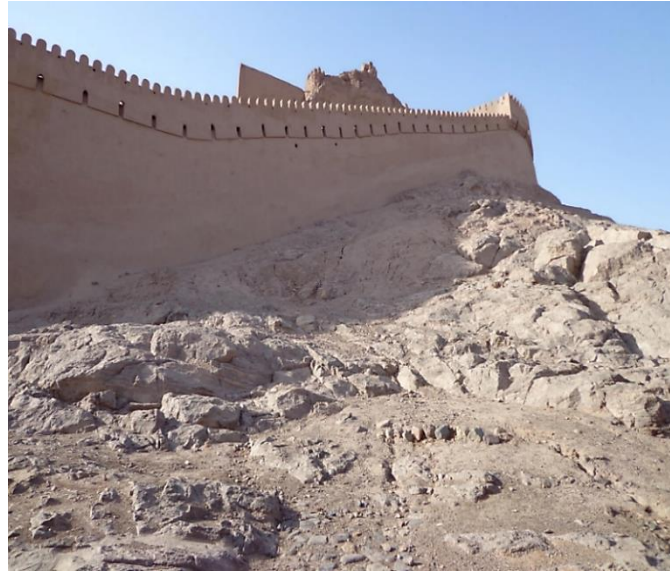
**Figure 2.21-** Bedrock base of the Governor's District of Bam Citadel (Photo by Rouhi, 2015).

different types of foundation: rock bed base and consolidated bed base. Buildings in the Arg-e Bam, apart from the governor's quarter that had been built in a level of rock bed, in other parts were built in a level of soft soil.

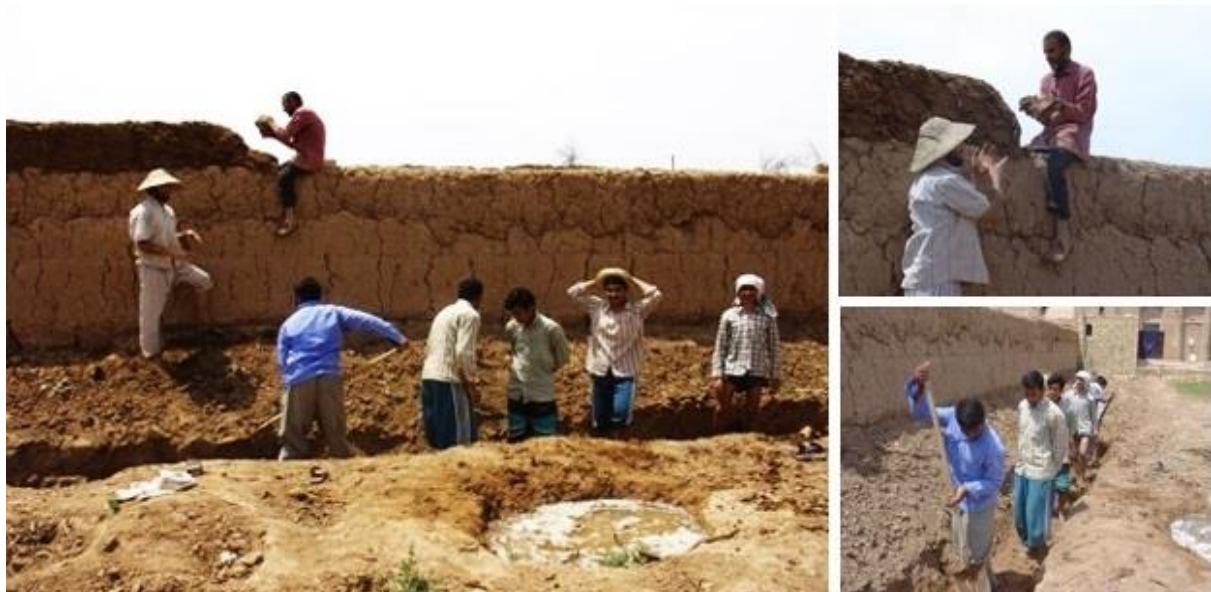
**Figure 2.22-** Steps for construction of a chine wall, as a part of courtyard's wall (Photo by Ghane Ezabadi, 2013. Source: <http://www.yazdfarda.com>).

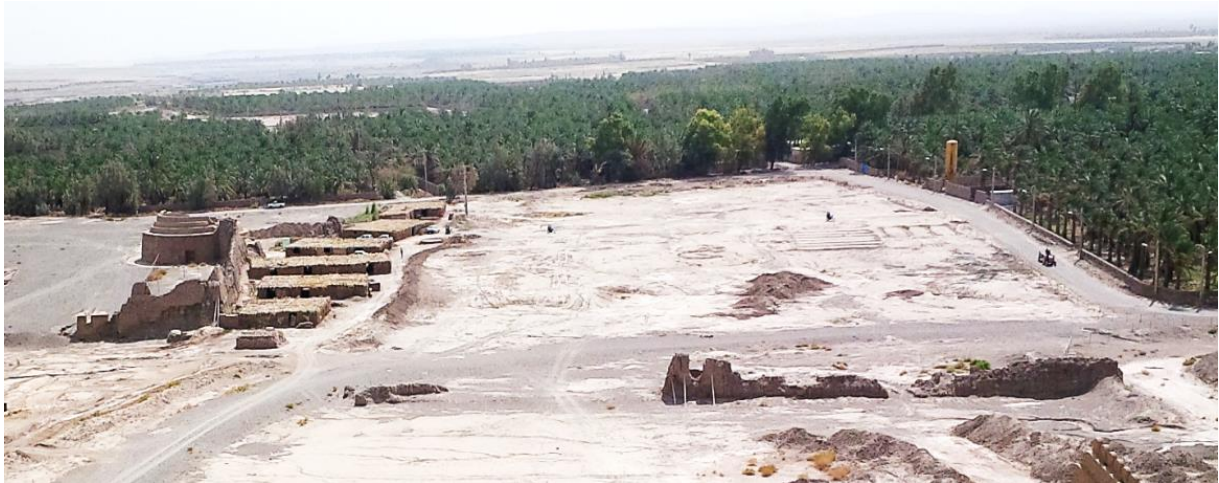
**Figure 2.23-** Brick manufacturing workshop of the Bam Citadel, close to Ice House or Yakhdan of Bam Citadel (Photo by Rouhi 2015).

of clay, the straw is not always necessary.<sup>120</sup> In this method to produce adobe bricks, some steps are to be followed. In this section, according to the Author's observations of Bam site (August 2015), all steps are briefly described as follow:

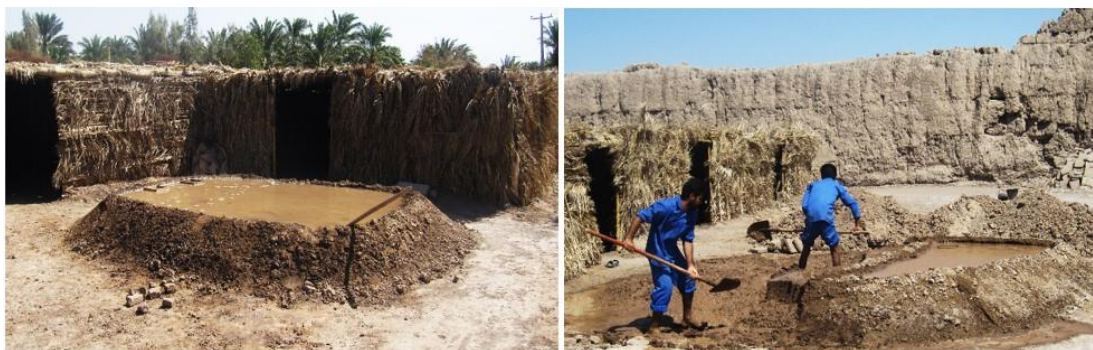
**Figure 2.25-** (Left) lying of soil in a pool of water; and (Right) mixing of the soil with chopped straw or other additives (Photo by Rouhi, 2015).

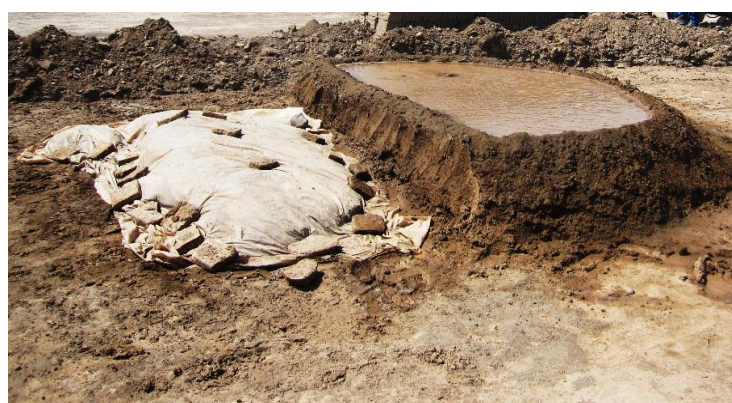
**Figure 2.26-** For better penetration of water within clay particles, the adobe mixture is laid under nylon plastic (Photo by Rouhi, 2015).

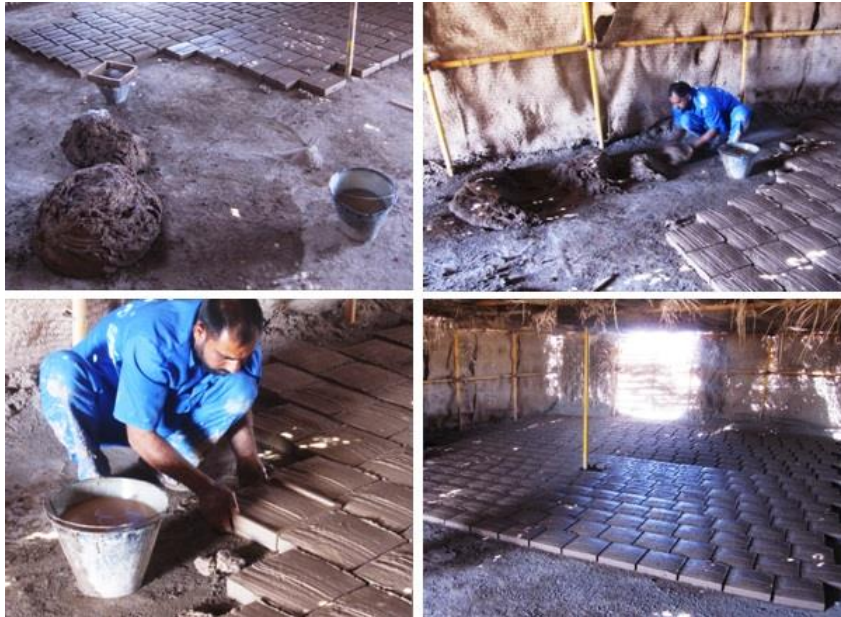
**Figure 2.27-** The process of adobe moulding under a shaded space in Bam Citadel’s workshop (Photos by Rouhi, 2015).

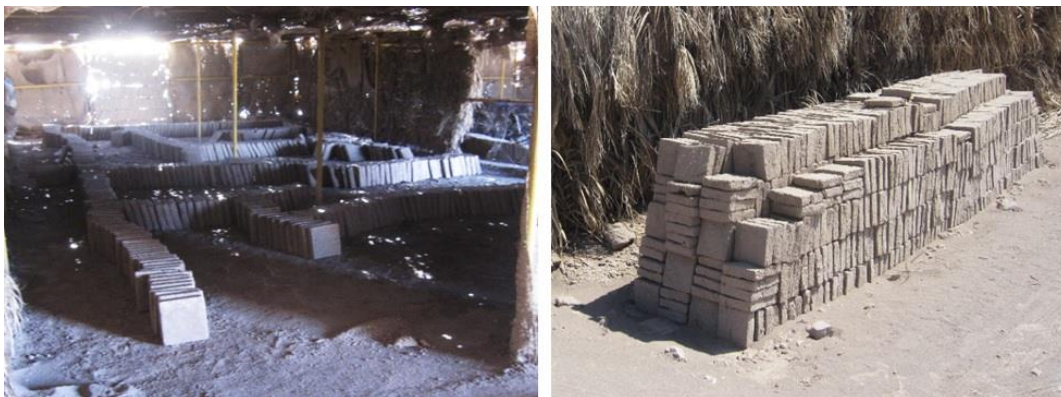
**Figure 2.28-** Chaining of adobe bricks to better aeration, and their piling up after drying (Photos by Rouhi, 2015).

This is the critical step in the production of adobe-mud bricks when the shrinkages begin to occur. In order to minimize the shrinkage effects (mainly cracking), special precautions should be taken, such as avoiding drying in direct exposure to the sun (slow drying in shade reduces the rate of evaporation and cracking), and severe wind (cracks are also extreme on windy days when the shrinking of clay occurs more rapidly). After at least two days of drying horizontally, the adobe-mud bricks must be stacked vertically, i.e. “chain making”. In this way, air circulation between adobe-mud bricks causes better drying up. After two more days, adobe bricks are finally dried, and then they are piled up and ready to use in construction process.

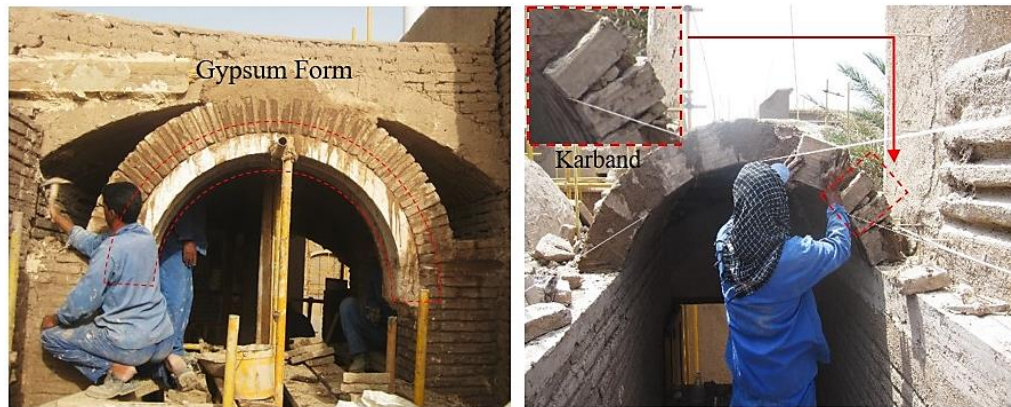
**Figure 2.31-** Using of gypsum forms and Karband for arches' construction in Bam Citadel (Source: (Left) archive of RPBCH; and (Right) Rouhi, 2015).

In Bam Citadel after the 2003 Bam earthquake, in order to reconstruct all damaged arches and to achieve an ideal formula for length and height of arches in a desired span, some tests were performed to achieve the ideal size and ratio of arches (see Figure 2.30). Sometimes to have a framework for making arches, some gypsum form which are fixed on side walls are placed under the abutment of arches. Meanwhile, at the time of arch construction, to fill the gap between the adobe-mud bricks, some wedge-shaped bricks ("Karband" in Persian) are inserted in the outer mortar joints (see Figure 2.31).

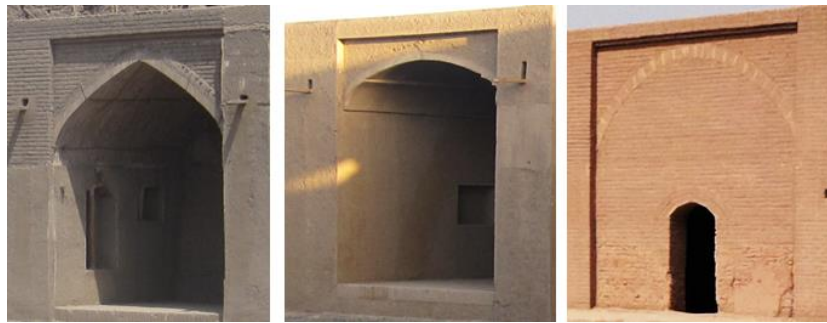
**Figure 2.34-** Some form of barrel vaults observed in Bam Citadel, respectively from left to right are named as pointed vault, segmental and semicircular barrel vaults (Photo by Rouhi, 2015).

as semicircular, catenary,<sup>132</sup> segmental, pointed, etc. Among different types of Barrel Vaults, the catenary vaults are known as a very common form, which gives maximum stability for a minimum use of material. Initially, to form a Barrel Vault, a load-bearing wall as a supporting wall with arched section is built at one end. Then, a skewed course of adobe brick towards the supporting walls is arranged. Other adobe courses are set in position up to two triangular transition segments in the form of either circular or linear shapes.

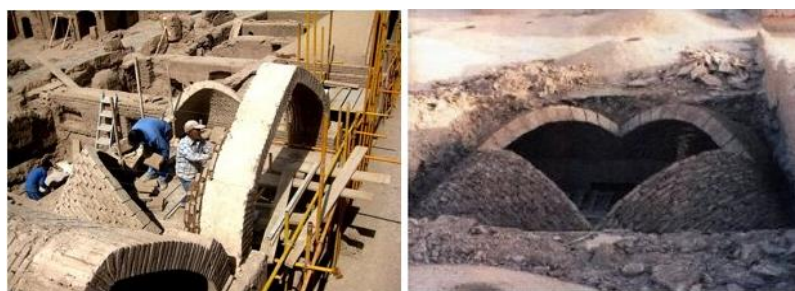
**Figure 2.35-** The quality of semi-dominical and dominical vaults in Bam Citadel (Source: archive of RPBCH).

Dominical vault is a combination of two-Barrel Vaults with the same profile, which is the result of the extension of one of the two vaults. To build these types of vaults, inclined supports are provided at four corners of a room. The first adobe brick is laid at the junction of two walls; after that, the second and the third course of adobe-mud bricks are inserted on the top of the first course with an overlap of a half-brick. Then the space of roof is divided into four parts and other courses are placed layer by layer at each corner in a circular or spiral manner to complete the vault. Depending on the size of the vaults, each corner may be shortened. Here the Trought Vaults are the type of Dominical Vaults that are longer in one direction.

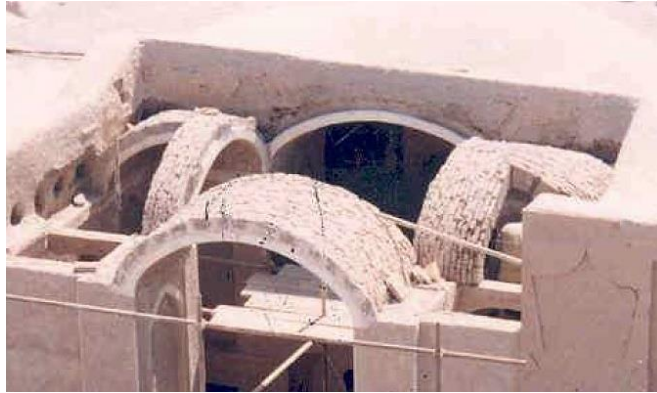
**Figure 2.36-** Sample of groined vault in southern part of Governor's House during the restoration works before the 2003 Bam earthquake (Source: archive of ICHHO).

This type of vault like Dominical and Trough Vaults is also composed of two Barrel Vaults with the same profile; the difference is that they can be built just on spaces with square or rectangular plan.

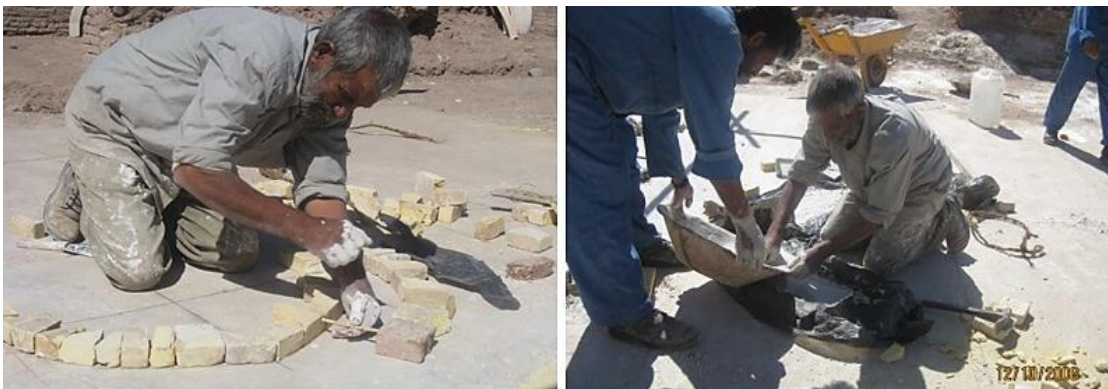
**Figure 2.37-** The drawing up of gypsum form within the mould of bricks (Source: archive of ICHHTO).

A Ribbed Vault is another type of Barrel Vault in which the ribs or curved twigs are rounded in the form of cones, and the vaults are built between adjacent ribs. Here the ribs are built by gypsum and are placed over the load-bearing columns or walls, it is vertically over the springers surfaces. To build a gypsum form, the arch of a gypsum is drawn on the ground. The intended land for manufacturing of the gypsum form must be completely flat and clean, and then a row of bricks along its thickness are arranged as mould to form its shape. To build a rib, two gypsum forms are needed. Since the gypsum is so fragile, in addition to gypsum, pieces of reeds are added as a reinforcer into the mixture. After drying the gypsum forms, they are placed in the position where the vaults have to be erected.

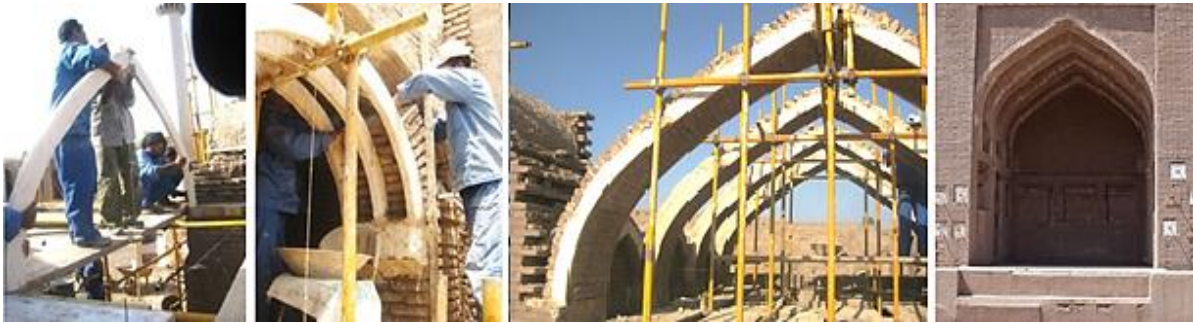
**Figure 2.38-** The ribbed vault in the Tekiyeh of Bam Citadel during and after total reconstruction, after the 2003 Bam earthquake (Source: archive of RPBCH).

The installation of ribs needs a high degree of accuracy. The ribs are held vertically without any movement until workers fix them with elements like scaffold and wooden piles. Afterwards, the traditional workmans (Usta in Persian), at first starts to brickwork in space between gypsum forms and then the space between the ribs. The brickwork in spaces between gypsum forms have three models: horizontal, vertical and diagonal. In Bam Citadel, ribs have more application in the new architectural history of Bam.

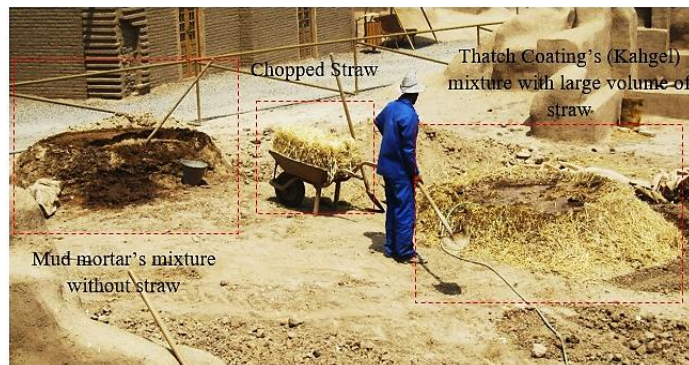
**Figure 2.41-** Mud mortar's mixture without straw, and thatch coating's mixture with large volume of straw prepared for surface coating of the Sistani House of Bam Citadel (Photo by Rouhi, 2015).

smoother, which also will fill the cavities between the earth particles that leads to a more integrated mixture.<sup>136</sup> The chapped straw added to the mud mortar mixture should make it more plastic as far as it is still workable. Since cement has less elastic property, it should be avoided in mud mortar, because they can lead to cracking. Meanwhile, mud mortar mixture should not contain of a large amount of clay, because when the amount of clay is higher than the standard level, it may lead to shrinkage cracks.

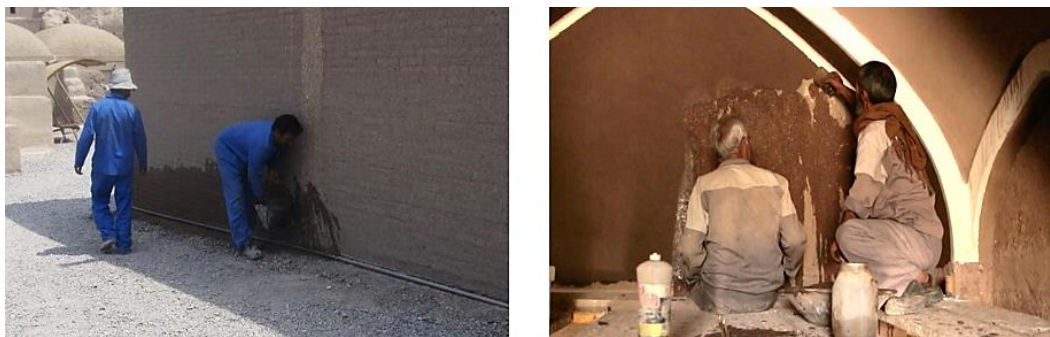
**Figure 2.42-** Wetting the external and internal parts of walls during thatch surface coating (Left), and mud mortar surface coating (Right) (Photos by Rouhi 2015).

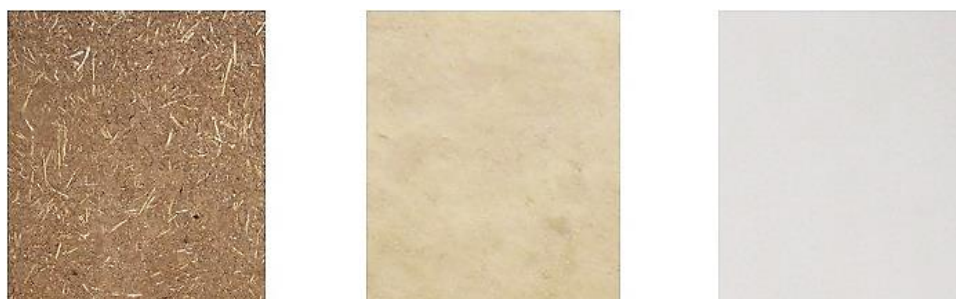
**Figure 22.43-** Finished part of adobe walls respectively from left to right by thatch coating, sieve coating and white wash, (Photos by Rouhi, 2015).

- **Whitewash (Sefidkari in Persian):** whitewash surface coating consists of gypsum, water and soil. Coloring materials may of course be added. This coating is inexpensive, easy to apply and just used for interior spaces.

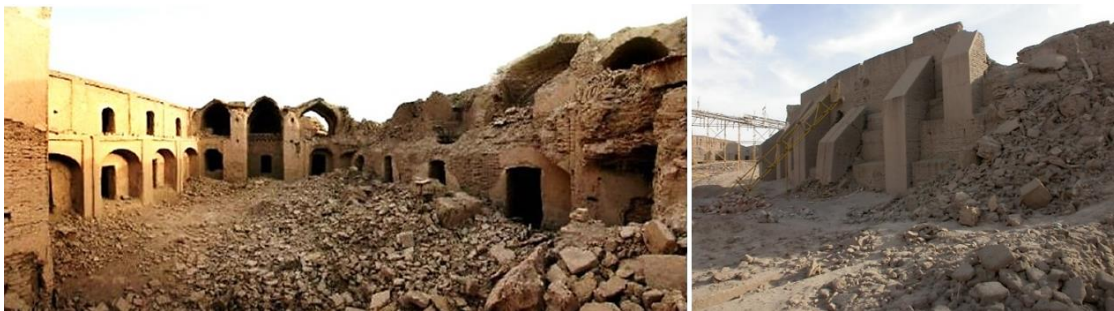
**Figure 2.45-** (Left) the ruins of the Caravanserai of Bam Citadel after the earthquake shows that the domed rooms along the non-buttressed wall, east side of Caravanserai, survived with partial destruction (Source: Langenbach, 2004), while the ones along the buttressed wall, west side of Caravanserai, embedded during restoration works (1978-2001 AD) mostly collapsed; and (Right) the buttresses in west side of Caravanserai have suffered partial damages (Photo by Chopin, 2007. Source: archive of Bam3DCG).

(III) Pervious intervention: as Croci (1998) noted, both lack of scientific knowledge and lowering of the strength are important factors in intensifying the erosion of historical buildings. Besides this, local geographical conditions and pathologies of the structures can also contribute to the acceleration of deterioration if they are not properly maintained (Correia & Fernandes, 2006). During the last few decades before the 2003 earthquake, most of the restoration works had just dealt with respecting the remaining properties and restoring their previous glory, which was the basis of restoration ethics. Hence, attempts had been made mostly to get back the monuments as close as possible to their former natural aspects. Thus, during this period the engineering knowledge of restoration and dynamic behavior of the structures have not been thoroughly considered. Based on surveys conducted in Bam Citadel for recognizing the causes of damages, it was observed that some changes in the original plans of structures had increased the side effects of the earthquake loads. Therefore, because of applying unsuitable new elements, those structures that had been recently maintained or restored sustained with significantly more damage than those that had not been restored and even strengthened in recent years.

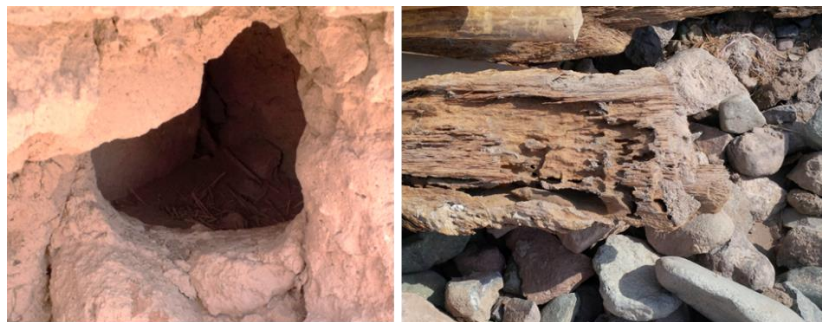
**Figure 2.46-** (Left) bird’s nest on the Barrack of Bam Citadel (Photos by Rouhi, 2015); and (Right) the evidence of termite’s attack on removed palm tree from debris of Bam Citadel after the earthquake (Photos by Rouhi, 2015).

there are large and beautiful traditional houses made by high quality and luxury materials, including even wood. Moreover, in some parts woods had been used as a tensile element in the higher level of the walls and towers. Hence, protecting the woods from desert termites was a major task for people in Bam. In the Takyieh of Arg-e Bam a large Muller was found, which was probably used for oil extraction. It can be precisely shown that the people of Bam used oil on the surface of woods to prevent termite damages. In addition, adobe brick seem to be the natural house of insects. Some vegetable fibers like straw can increase the probability for termite attacks, thereby weakening them. Termites can survive in places with sufficient water and organic matter. In this case, even after earthquake, during his observation from the ruins of Bam site along the “International Workshop on Bam” (17-20 April 2004) sponsored by UNESCO, ICOMOS, and the Iranian Cultural Heritage Organization (ICHO), Langenbach (2004) drew his attention to the evidence of some infections caused by termite penetration into the walls. In addition to termites, pigeons can cause physic-chemical corrosion on the adobe structures by creating holes in the walls and their excrements. Elsewhere, there are other animals such as foxes, snakes and chameleons that fit their underground activities contribute to the decay of adobe structures by walls subsidence.

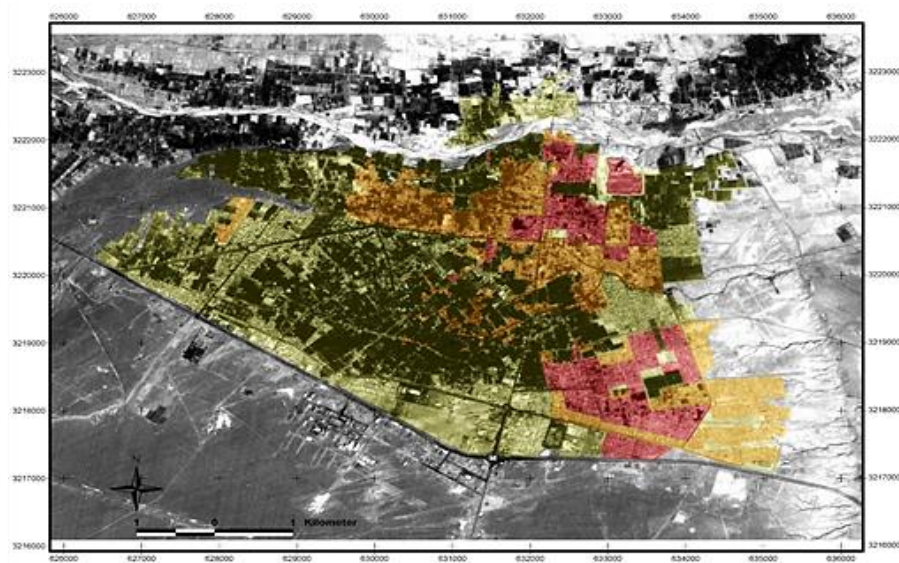
**Figure 3.4-** According to Damage Zonation Map from satellite data (Source: Sertit, 2003. Retrieved from [http://sertit.u-strasbg.fr/SITE\\_RM/Archives/16\\_iran\\_2003/iran\\_2003.html](http://sertit.u-strasbg.fr/SITE_RM/Archives/16_iran_2003/iran_2003.html)) and report presented by International Institute of Earthquake Engineering and Seismology (Source: IIEES, 2004), sever damages were concentrated in the city of Bam, and that in the olden parts, i.e. northeastern and southeastern part of the city more than 80 percent of the buildings were collapsed completely. The Citadel of Bam located within the area was also thoroughly damaged.

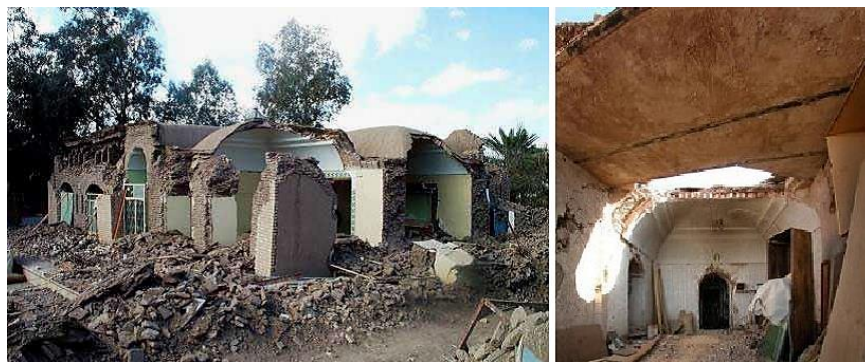
**Figure 3.5-** Damage to traditional jack arch slab during Bam earthquake (Source: Manafpour & Halcrow Group Limited, 2004; and Mehri, 2003).

In general, here the order of new construction system is not that of adobe-mud bricks, which have entirely been displaced by modern materials of steel and concrete, but the evidence shows that traditional buildings in the city of Bam were usually made of adobe bricks. Bam's residents always copied the adobe construction technique from their predecessors and inspired from those technique used in the Citadel of Bam. In fact, these methods not only were not forgotten by the people of the region, but also by passing of time they developed them by a combination of modern and traditional techniques. In this way, the roofs were constructed with steel beam supporting jack-arches of fired brick masonry. These roofs were resting directly onto the unfired brick walls, with no anchors or ties to the walls (Langenbach, 2008). In this case, because of heavy weight of roofed adobe structures by vaults and domes, the walls of these structures were usually thinner than those in adobe supporting roofs.

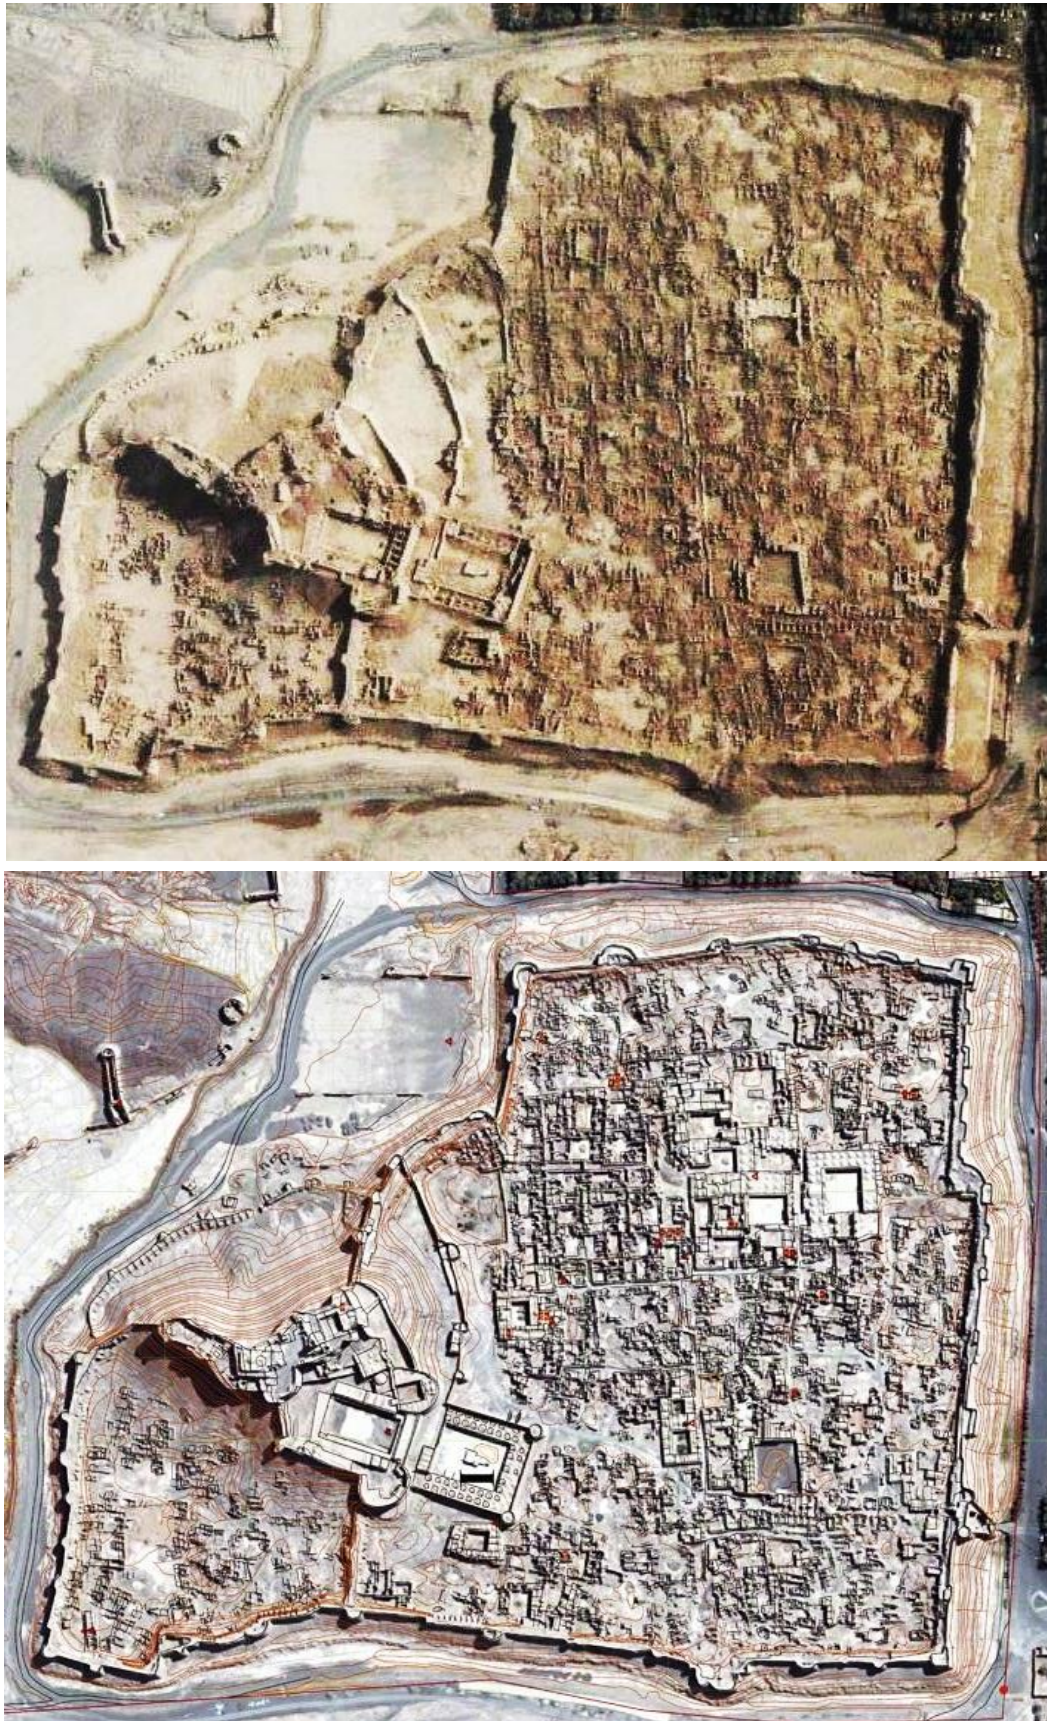
**Figure 3.11-** Satellite photo from Bam Citadel before and after earthquake (Source: archive of RPBCH).
