**UNIVERSITÀ DEGLI STUDI DI NAPOLI FEDERICO II**  
**DiArc - DIPARTIMENTO DI ARCHITETTURA**

**DOTTORATO DI RICERCA - XXIX CICLO**

Conservation and Restoration of Adobe Architectural Heritage of Bam Citadel (Iran),  
Affected by the 26 December 2003 Bam Earthquake: Problems and Issues

Aprile 2017

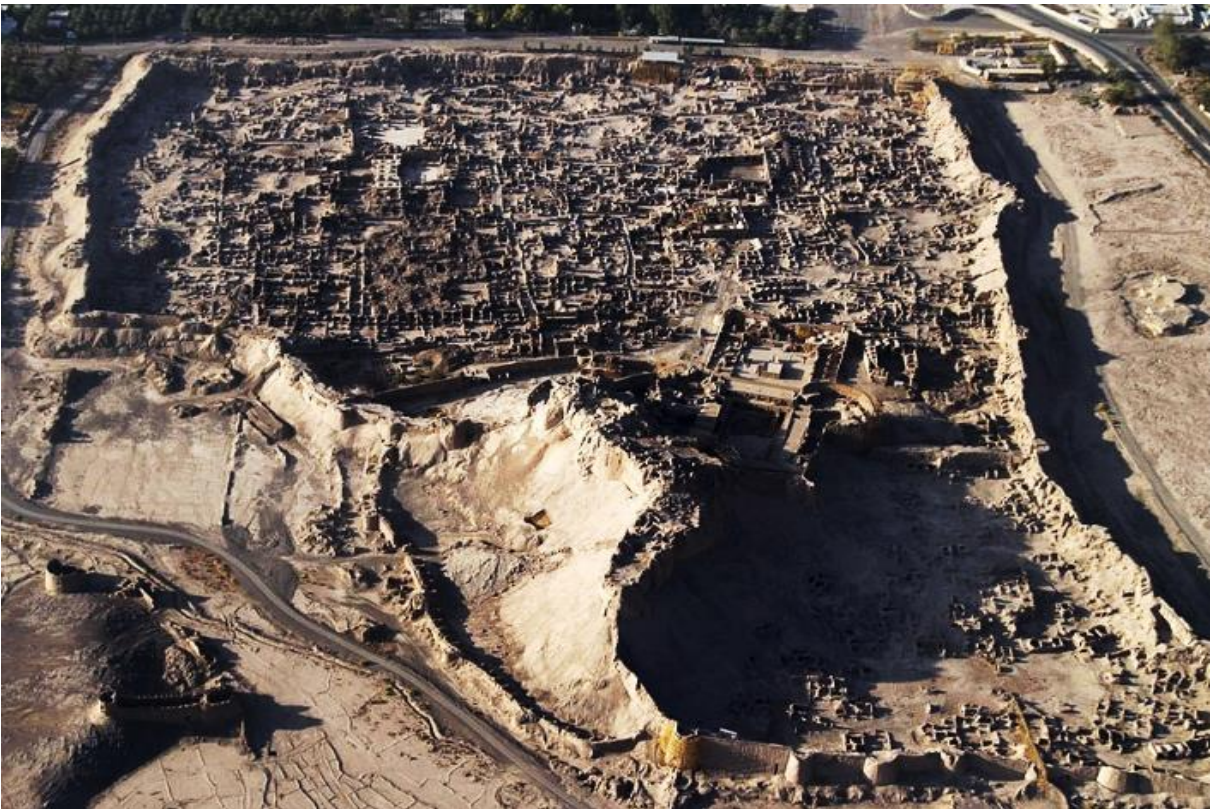
**Figure 3.12-** Aerial photo from Bam Citadel before and after the earthquake (Source: archive of RPBCH).

According to damage zonation map prepared by Keramat (2008), it can be seen that the intensity of damage caused by the earthquake varied widely from one point to another point of the Citadel. Such variation was caused by several factors and their combination, including building material and construction method, geological and seismic issues.<sup>153</sup>

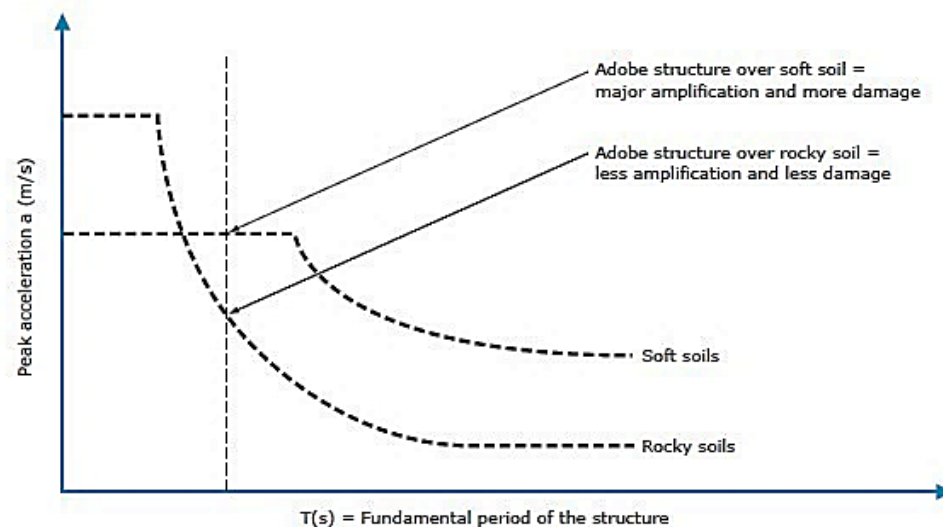
**Figure 3.14-** The diagram shows the theoretical response spectrum of an adobe building over rocky vs. soft soil (Source: Cancino et al., 2009).

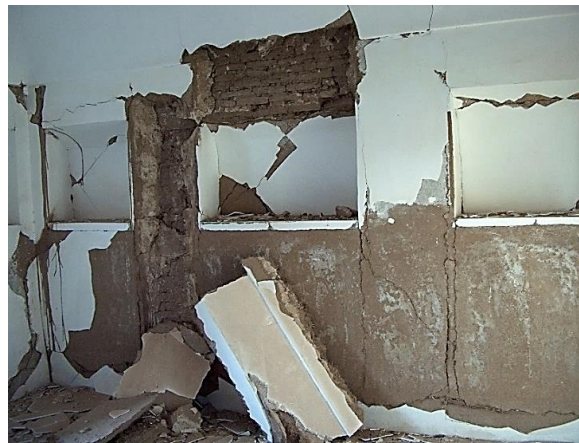
**Figure 3.17-** Damage on adobe surface coating in the Mirza Na'im School of Bam Citadel (Source: personal archive of Prof. Luigi Marino, 2007).

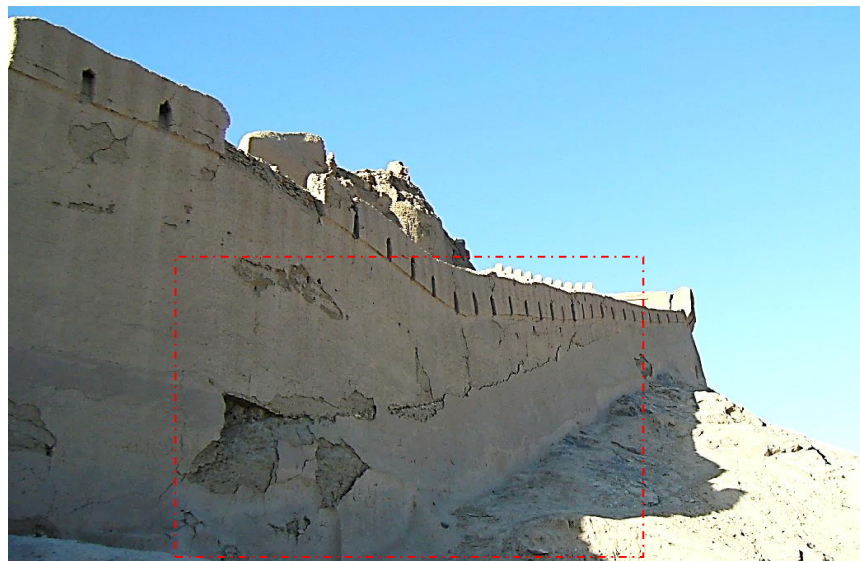
**Figure 3.22-** Mid-height, out-of-plane flexural damage without collapse in third defensive wall of Bam Citadel. Fortunately as can be seen, the horizontal and vertical cracks across the length of wall could not cause to detachment of wall, if the seismic motion had been more prolonged, the total collapse of wall might have occurred (Source: archive of ICHHTO).

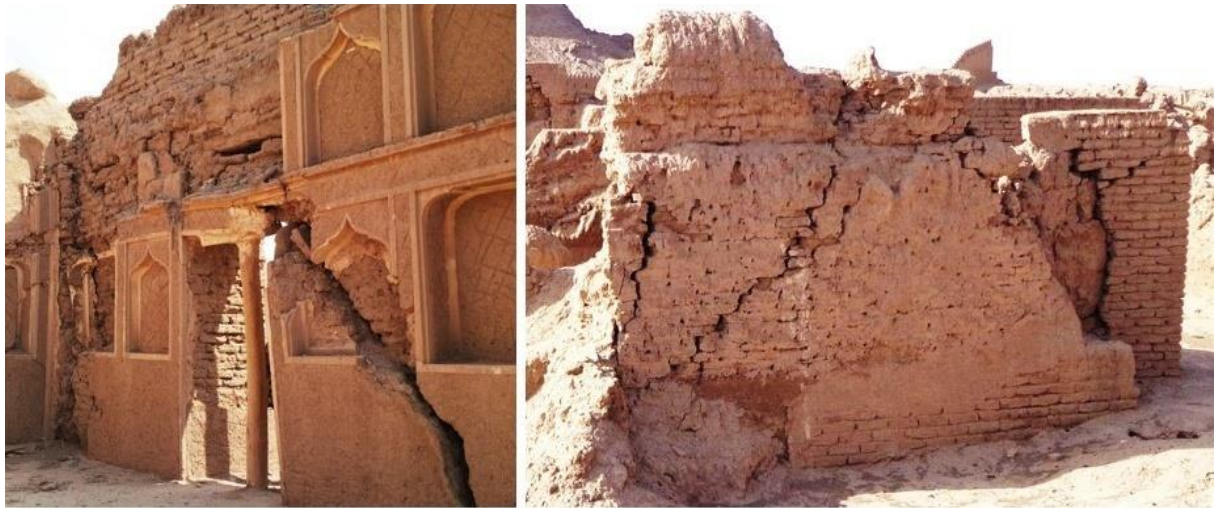
**Figure 3.23-** The in-plane shear cracks in Bam Citadel after the 2003 Bam earthquake (Photos by Rouhi, 2015).

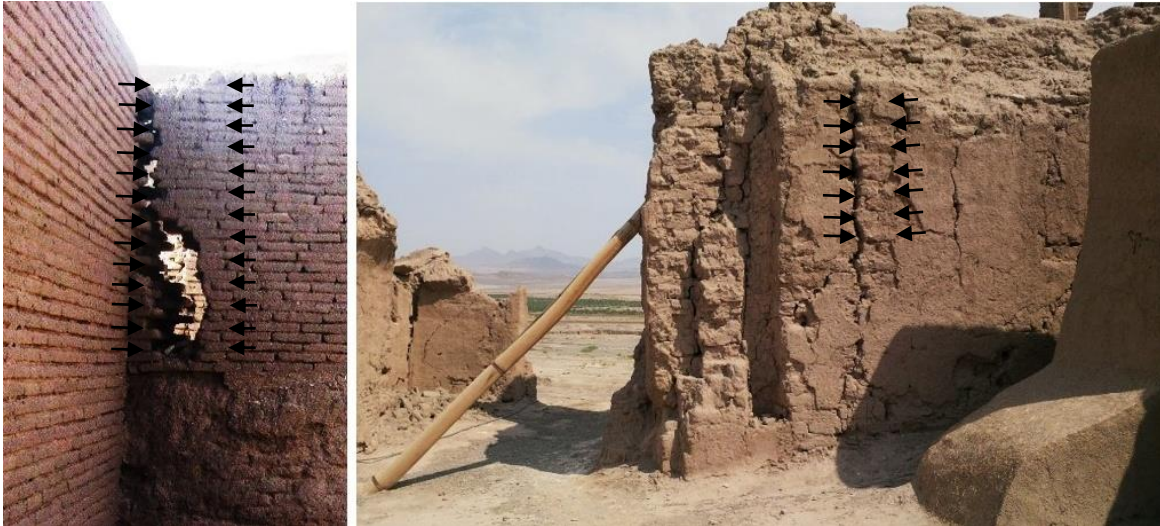
**Figure 3.24-** Intersection of perpendicular walls in Bam Citadel after the 2003 Bam earthquake (Photos by Rouhi, 2015).

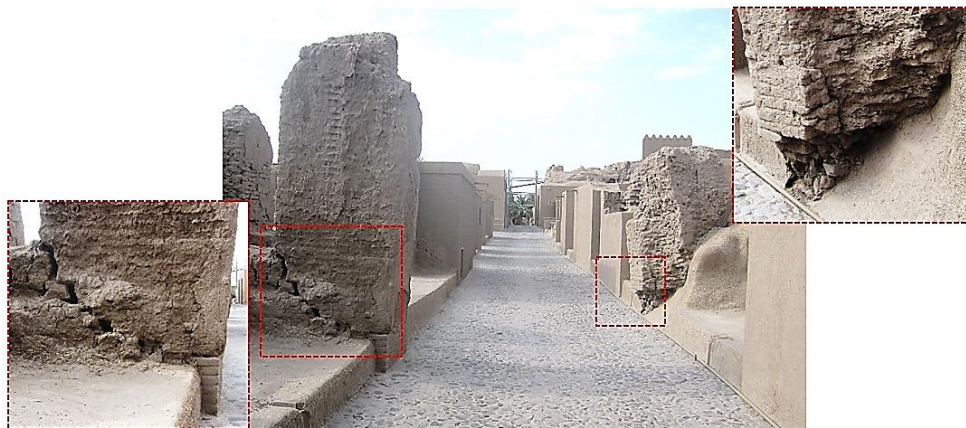
**Figure 3.25-** High adhesion of seismic damaged adobe wall in the Bazaar of Bam Citadel (Photos by Rouhi, 2015).

Cracks caused by seismic motions often occur in locations with high stress concentrations. Cracks in corners of an adobe building are very common because relative response is largest at the wall's interfaces. That is why the probability for occurrence of cracks at the corners of buildings during an earthquake is more than other parts. A thin adobe wall may become unstable soon after the initiation of cracks through the wall. However, a thick-walled adobe building is still a long way from losing its stability after the first cracks develop (Tolles et al., 1996). The extent of damage caused in a building will depend on the width of the crack generally characterized as hairline cracks, fine cracks, moderate cracks, extensively damaged cracks and structural cracks (Varum et al., 2014). It should be noted that, since adobe materials have high adhesion properties, any cracks could not cause serious damages.

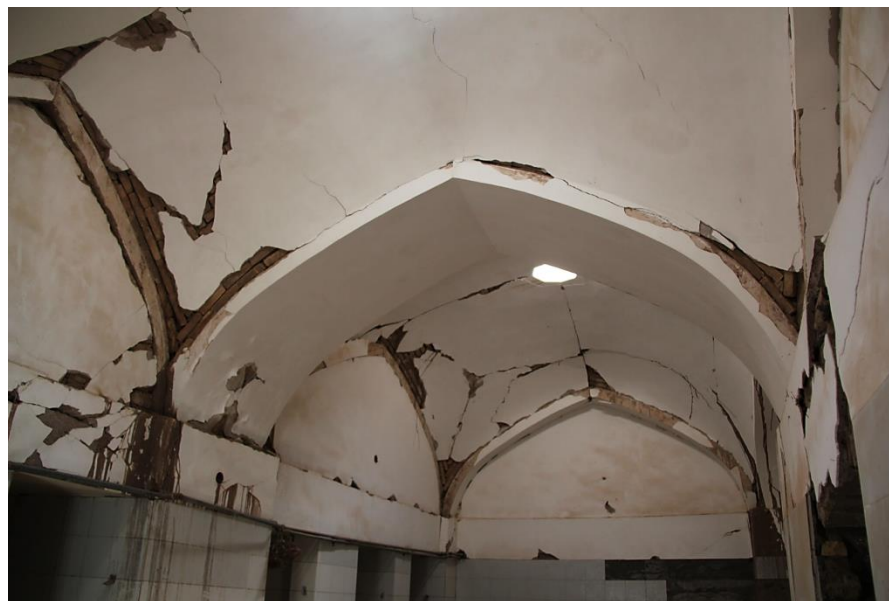
**Figure 3.26-** Different types of cracks in Mirza Naem School of Bam Citadel after the 2003 Bam earthquake (Photo by Rouhi 2015).

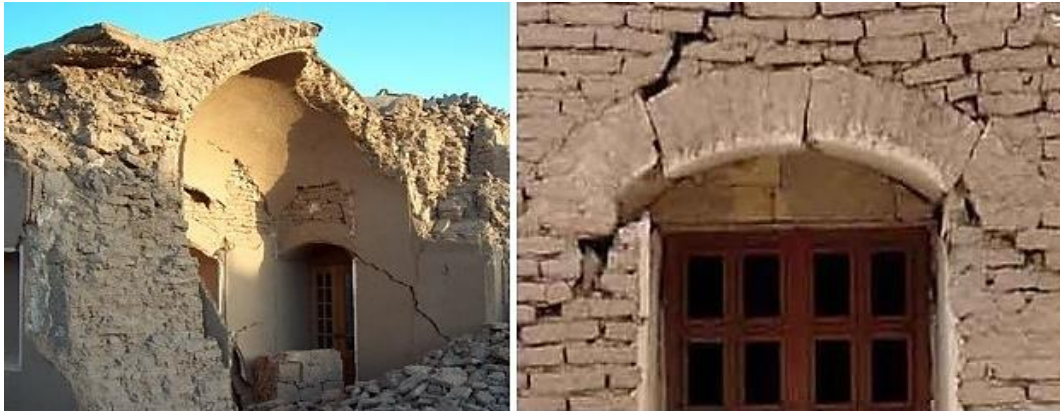
**Figure 3.27-** Crack at opening of Bam Citadel after the 2003 Bam earthquake (Source: (Left) personal archive of Prof. Luigi Marino; and (Right) Auroville Earth Institute “BAM AND ARG-E-BAM”, after the 2003 Bam earthquake).

An opening in a frontage constitutes a vulnerable point in the event of deformation of the adobe frame. The cracks of the front walls are found in the contours of the openings, where the stresses are most significant and in particular close to the re-entrant angles (NIKER, D3.1, 2010). Since more often during seismic motions, cracks occur in locations that stress concentrations are high, the openings are deep interested in cracks phenomena. Usually, these cracks start at the top or

bottom corners of openings and develop vertically, diagonally and horizontally to the tops or bases of the walls. In adobe building, cracks over the openings may be hazardous to occupants if they are dislodged. The best way to control cracks at openings is keeping the openings in the walls small and well-spaced.

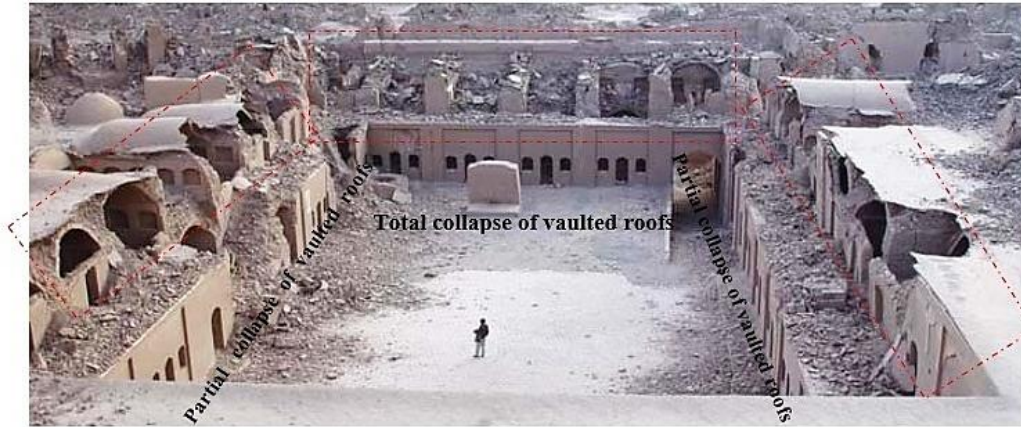
**Figure 3.30-** Total and partial collapse in the Barrack of Bam Citadel after the 2003 Bam earthquake (photo by Ahmadi and Boroomandi, 2003. Source: archive of ICHHTO, designed by Author).

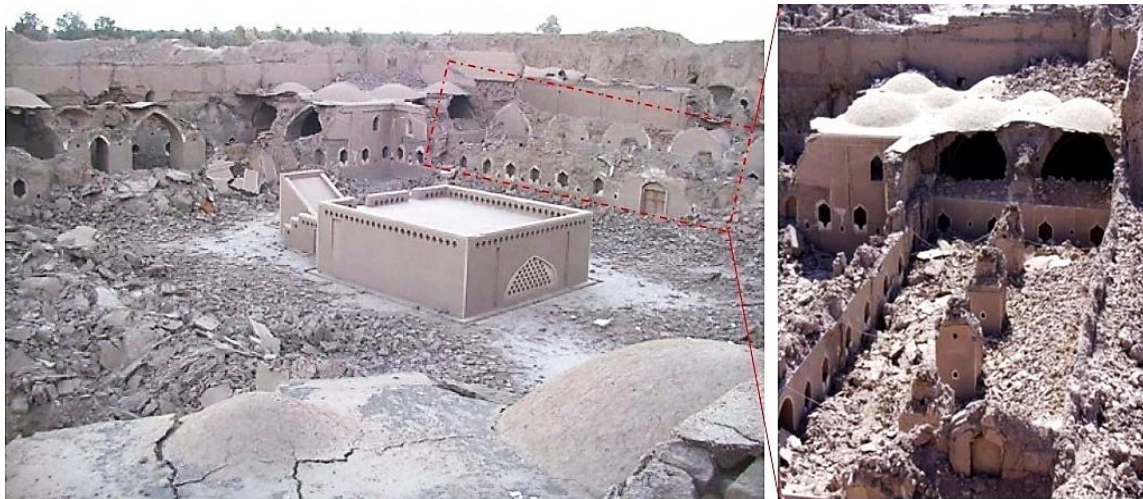
**Figure 3.31-** Damage on domed roof in the Stable of Bam Citadel after the 2003 Bam earthquake (Source: archive of RPBCH, designed by Author).

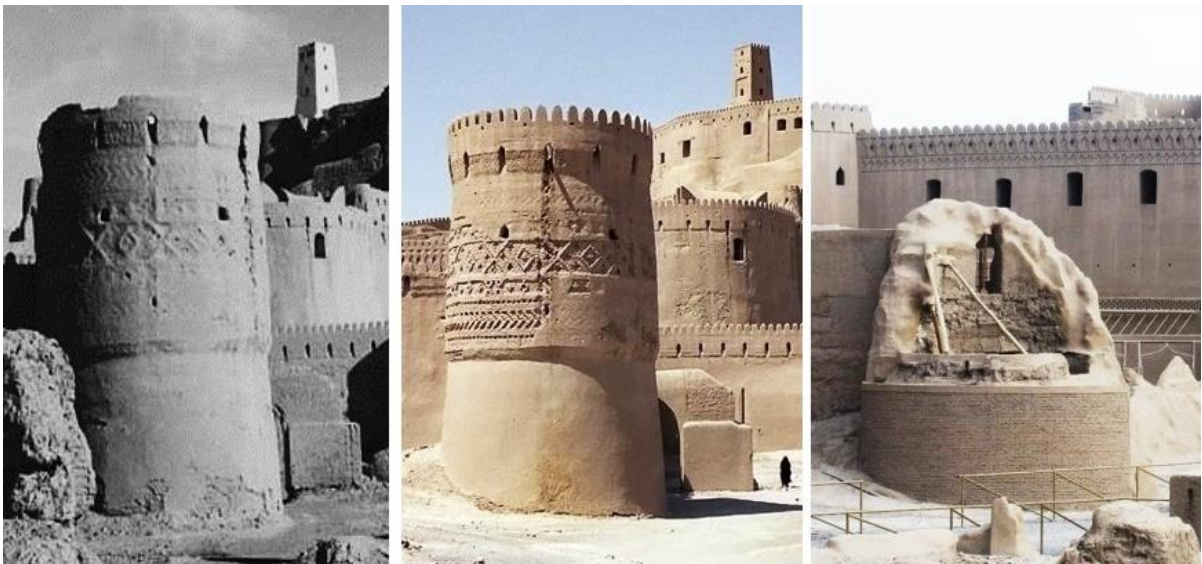
**Figure 3.32-** The condition of east-south tower of the Stable of Bam Citadel in different periods before and after earthquake (Source: archive of ICHHTO, before the 2003 Bam earthquake; and Rouhi, 2015).

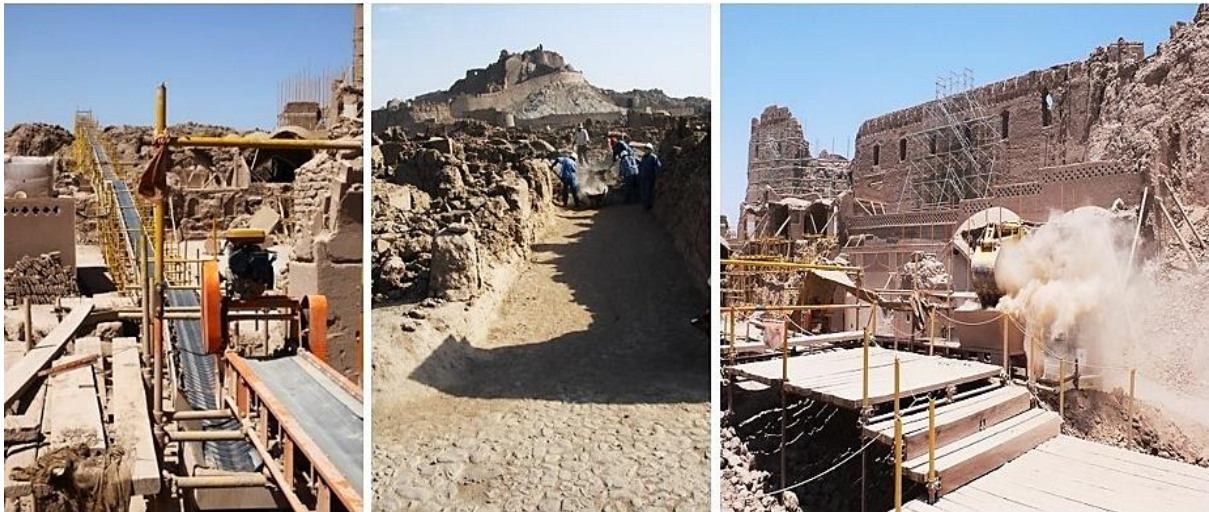
**Figure 3.39-** Debris removal in Bam Citadel after the earthquake (respectively from left to right photos by fs, 2007; Marino, 2004, Cheng, 2006. Source: <https://www.flickr.com/search/?text=bam%20citadel>).

Since the full extent of damage continues to emerge over time, one of the most important emergency actions was debris removal, securing the structures and preparation of site for next restoration phase. In this case, all measures were under the supervision of archeologists so that valuable heritage assets would be conserved, and adobe bricks which remained in good state were also stored for possible re-use in the future. Depending on the condition of damages and their location, different methods and equipment were used for debris removal; removal by hand, removal by hand and using mountain climbing equipment, removal by using chutes and removal by other mechanism like wagons on rails, cable wagons and etc. Besides all aforementioned measures, there were also carried out other tasks, such as physical security consisting of detection, consolidation and scaffolding of vulnerable parts; collection of related information, documents, photos etc., at national and international levels; and daily monitoring of the site and their records.

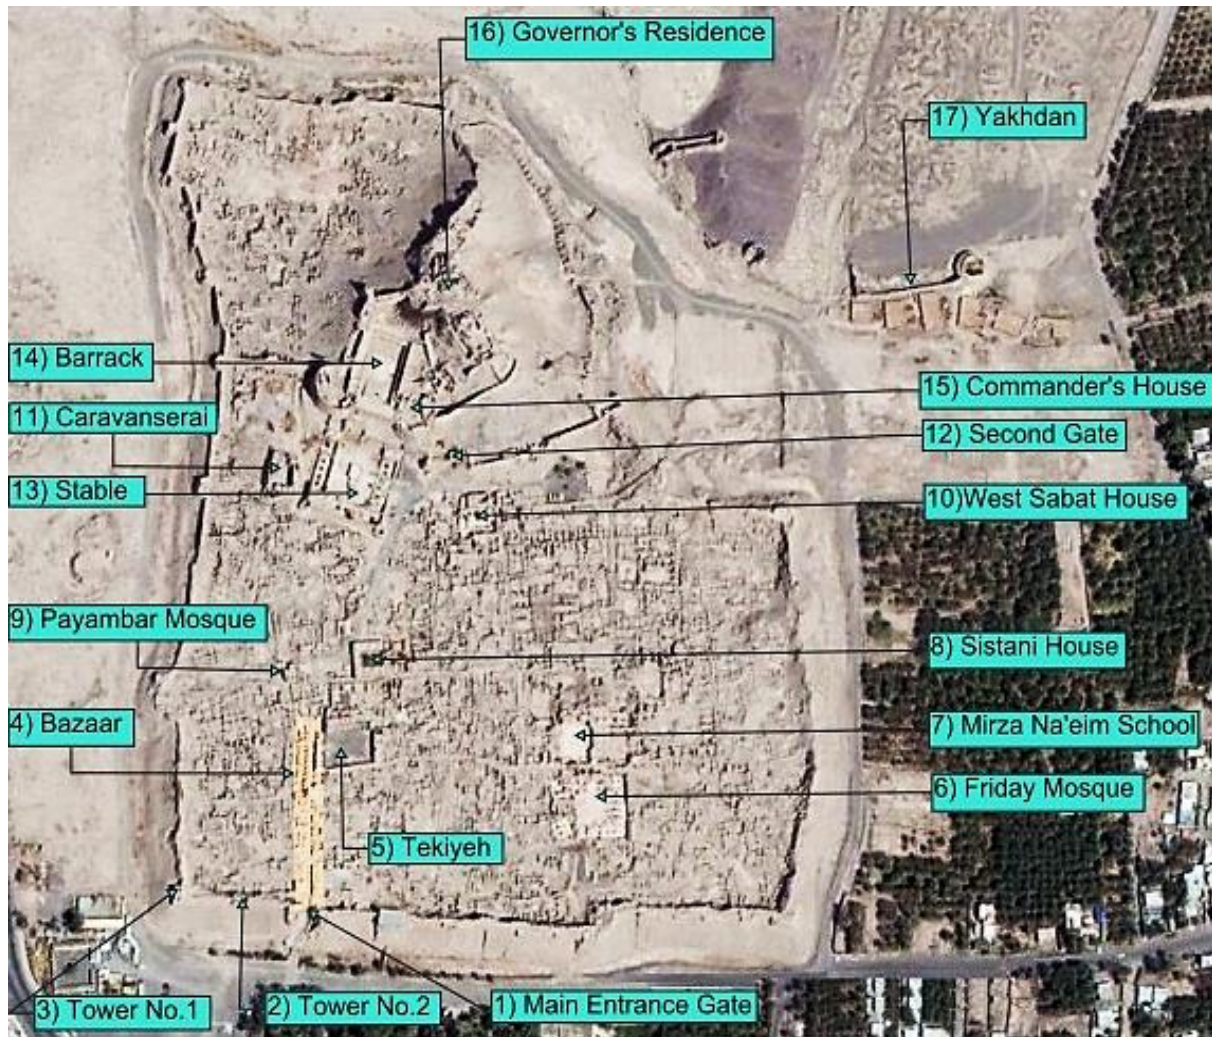
The selected properties inside of Bam Citadel for assessing the quality of their reconstruction process					
Property's Name and No.	Page No.	Property's Name and No.	Page No.	Property's Name and No.	Page No.
1. Main Entrance Gate	291	7. Mirza Na'eim School	332	13. Stable	370
2. Tower No. 2	297	8. Sistani House	343	14. Barrack	376
3. Tower No. 1	304	9. Payambar Mosque	350	15. Commander's House	381
4. Bazaar	311	10. West Sabat House	356	16. Governor's Residence	385
5. Tekiyeh	319	11. Caravanserai	358	17. Yakhdan	392
6. Friday Mosque	327	12. Second Entrance Gate	363

**Figure 4.26-** The selected properties inside of Bam Citadel for assessing the quality of their reconstruction process (Designed by Author).

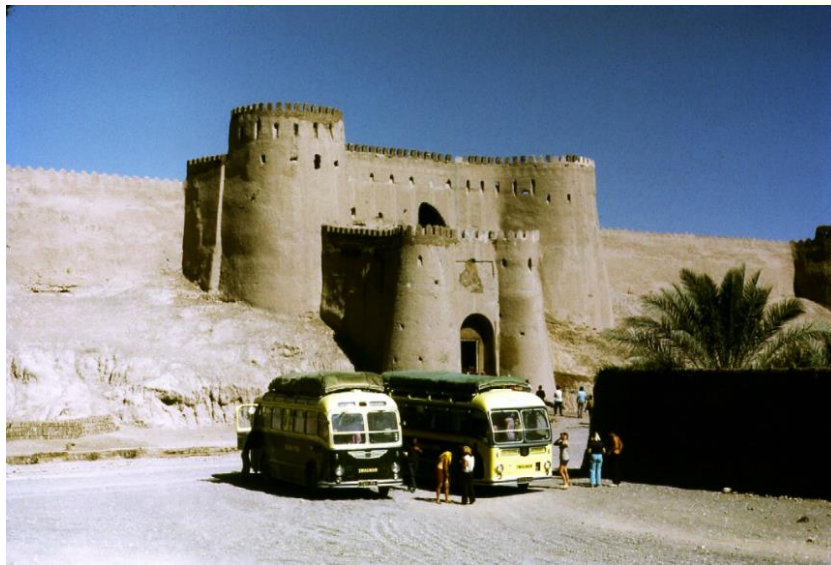
**Figure 4.29-** The Main Entrance Gate of Bam Citadel during restoration works (Photo by Eastbound, 1973-1975 AD. Source: <https://www.flickr.com>).

by installation of a guard post in ground floor. Until 1993, no special activities had been reported, as far as in this year, the work continued more seriously with restoration of the upper floor of this gate and some conservation activities were carried out in its different parts. Between the years 1995-1996 AD, the restoration procedures were followed by the restoration and renovation of the rooms in the ground floor and conservation work in its towers and crenellations. In later years until 1999, the total restoration of main entrance gate and conservation of its different part was completed.

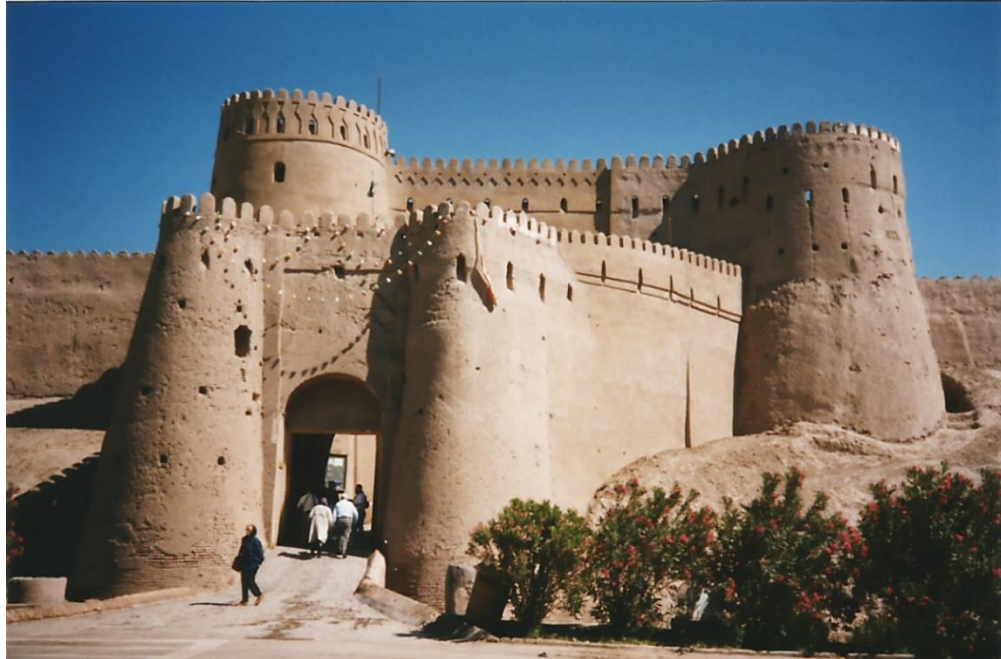
**Figure 4.30-** As can be seen in this photo, the recovering of the façade with mud and sieved straw is started in the second-two watchtowers of Main Entrance Gate (Photo by Adam, 1998. Source: <https://www.flickr.com>).

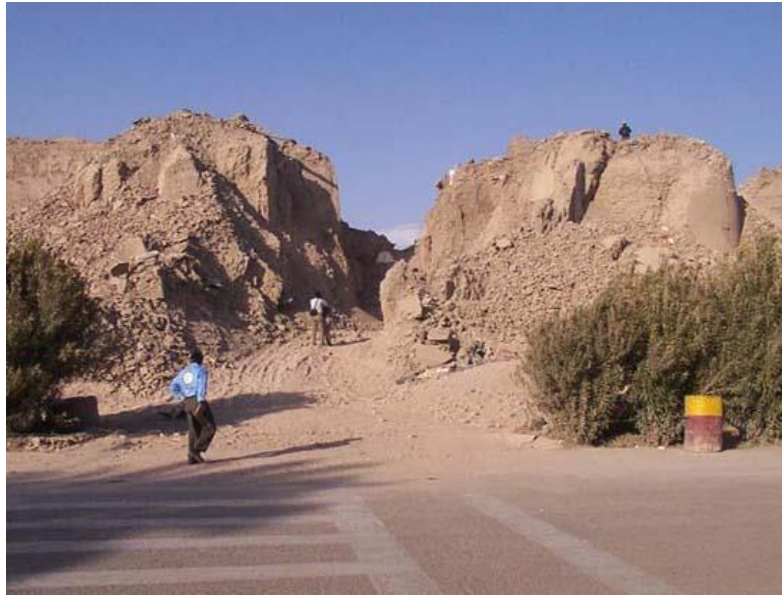
**Figure 4.34-** The Main Entrance Gate after the 2003 Bam earthquake (Photo by Ahmadi and Boroomandi, 2003. Source: archive of ICHHTO).

▪ **Physical Condition after Earthquake:** As shown in Figure 4.33, this property after the earthquake was damaged to a considerable extent; all of the floors with their adjacent watchtowers had totally collapsed. The damages in the second-two watchtowers due to their conjunction with adjacent fortifications were less than the first-two watchtowers. According to the placement of this property in manmade steep area and also because of the weakness of its foundation, occurrence of this level of damage was predictable.

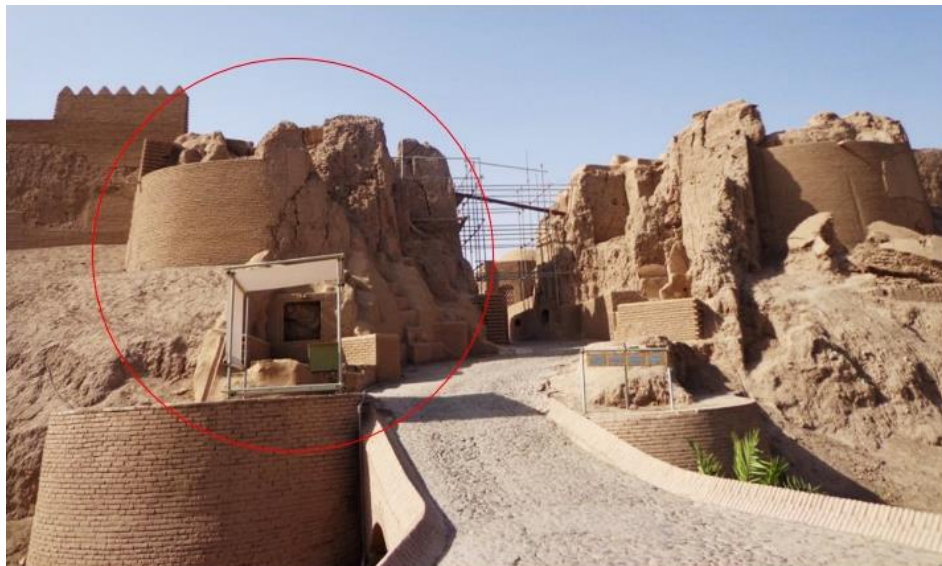
**Figure 4.35-** The Main Entrance Gate under restoration (Photo by Joao Leitao, 2012. Source: <https://www.flickr.com>).

location as the only way for entering the Citadel, and the high volume of the damage made it difficult to restore or reconstruct the whole Main Entrance Gate as before. During the years after the earthquake, some parts of the watchtowers have been preserved and restored, some more restoration and reconstruction is on the way.

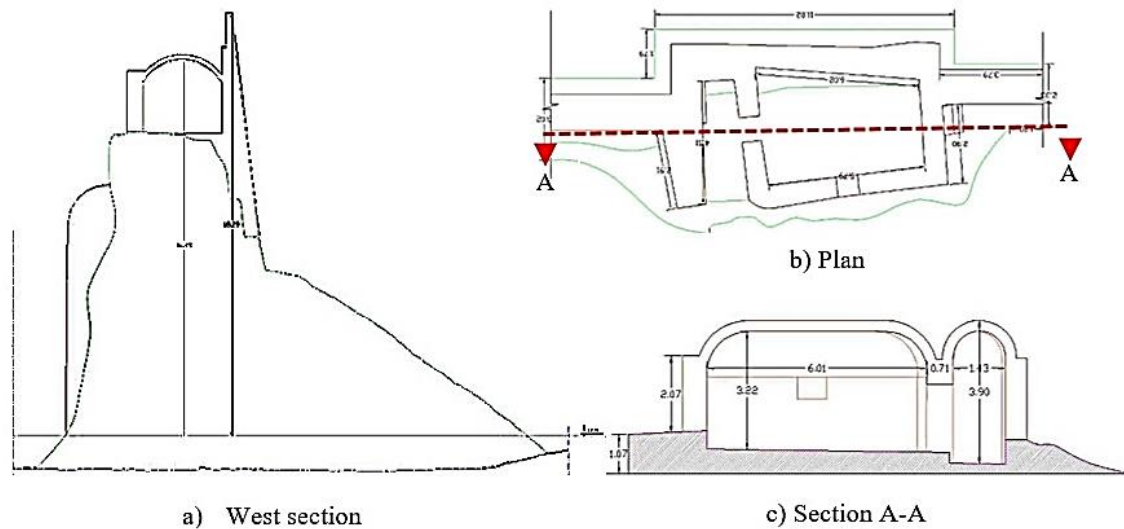
**Figure 4.37-** Plans and sections of the Tower No. 2 of Bam Citadel and its adjacent fortifications (Source: archive of RPBCH).

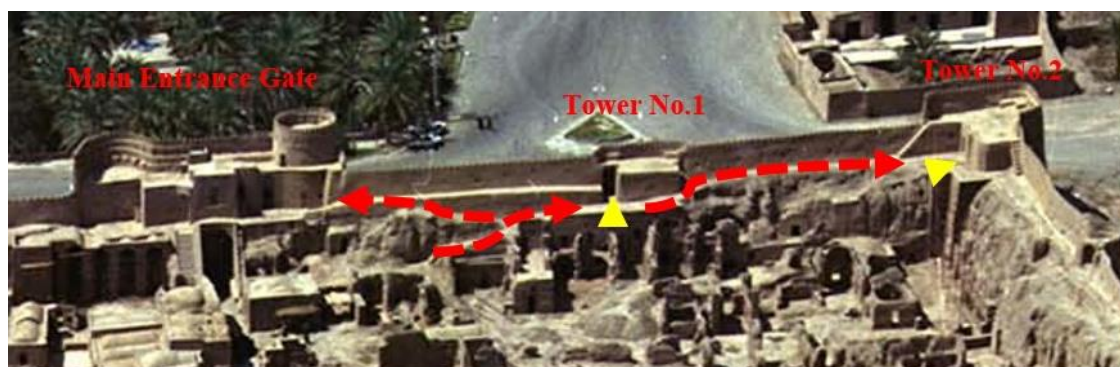
**Figure 4.38-** The access way to the Tower No.2 and Tower No.1.

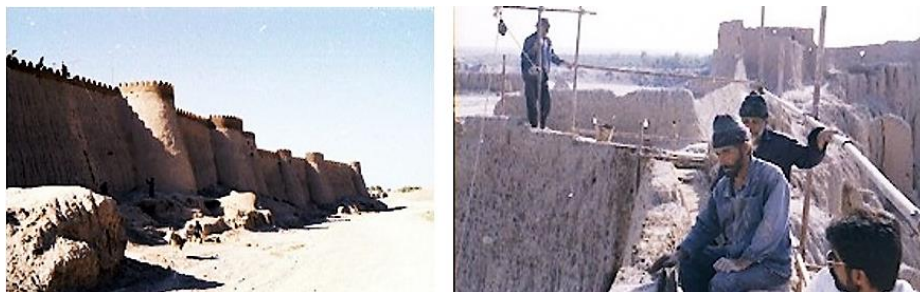
**Figure 4.39-** Some restoration works in enclosure wall of Bam Citadel before the earthquake (Source: personal archive of Prof. Tayari, 2001).

▪ **Conservation History before Earthquake:** About the conservation history of Bam Citadel's enclosure wall, there are no exact written documents. Although more extensive conservation works which started in 1977 were mainly concerned with the repair and preservation of the fallen and olden parts of fortification, during this time most of activities were done randomly. From 1993 until 2003, the conservation activates on Bam Citadel's fortifications had been performed more precisely. As a review of the activities that have been carried out in this area, we can refer to conservation, restoration and renovation of the enclosure wall, including its crenellations, the middle corridors and towers. These activities have concentrated more on obstructing holes and cracks, sloping of corridors and new plastering of façades. In addition, some consolidation work has been carried out on the body of fortification such as replacing the deteriorated and troubled parts with new similar materials.

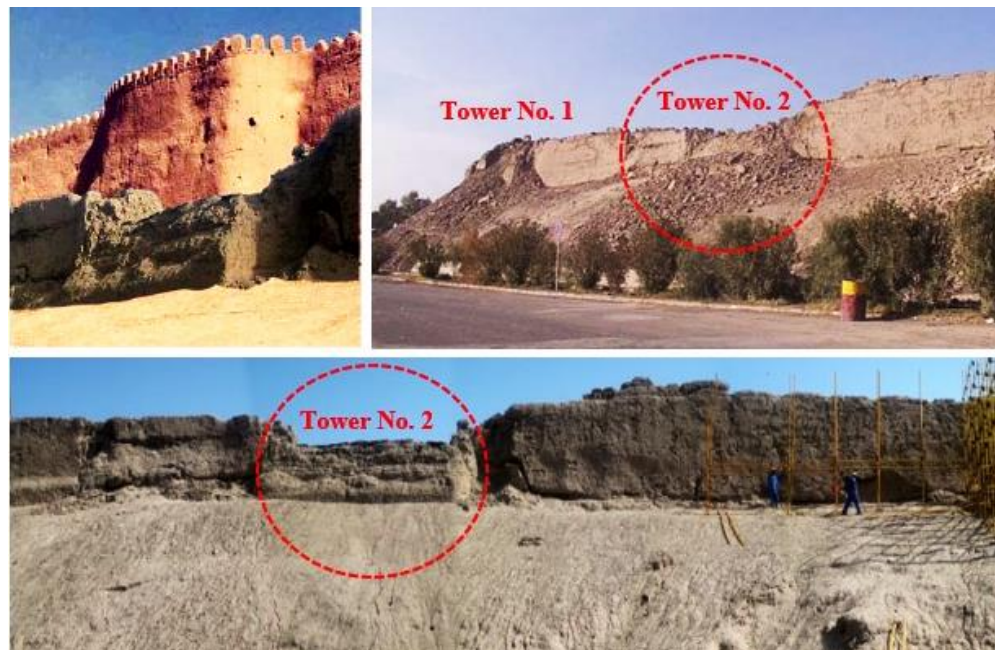
**Figure 4.41-** A comparison between the original state of Tower No.2 and its condition after the 2003 Bam earthquake, and after debris removal ((Top right) photo by Ahmadi and Boroomandi, 2003 (Source: archive of ICHHTO); and (Top left and Down) archive of RPBCH 2008-2009).

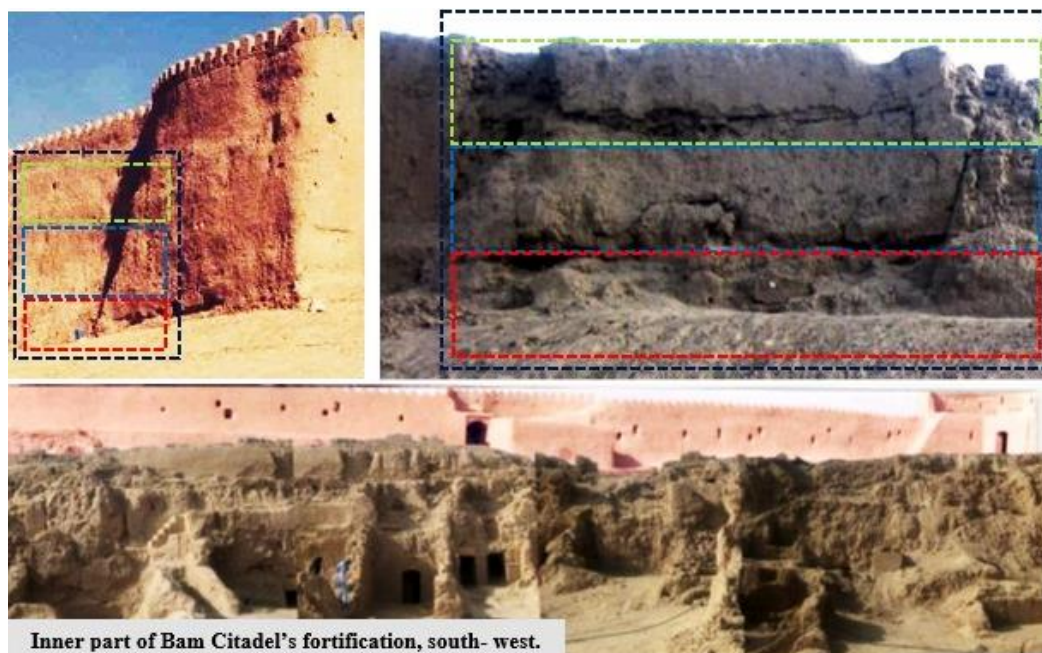
**Figure 4.42-** (Top) the state of destruction, cracks and detachments in west side of Tower No. 2 (Source: archive of RPBCH); and (Down) a comparison between the original state and destroyed state of the inner part of Bam Citadel's fortification, south-west (Source: archive of RPBCH).

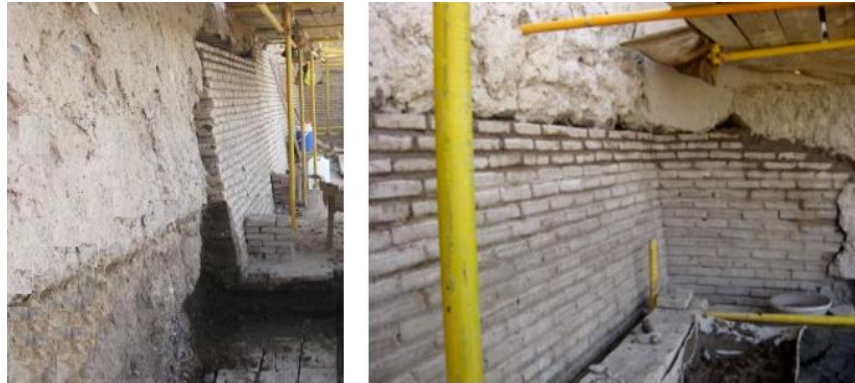
**Figure 4.43-** The consolidation of foundation in inner part of the Tower No.2 and its adjacent fortification (Source: archive of RPBCH, 2010).

restored and finalized by thatch coating. The purpose was to give the visitors an opportunity to be able to have a comparison between new restored layers and original layers of the fortification. At present, the guard's room of the Tower No. 2 is not restored yet. In the case of crenellations, there are just two small sections in the western and eastern corners of the fortification that are restored like before the earthquake by using mesh made of palm fibers (SIS) and traction elements like fiberglass rods. Here SISs are employed in the crenellations in every five brickworks at lowest parts and every two brickworks in upper parts<sup>338</sup> along with using of fiberglass rods in every 1.1 m length.

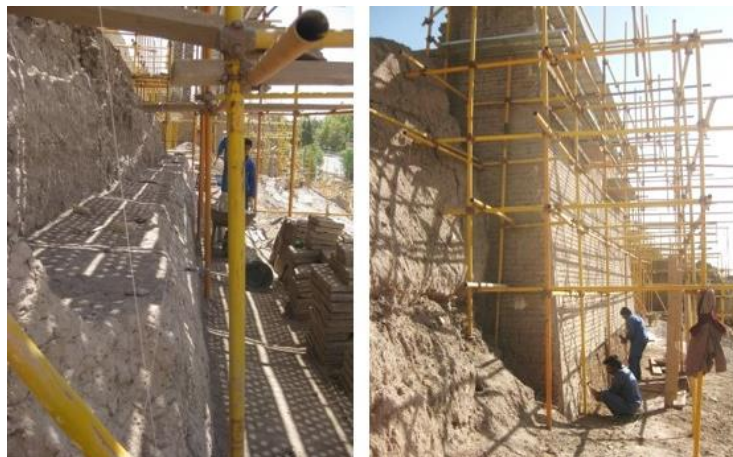
**Figure 4.44-** Consolidation and restoration of the outer part of Tower No.2 (Source: archive of RPBCH, 2010).

<sup>338</sup> Since the effect of Bam earthquake in height of buildings was more destructive, to reduce this effect during the future earthquakes, the SIS in the lower parts of the crenellations was employed with long distance instead of upper parts.

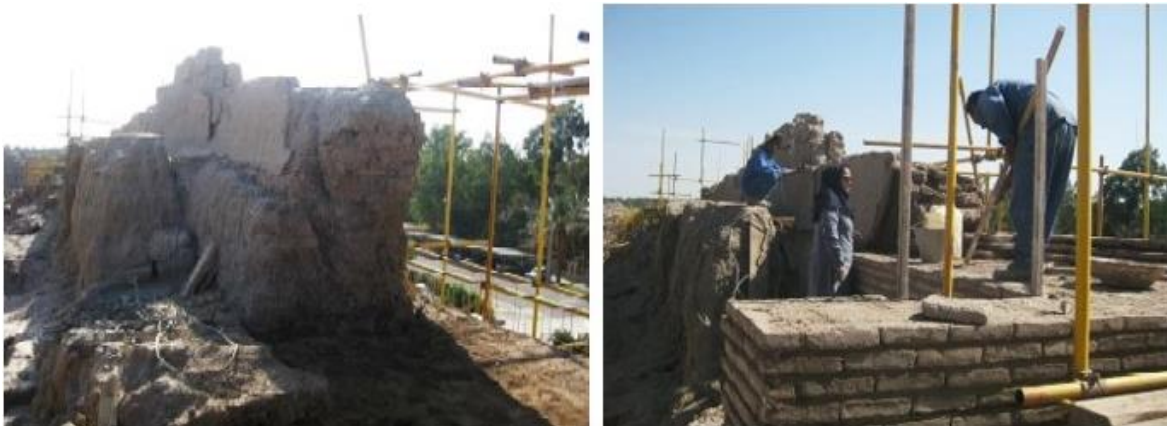
**Figure 4.45-** Reuse of usable ruins remained during the earthquake in restoration procedures of Tower No.2 (Source: archive of RPBCH, 2010).

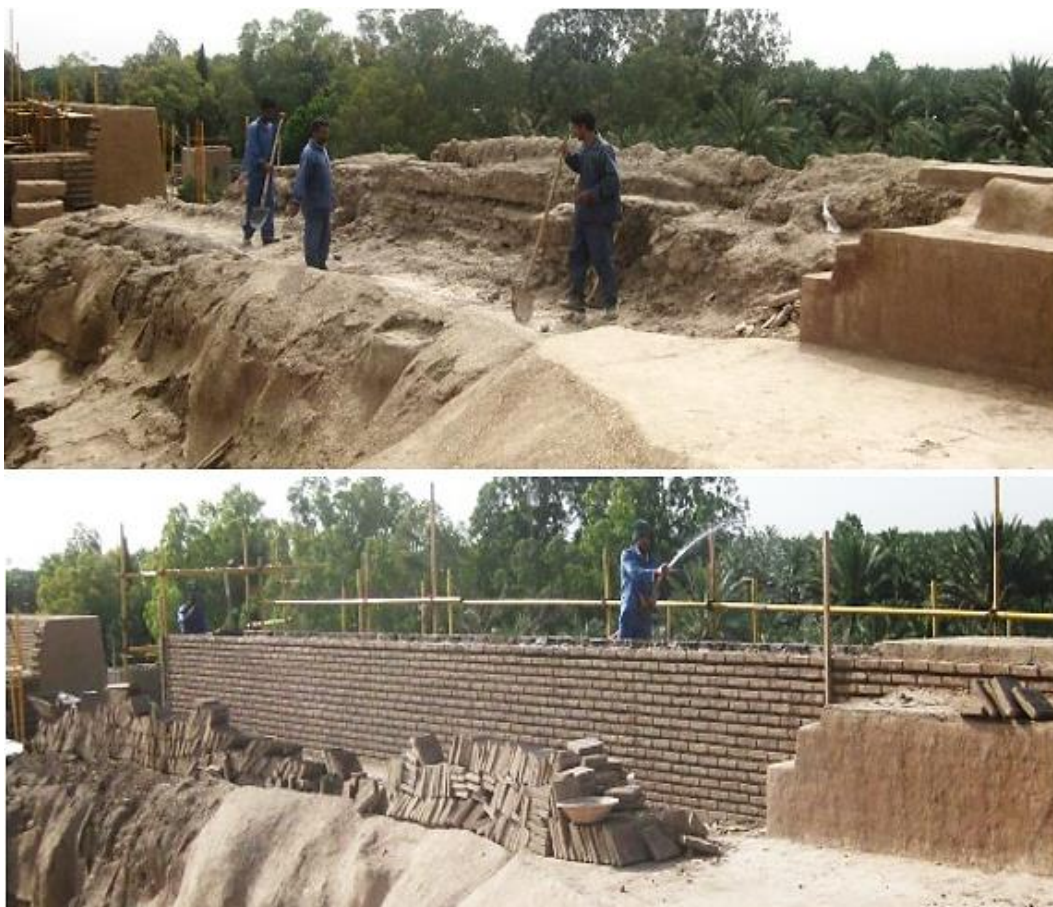
**Figure 4.46-** The upper part of fortification between Tower No.1 and Tower No.2 during restoration works after debris removal (Source: archive of RPBCH, 2010).

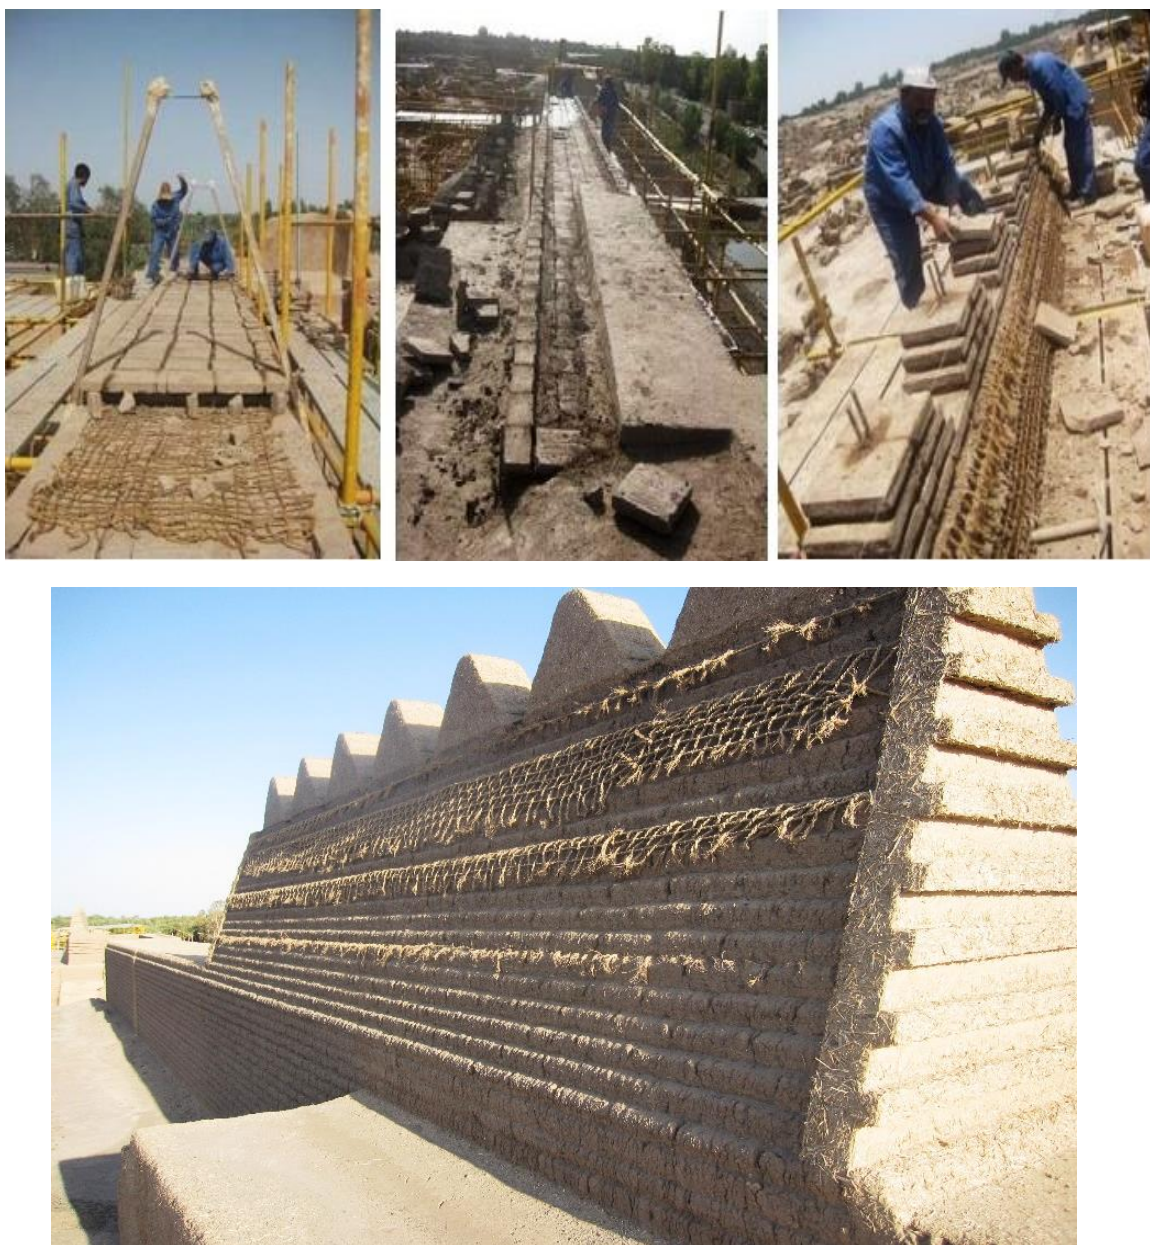
**Figure 4.47-** (Top) restoration and stabilization of crenellations by palm fibers and fiberglass rods (Source: archive of RPBCH, 2010-2011); and (Down) the crenellations in the western side of Tower No.2 after complete restoration (Photo by Rouhi, 2015).

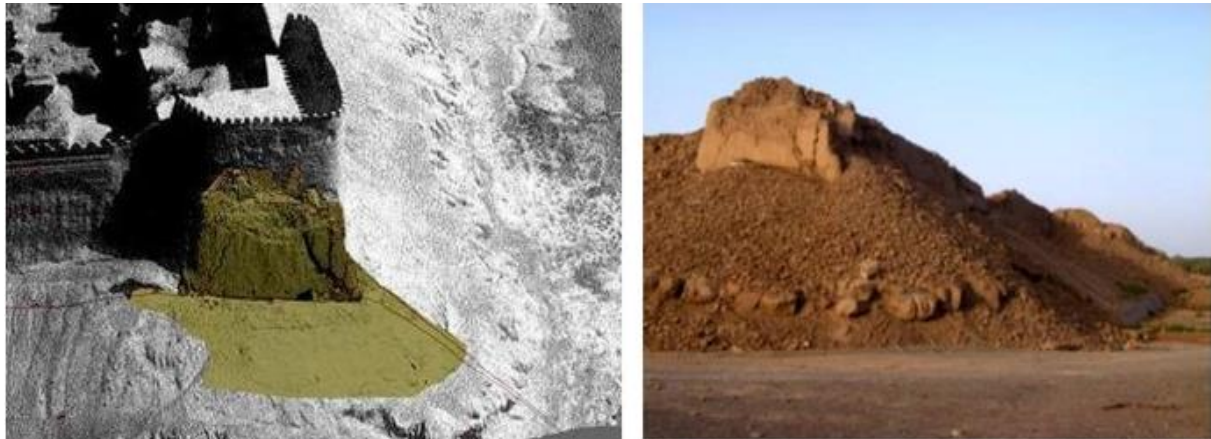
**Figure 4.49-** The damage induced to Tower No.1 during the earthquake, the highlighted part is the ruin remained after the earthquake (Sources: (Left) Jung, 2007; and (Right) Porta & Santoro, 2010).

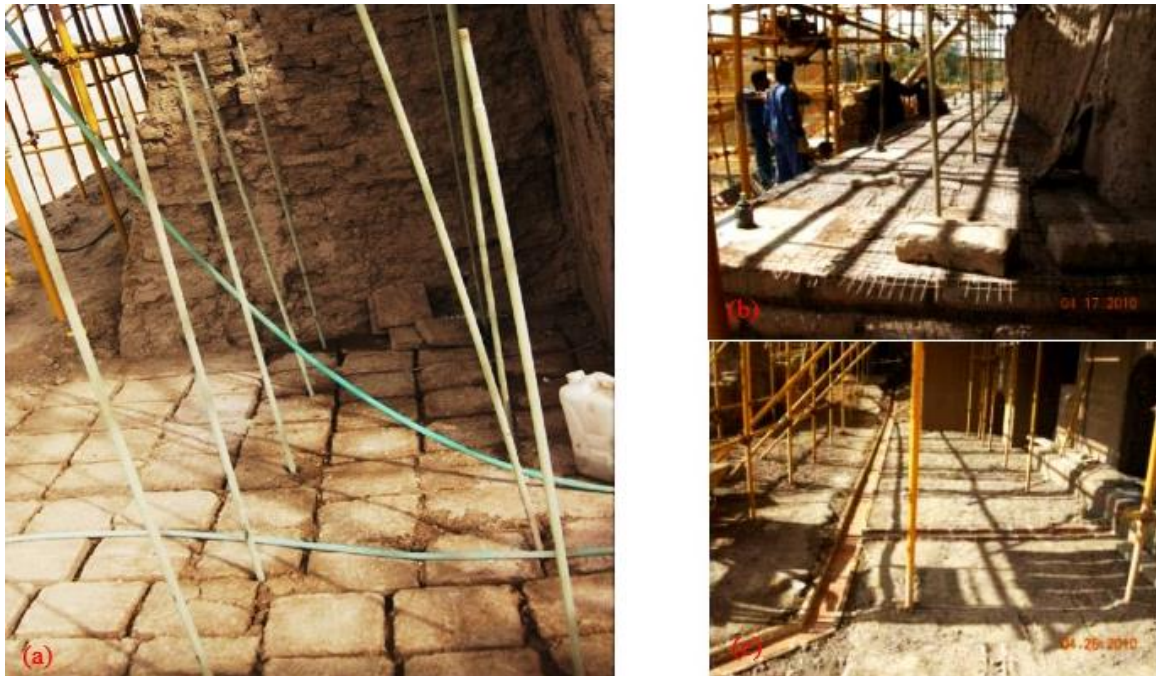
**Figure 4.52-** (a) after the finishing of the nailing, the inclination of the wall based on the original form of the ancient wall are executed (Source: archive of RPBCH, 2010); (b) consolidation and reconstruction of foundation by fiberglass mesh (Photo by Pandidar, 2010. Source: personal archive of Prof. Santoro, from IGeS World srl - IGeS Ingegneria Geotecnica e Strutturale snc); and (c) surface water management system during reconstruction (Photo by Pandidar, 2010. Source: personal archive of Prof. Santoro, from IGeS World srl - IGeS Ingegneria Geotecnica e Strutturale snc).

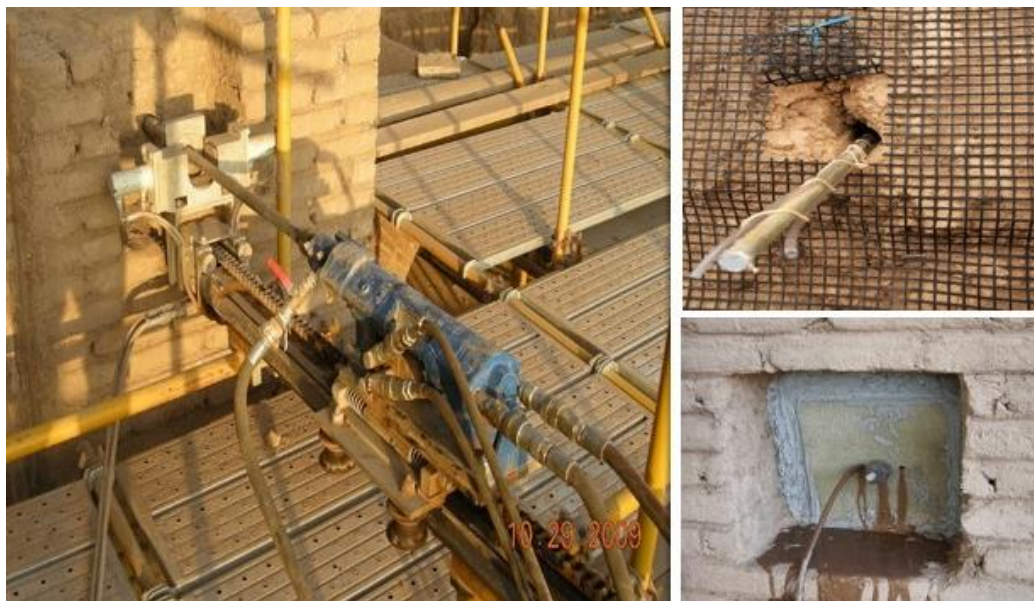
**Figure 4.53-** The drilling process for installation of fiberglass rod in the body of Tower No. 1, and the methods for injection of grout in empty space around rods (Source: archive of RPBCH, 2009).

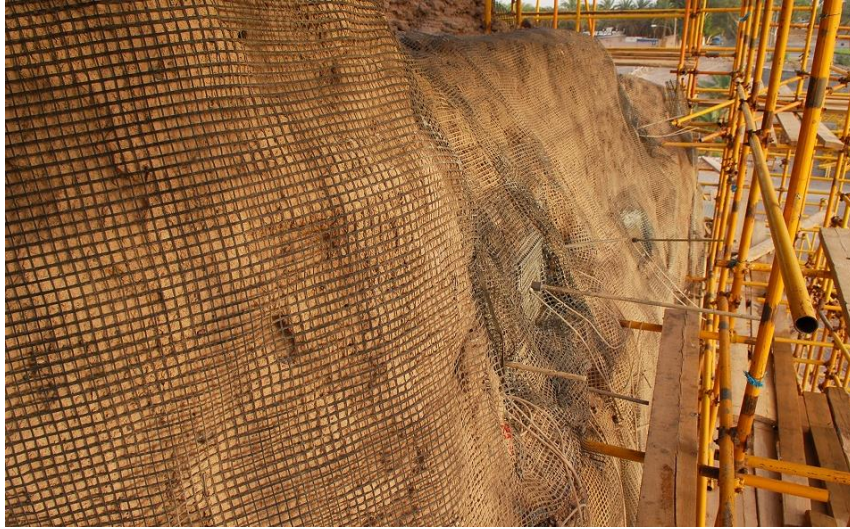
**Figure 4.54-** The finished state of stabilization of the façade of Tower No.1 by fiberglass meshes and fiberglass rods before surface covering (Source: archive of the RPBCH, 2010).
