**UNIVERSITÀ DEGLI STUDI DI NAPOLI FEDERICO II**  
**DiArc - DIPARTIMENTO DI ARCHITETTURA**

**DOTTORATO DI RICERCA - XXIX CICLO**

Conservation and Restoration of Adobe Architectural Heritage of Bam Citadel (Iran),  
Affected by the 26 December 2003 Bam Earthquake: Problems and Issues

Aprile 2017

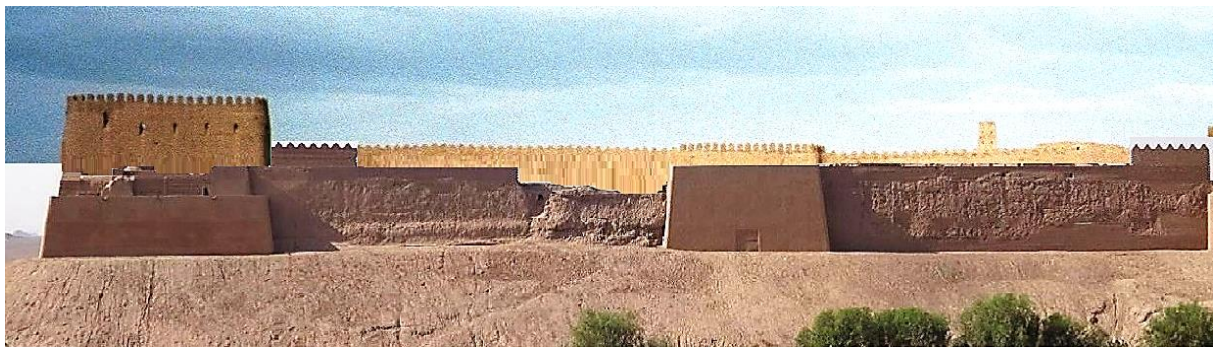
**Figure 4.55-** The difference between original and present state of Tower No.1, Tower No.2 and their adjacent fortifications (Designed by Author).

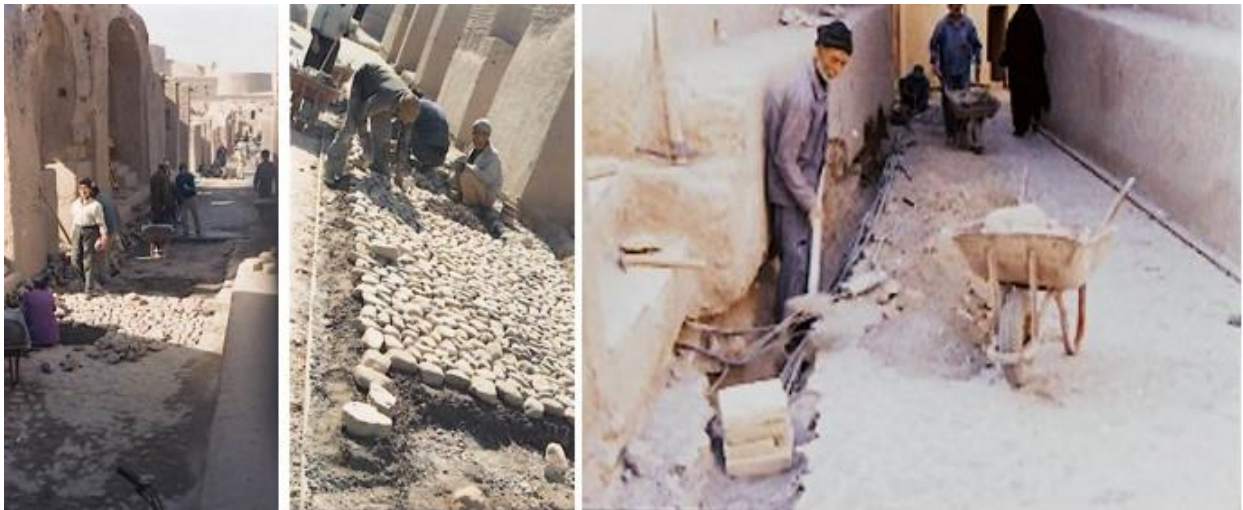
**Figure 4.58-** The renovation of the Bazaar's pavement, and uncovering and consolidation of wall's foundation between Bazaar and Main Entrance Gate (Source: personal archive of Prof. Tayari, 1993).

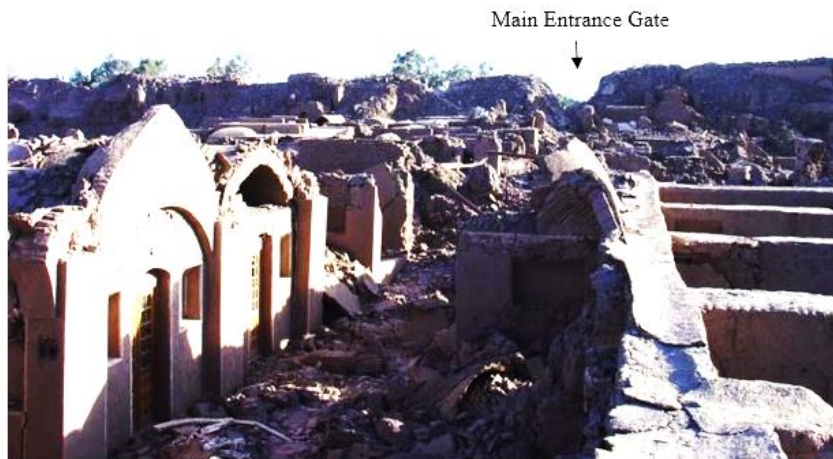
**Figure 4.61-** The Bazaar of Bam Citadel after the 2003 Bam earthquake (Photo by Ahmadi & Boroomandi, 2003. Source: archive of ICHHTO).

▪ **Physical Condition after Earthquake:** As can be seen in Figure 4.60-61, the percentage of damage in different parts of Bazaar and its alleys were different from one point to another. The damage in the southern part of Bazaar was in a range between 60-80%, around Chāhārsuq, due to the complete collapse of its roof, the damage was at the highest degree 80-100%, and in the northern part of Bazaar, it was in the lowest range from 5-25%. However, in most of the shops, walls showed a good behavior against the earthquake, and a few numbers of them were disintegrated.

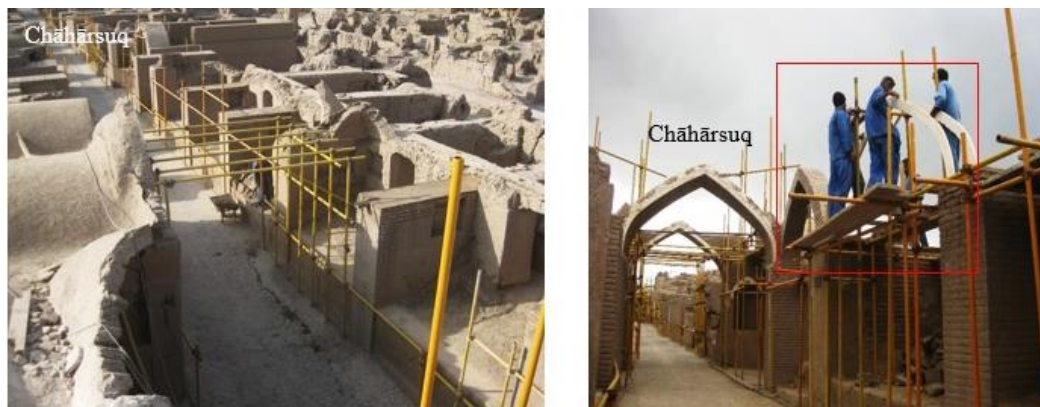
**Figure 4.63-** The Chāhārsuq and north-west part of the Bazaar after debris removal, and during restoration works (Source: archive of RPBCH, 2008).

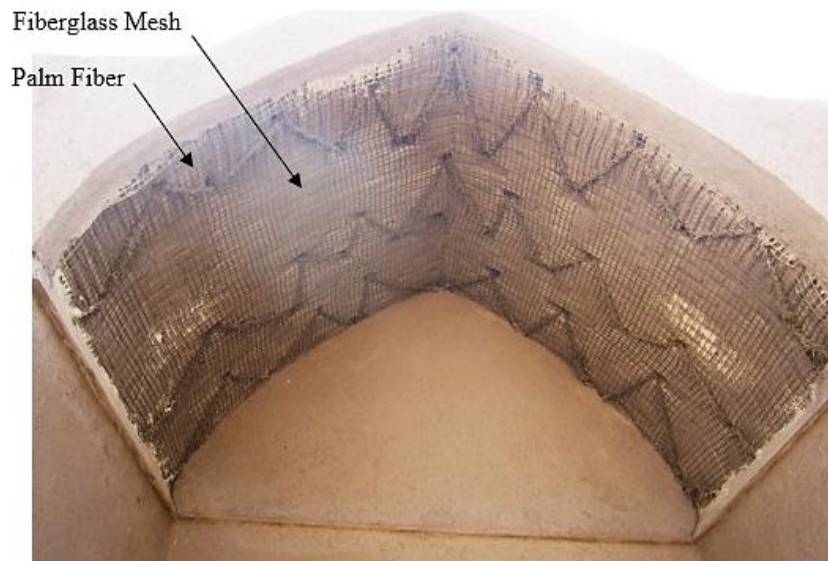
**Figure 4.65-** The quality of restoration works in a room (south-east of the Bazaar) by palm fibers and fiberglass meshes (Photo by Rouhi, 2015).

III) The third one like the second one was implemented by RPBCH, but the difference was in the use of new tension elements for roofs such as palm fibers and fiberglass meshes used prior to the injection process, which became post-tensioning elements with back plates in two sides of load-bearing walls (brown lines in Figure 4.56).

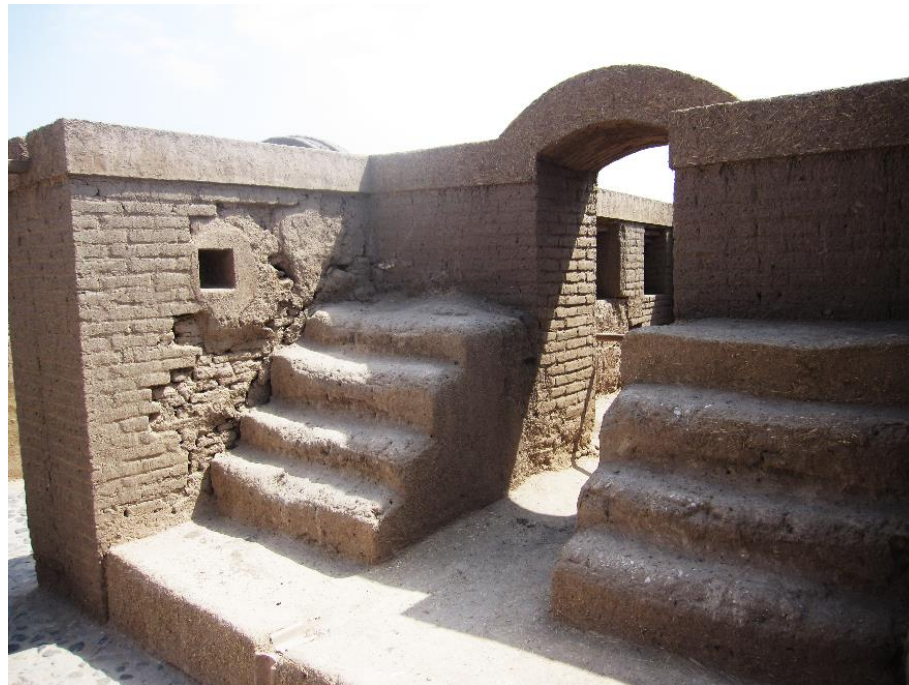
**Figure 4.66-** The condition of an adobe shop (north-east of the Bazaar) after slight preventive measures (Photo by Rouhi, 2015).

IV) The last one was some slight preventive measures carried out in southern part of the Bazaar by mud and straw plastering in deteriorated parts (other shaded lines in Figure 4.56).

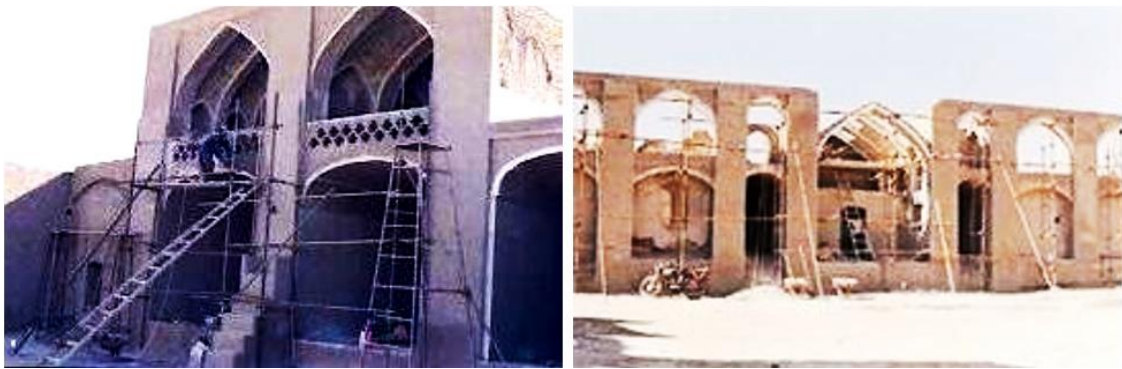
**Figure 4.70-** (Left) the eastern part of the Tekiyeh under restoration works (Photo by Arfaei, 1997. Source: archive of ICHHTO); and (Right) the western part of the Tekiyeh under restoration works (Photo by Louyot, 2003. Source: archive of Bam3DCG).

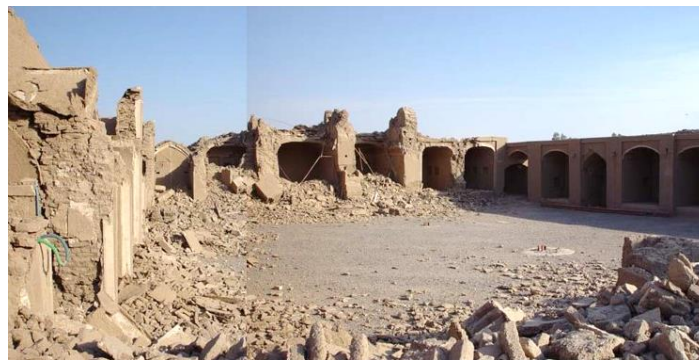
**Figure 4.74-** The eastern part of the Tekiyeh after the 2003 Bam earthquake (Source: archive of RPBCH).

▪ **Physical Condition after Earthquake:** The damage state in Takyieh of Bam Citadel was almost slight compared with that in other parts of the Citadel. However, the rate of damage in parts, where the property were built on two floors were more than other parts (eastern and western parts) due to complete collapse of the second floors. In other parts, except for partial collapse and cracks in some parts of the property, no special damage has been reported.

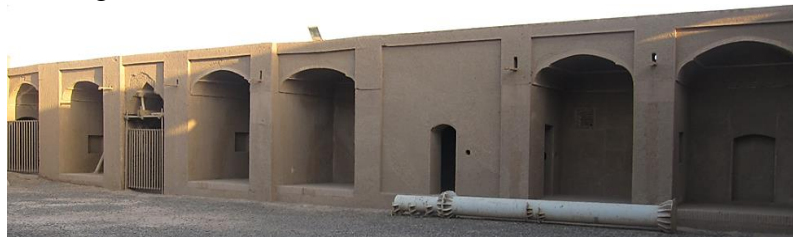
**Figure 4.75-** View from the southern part of the Tekiyeh (Photo by Rouhi, 2015).

- The southern side of Tekiyeh: since the damage was so slight in this part, the procedures were mostly focused on protective and preventive measures with some restoration measures in the necessary parts, (see Figure 4.75).

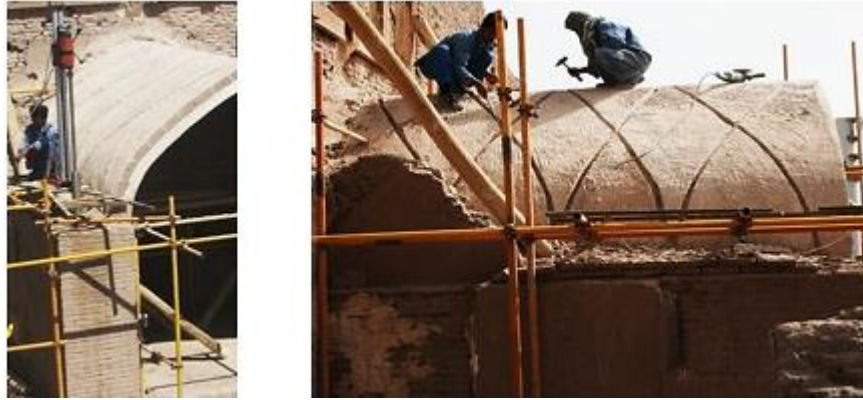
**Figure 4.76-** (Left) drilling of walls vertically for insertion of palm ropes; and (Right) creation of grooves in outer surface of roofs for placement of palm ropes (Source: archive of RPBCH, 2008).

- The northern side of the Tekiyeh: for the stabilization of roofs, the palm rops and palm meshes are used. For more detail, on the outer part of roofs, some diagonal grooves were created along with some holes between their outer and inner parts for insertion of palm ropes and sewing the roofs. Then, ropes were tied on wooden plates by passing from the side’s load-bearing walls. Finally, palm meshes and clay and straw mortar (Kahgel) covered the outer part of the roofs. In this part, the walls were stabilized by new technique, so walls were vertically stabilized by natural tension elements of palm. In this case, after vertical drilling of walls until 150 cm under the wall’s foundations, the palm cables with a thickness larger than palm rops were inserted. For the fixation of palm cables, their lower parts consisted of a metal hook and their upper parts were fastened by metal interfaces on the wooden plates, and the end holes were injected by compatible mud-grouts. In addition to those works, walls have been also reinforced in their width by palm cables and back plates.

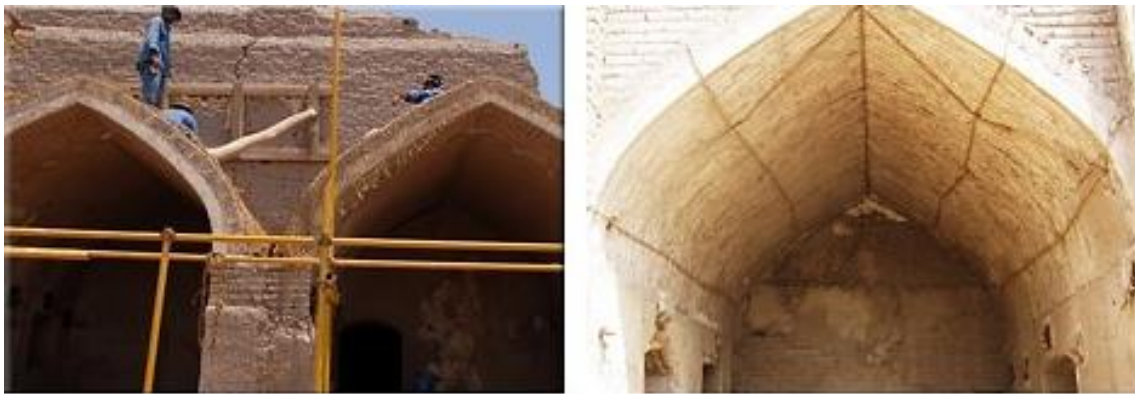
**Figure 4.77-** (Left) stabilization of the roofs by their wrapping out with palm meshes (Source: archive of RPBCH); and (Right) the quality of the sewing of inner and outer parts of roofs by palm ropes (Photo by Rouhi 2015).

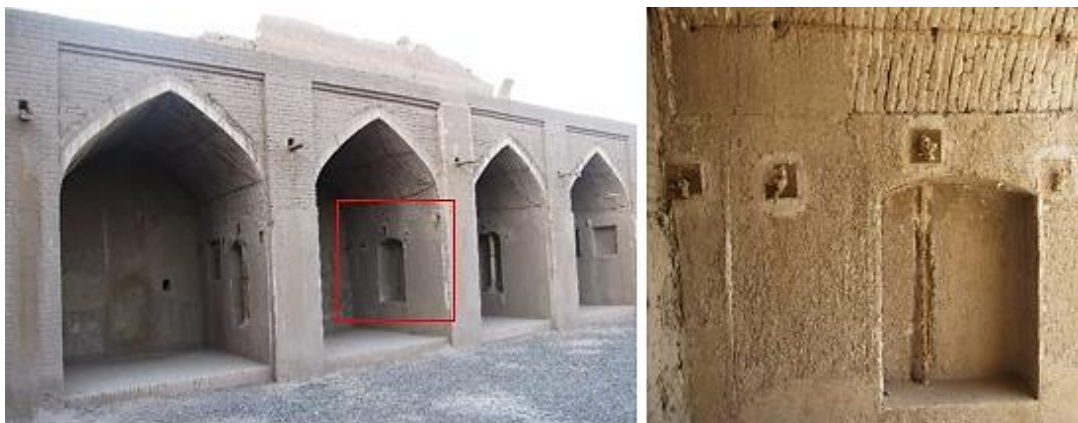
**Figure 4.78-** (Left) the northern part of the Tekiyeh after complete restoration; and (Right) the quality of the tying of palm cables on the back plates, and the quality of the passing of palm cables from inside of load-bearing walls (Photos by Rouhi, 2015).

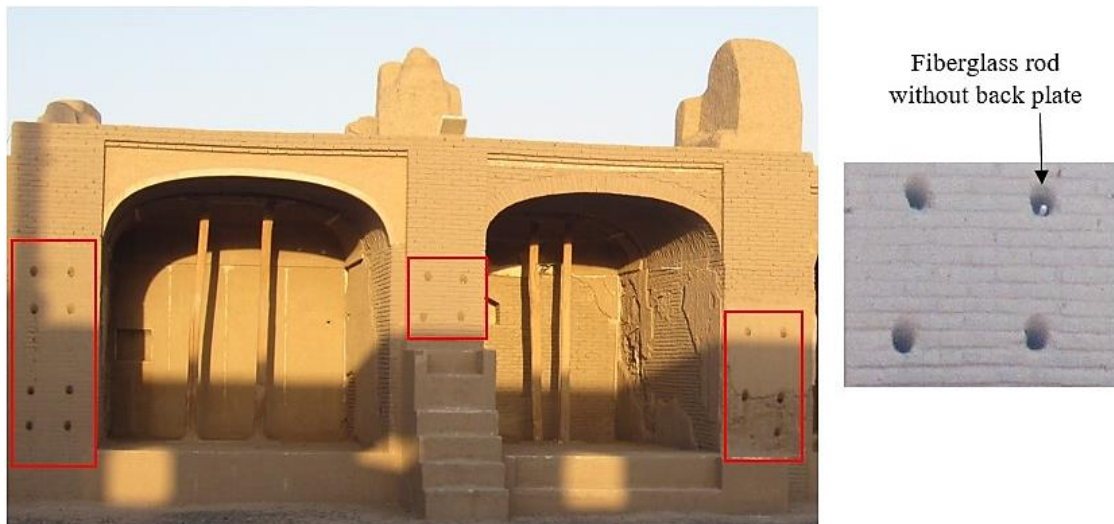
**Figure 4.80-** Stabilization of load-bearing walls in the eastern side of the Tekiyeh by insertion of tensile elements (Photo by Rouhi, 2015).

- The eastern side of Tekiyeh: in this part, the only stabilization activity was the employing of the fiberglass rods in the length of walls horizontally without any back plates, see Figure 4.80. In this part, the restoration and reconstruction activities have been limited just on the first floor.

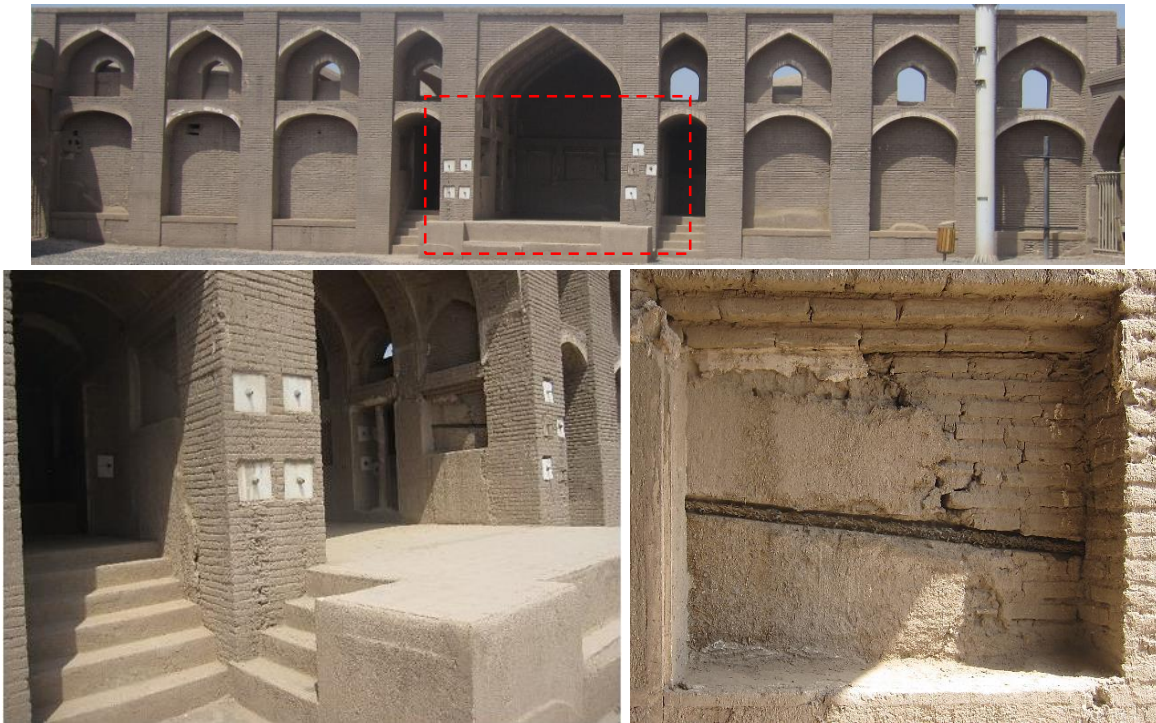
**Figure 4.81-** The western part of the Tekiyeh after total restoration (Photos by Rouhi, 2015).

- The western side of the Tekiyeh: in this part, due to the high height of the walls, the only main stabilization work was carried out in two main load-bearing walls of the theater stage. So far, after drilling the walls horizontally, in the length of walls, cables weaved by palm fibers were inserted and later they were fastened by ‘metal interfaces’ on the ‘teflon plates’. Once the tension elements were inserted into the walls, they were grouted in place (see Figure 4.81).

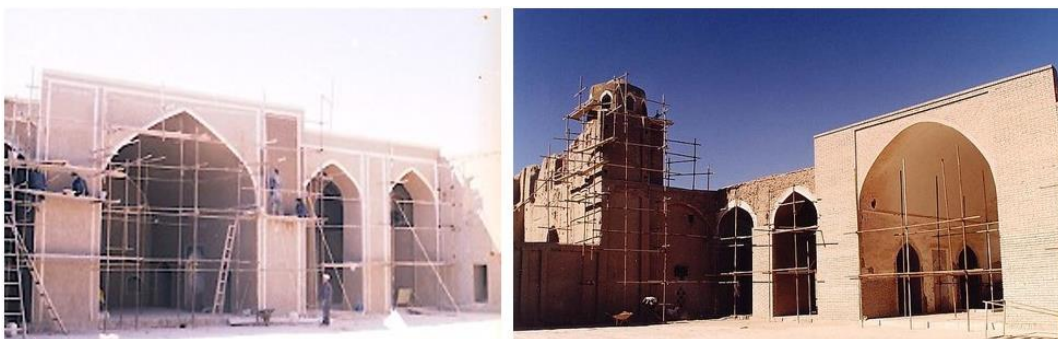
**Figure 4.84-** (Left) new plastering of the façade in around of central courtyard of the Friday Mosque (Source: personal archive Prof. Tayari); and (Right) the restoration works in the Azan Tower of the Friday Mosque (Photo by Ingham, 2002. Source: <https://www.flickr.com>).

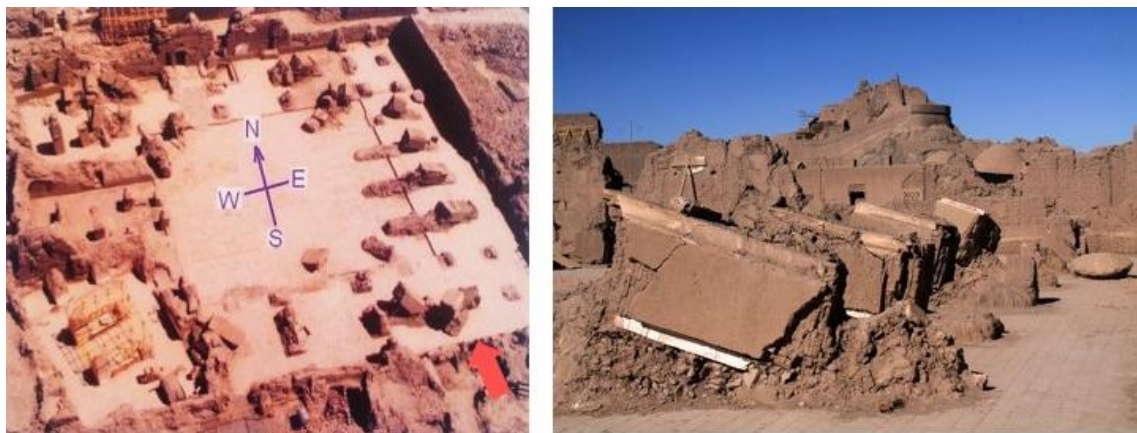
**Figure 4.86-** (Left) aerial photo from the Friday Mosque of Bam Citadel after debris removal (Source: Annual Report of Arg-e Bam Research Foundation, 2008); and (Right) the quality of protective and preventive measures on the remains of pillars after the earthquake (Source: <http://shahrkhabar.ir>, 2013).

▪ **Physical Condition after Earthquake:** This property was badly destroyed after the 2003 earthquake. Almost all of the bases of pillars were crashed, and roofs were fell down, and nothing remained by the earthquake except ruins.

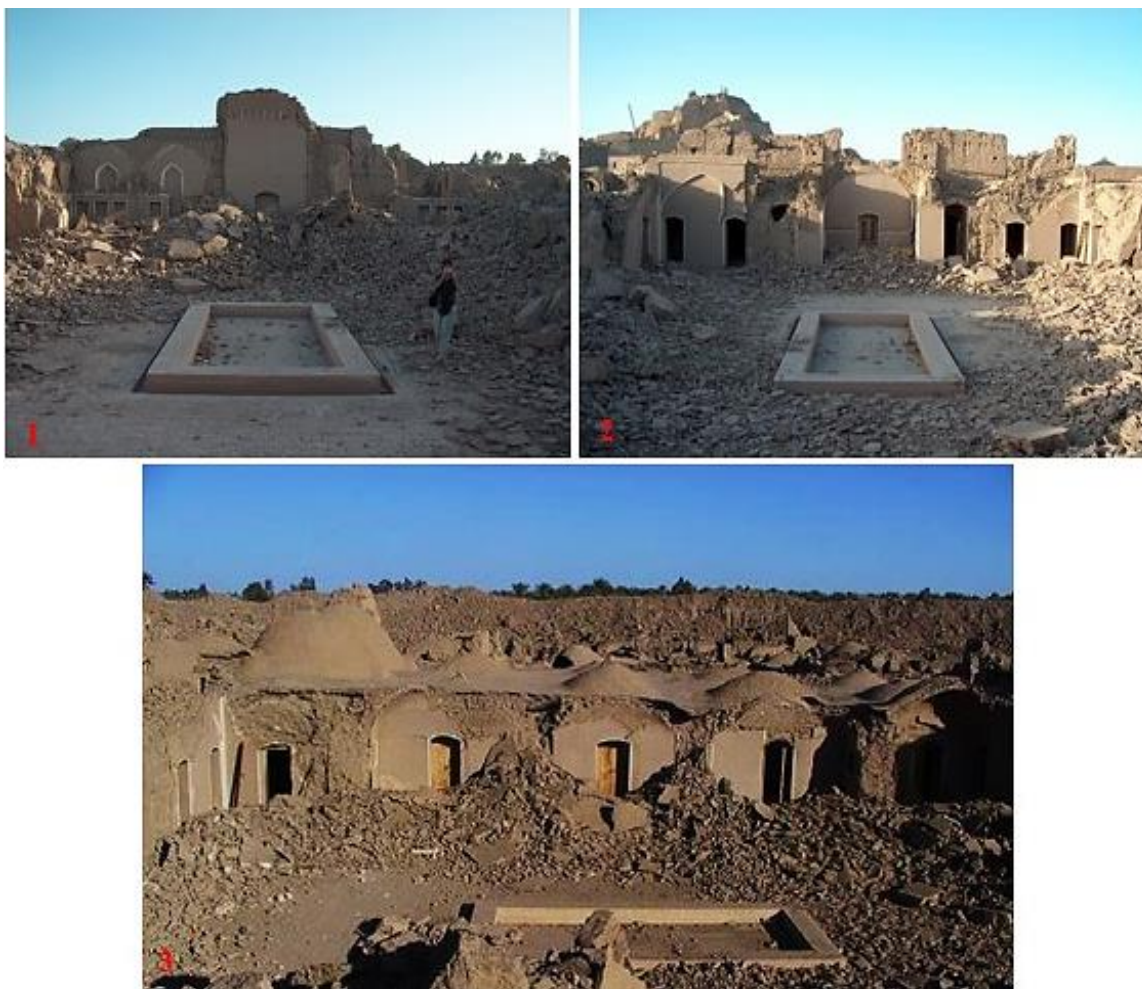
**Figure 4.91-** Damage induced by the 2003 Bam earthquake to different parts of the Mirza Na'eim School (Source: personal archive of Prof. Luigi Marino).

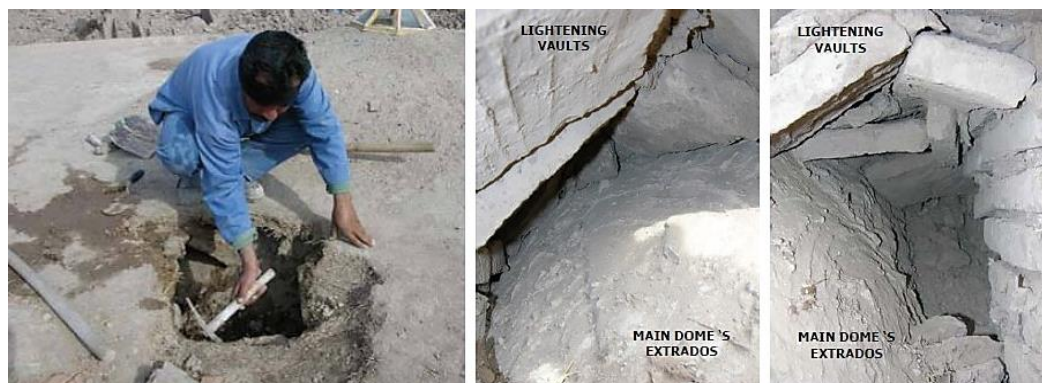
**Figure 4.92-** Traditional lightening vaults to increase the building's strengthen against the earthquake discovered on the roof during one of the mission carried out by Milan Polytechnic (Photos by Milan Polytechnic, 2006. Source: UNESCO Contract Bam Citadel, Mirza Na'eim School, 2007).

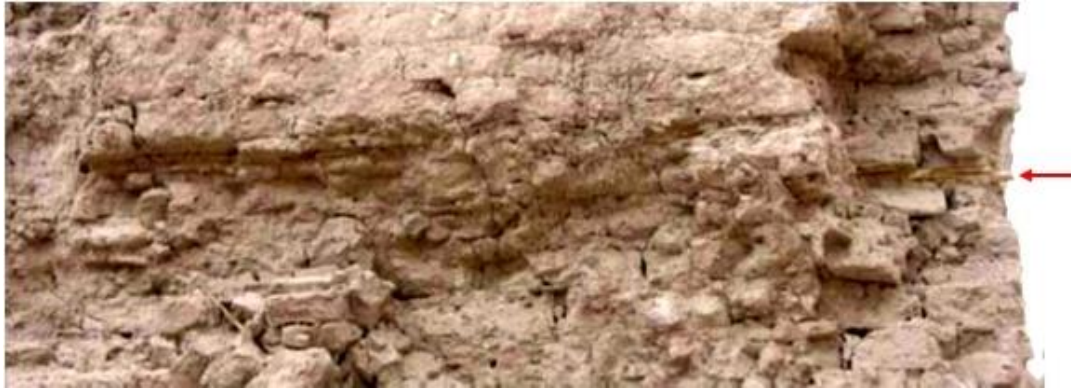
**Figure 4.93-** Traditional horizontal wooden reinforcements to increase the building's strength against the earthquake discovered on the north wall during one of the mission carried out by Milan Polytechnic (Photos by Milan Polytechnic, 2006. Source: UNESCO Contract Bam Citadel, Mirza Na'eim School, 2007).

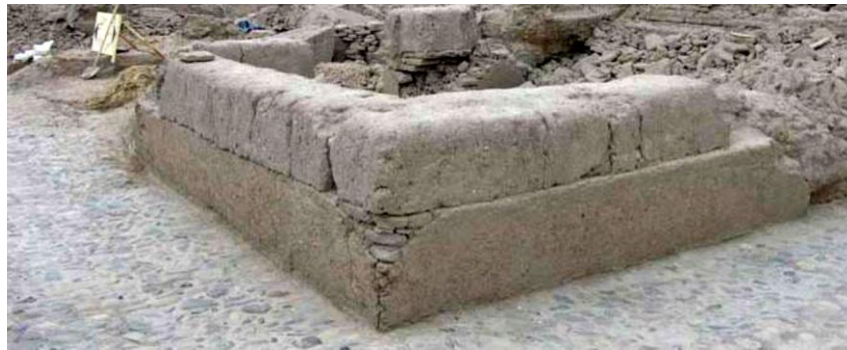
**Figure 4.94-** Ruined building beside the Mirza Na'eim complex. Before the preservation was carried out by Milan Polytechnic (Photos by Milan Polytechnic, 2006. Source: UNESCO Contract Bam Citadel, Mirza Na'eim School, 2007).

The next two pictures show the structure where the workshop was held, before and after the intervention works, see Figures 4.94 and 4.95.

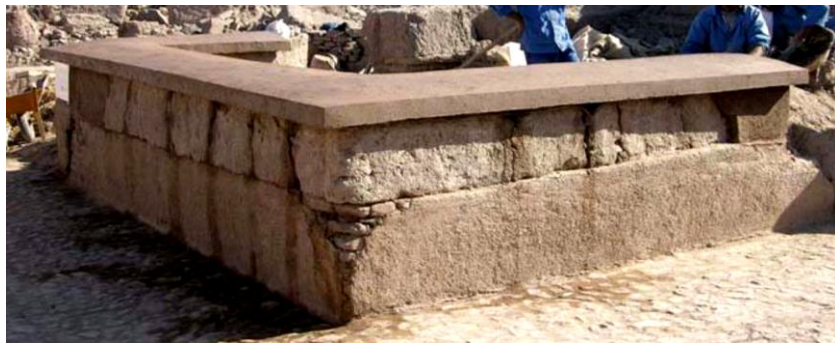
**Figure 4.95-** Ruined building beside the Mirza Na'eim complex. After the preservation was carried out by Milan Polytechnic (Photos by Milan Polytechnic, 2006. Source: UNESCO Contract Bam Citadel, Mirza Na'eim School, 2007).

- wetting of top of the remaining walls to ensure a proper connection between existing and new materials;
- structural reinforcement of existing walls, through either new bricks crossing old and new structures, and execution of water injections to join all cracked fragments;
- placement of wet cotton fabric to separate old and new structures with a physical layer, leaving a trim that is directly visible allowing people to recognize the intervention;
- integration of collapsed parts in order to have only one horizontal layer, respecting the 1964 Charter of Venice on the preservation of cultural heritage. All new materials were suggested and analyzed by the laboratory established nearby the site by the local Authorities;

- realization of a continuous layer made of mud bricks arranged in such a way to keep rainfall water away without flowing on the surfaces of the structures; execution of a small step made of clay to allow rainfall water dripping without eroding the surfaces of walls;
- laying of a finishing layer of mud mortar added with straw to protect the preservation and create a surface that could be replaced in the next years without making again all previous work phases; and carving of the year 2006 in Gregorian and Persian calendar and placing of pictures showing the Institutions involved in the activity.

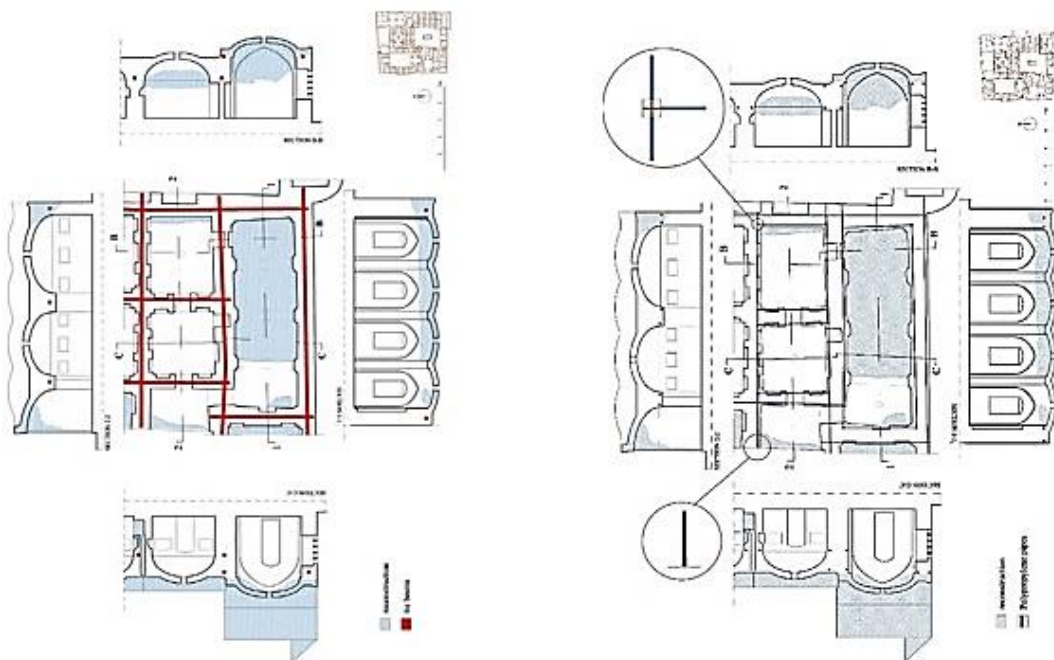
**Figure 4.96-** (Left) positioning of the timber beam; and (Right) positioning of the Polypropilane pipes (Source: UNESCO Contract Bam Citadel, Mirza Na'eim School, 2007).

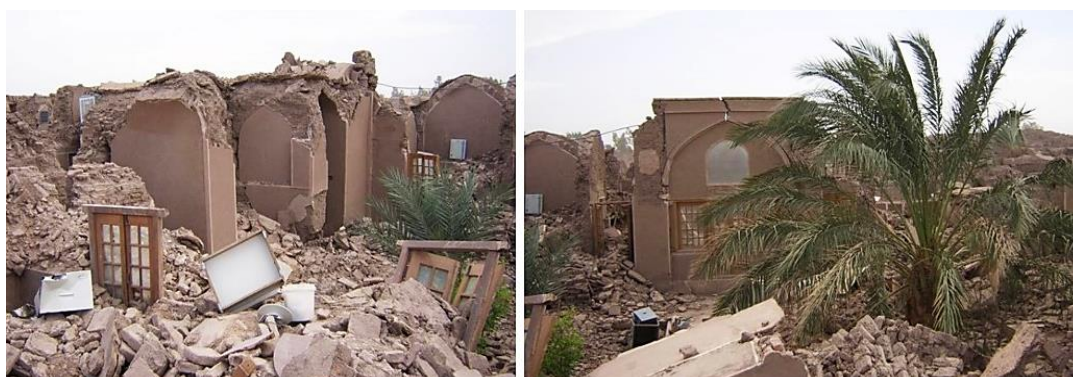
**Figure 4.103-** Sistani House after the 2003 Bam earthquake (Photos by Andaroodi, 2003. Source: archive of Bam3DCG).

▪ **Physical Condition after Earthquake:** After 2003 Bam earthquake, this Iranian traditional residence house suffered severe destruction, so most of the roofs and walls were completely destroyed. The half north (north towards west) and western side of the Sistani House faced with total destruction, but damages were more slight in other sides.

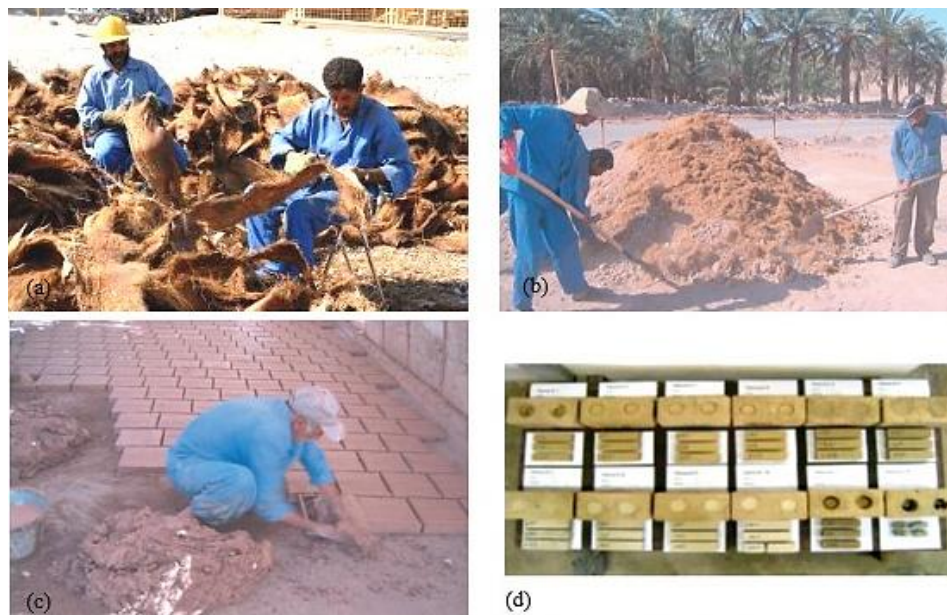
**Figure 4.105-** (a, b and c) the process of the producing of reinforced adobe brick with palm fibres in Bam Citadel's workshop (Source: Jaeger & Fuchs, 2008); and (d) test specimens for grouting material in the laboratory of the Dresden Technical University (shrinkage of the grouting material in the borehole) (Source: Jaeger & Fuchs, 2008).

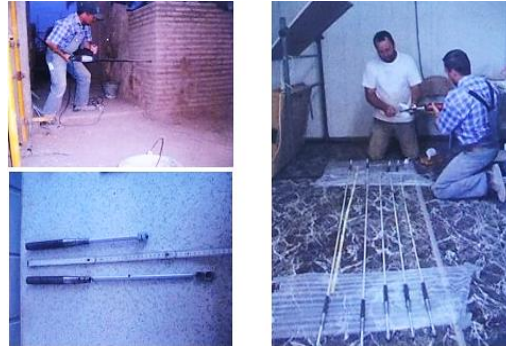
**Figure 4.106-** Tension elements employed in Sistani House (Source: Annual Report of Arg-e Bam Research Foundation, 2008).

(IV) Needling and anchoring: for cracks with larger than 2 cm width, the technique of needling and anchoring were applied. The anchors were placed in boreholes and fixed with the chosen grouting material (Jäger & Fuchs, 2008).

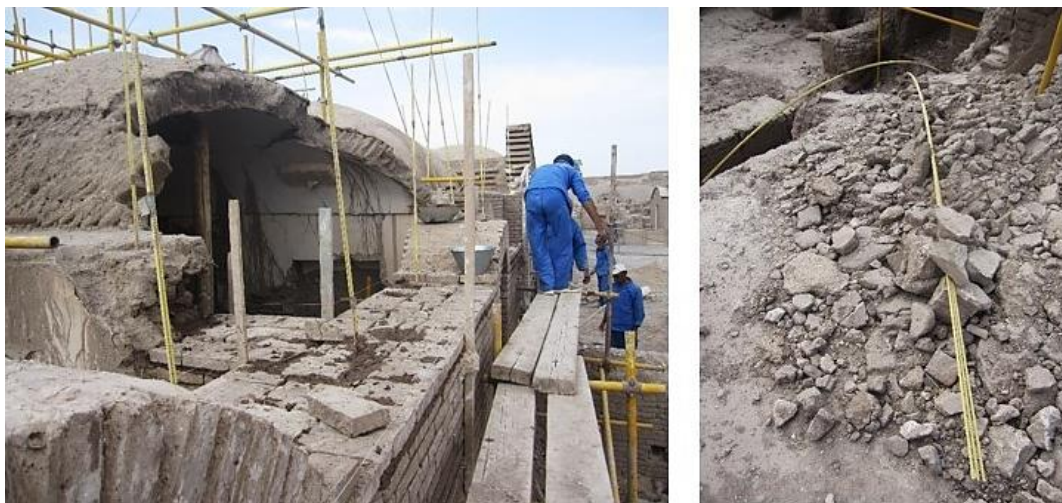
**Figure 4.107-** The quality of the insertion of fiberglass rods in walls, each fiberglass rods are consisted of three rods in an unique set (Source: archive of RPBCH, 2008).

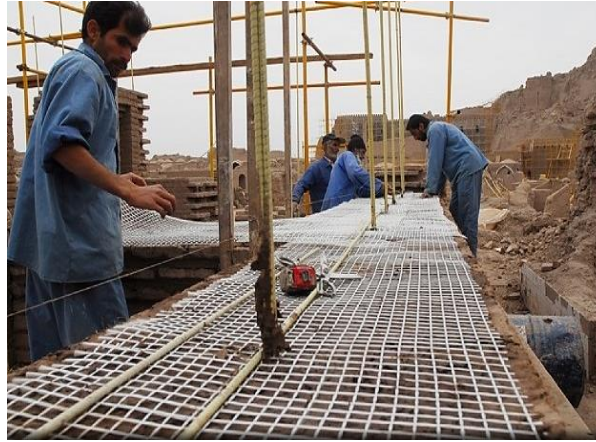
**Figure 4.108-** The strengthening of walls horizontally with fiberglass meshes in the Sistani House (Source: archive of RPBCH, 2008).

(VI) Reinforcement of walls horizontally: in this case, every 0.50 m in height, a layer of fiberglass mesh was inserted into the horizontal joint in the masonry. In addition to that, a horizontal rod of fiberglass was fixed to the vertical anchors (Jäger and Fuchs, 2008).

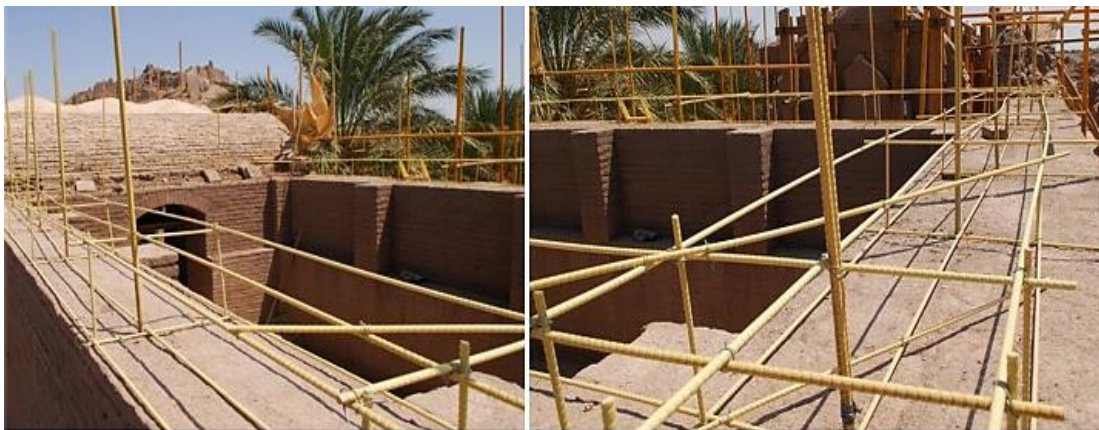
**Figure 4.109-** Enhancing the integrity of roofs and walls through construction of ring beam in Sistani House (Source: archive of RPBCH, 2008).

(VII) Increasing roofs fixed end and wall through the installation of ring beam: inserting ring beam is among the methods of stabilization that can have positive effects on the seismic resistance of earthen structures while preserving their integrity. These ring beams are located under the floor, as shown in Figure 4.109. On the height of the impost of the vaults, a ring beam composed of six fiberglass rods (width 0.60 m, height 0.30 m) is constructed and bricked up (Jäger and Fuchs, 2008). Specific elements, including glass fibers and mud grout compatible with the old parts of the wall, are inserted into these beams for reinforcement (Vatandoust et al., 2008).

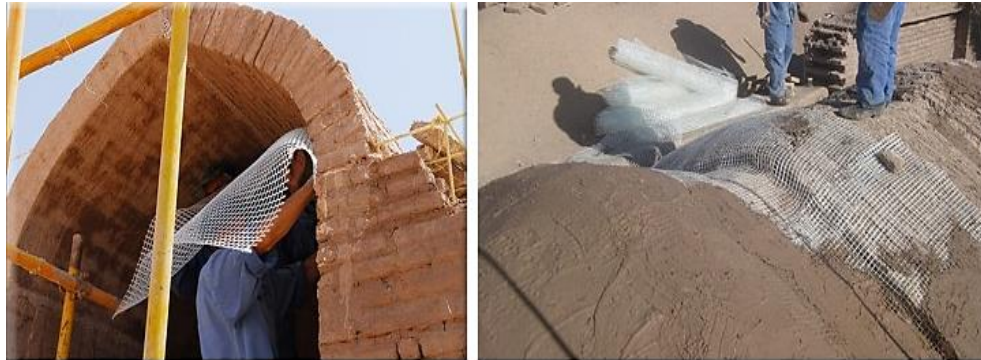
**Figure 4.110-** Stabilization of the roofs in the Sistani House with installation of fiberglass meshes (Source: archive of RP BCH, 2008).

(VIII) Reinforcement of roofs: to improve the inner integrity of the roofs, it was decided to wrap the transversal arches, as well as the sectroids of the vaulted roofs with the same fiberglass that has been used for the horizontal joints. Then, the traditional adobe surface coating covered the meshes.

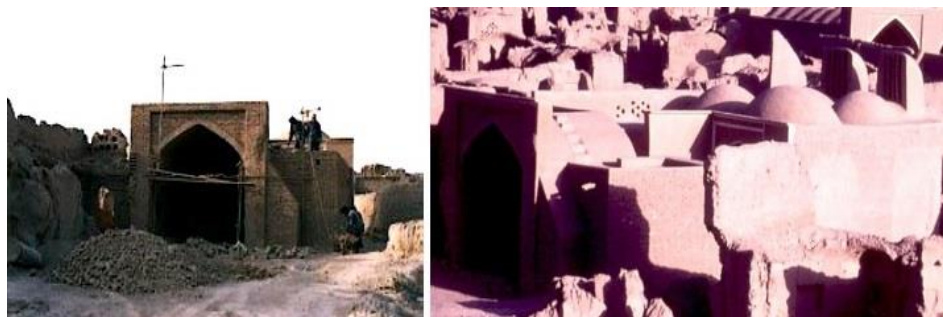
**Figure 4.112-** (Left) restoration activities in Payambar Mosque of Bam Citadel (Source: archive of the RPBCH, 1990); and (Right) view from Payambar Mosque before the earthquake (Photo by Louyot, 2003. Source: archive of Bam3DCG).

▪ **Conservation History before Earthquake:** There is no precise report regarding the previous conservation activities of the Payambar Mosque before the 2003 earthquake. In this case, I have just found a picture that shows the intervention works in process in 1990 (Figure 4.112 (left)).

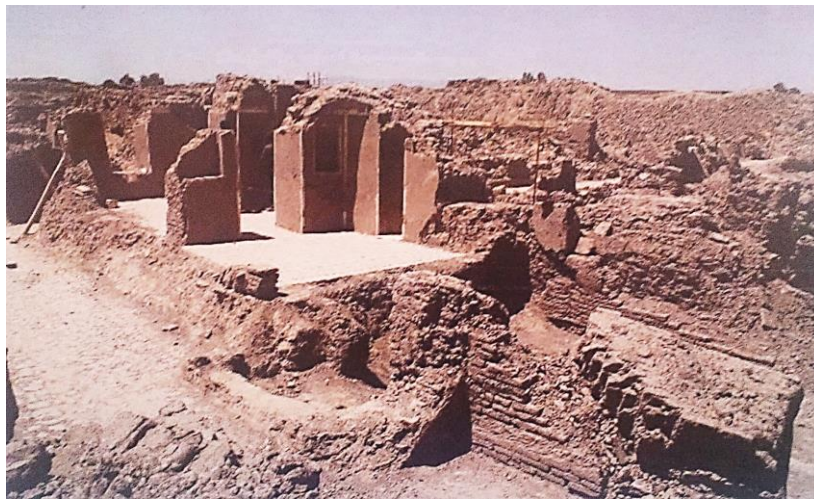
**Figure 4.414-** The state of damage in the Payambar Mosque after the 2003 Bam earthquake, view to south-west, 2007 (Source: Annual Report of Arg-e Bam Research Foundation, 2008).

▪ **Physical Condition after Earthquake:** The Payambar Mosque was severely destroyed during the 2003 earthquake. Through the earthquake, this religious property sustained a damage more than the other properties; all the western and northern parts of the Payambar Mosque were fully destroyed. The central column of the Mosque, which suffered all of loads transferred by the four domed shape roofs, could withstand by cracks in its lower part, but the domes were completely shattered.

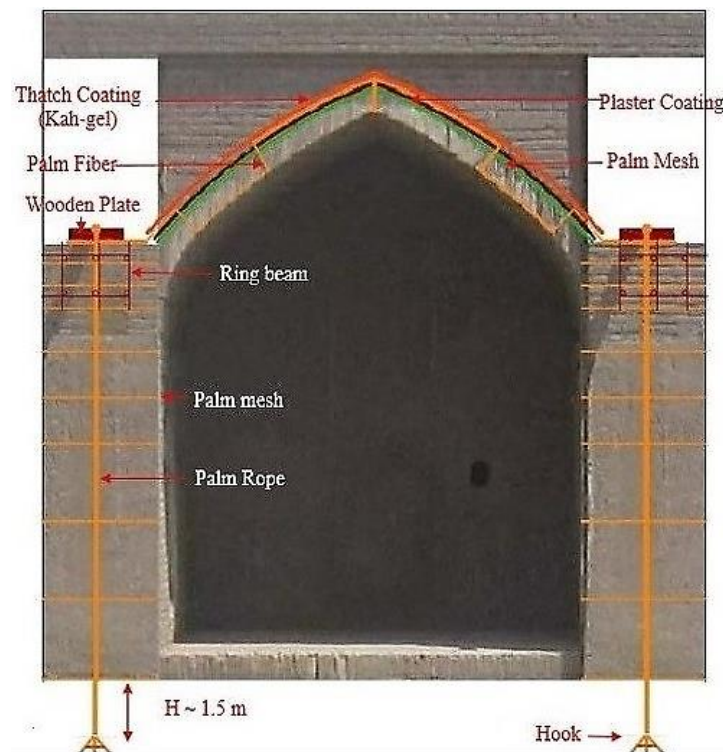
**Figure 4.115-** Schematic picture from intervention plan proposed for the Payambar Mosque of Bam Citadel (Designed by Author).

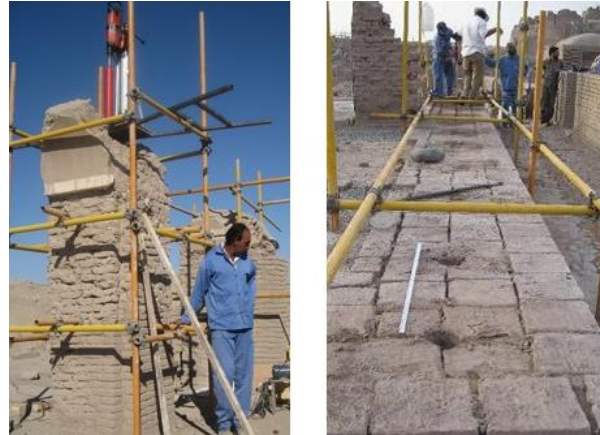
**Figure 4.116-** (Left) drilling of the remained pillars for insertion of vertical elements (palm cables); and (Right) drilling of new reconstructed part of walls for insertion of palm cables (Source: archive of RPBCH).

(III) Reinforcement of walls vertically: to provide any required bending resistance in the monument, the structure was connected to the ground with some innovative method by embedding local tension elements “palm cables”. The Figure 4.116 exactly shows the details of drilling procedures by halter for inserting vertical elements to the foundation soils at depths of 150cm. In this case, vertical elements were installed along a certain line by maximum distance of around 110cm that is reduced to 60cm in the compulsory points at the center of main walls.

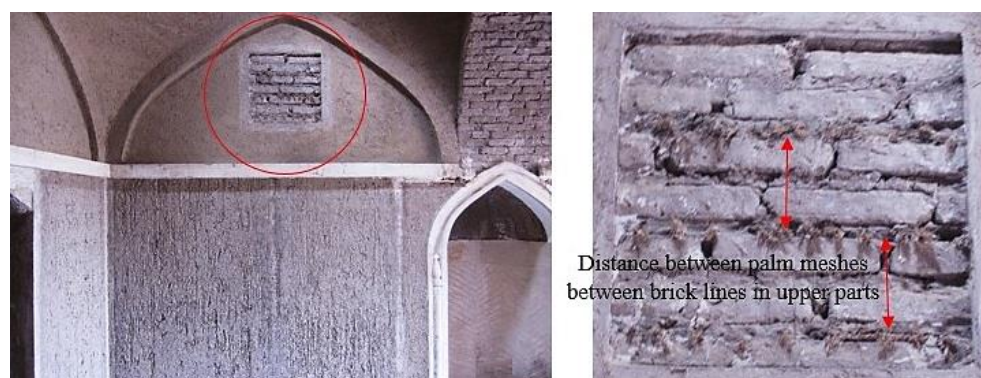
**Figure 4.118-** As pilot frame embedded on the Payambar Mosque, the palm meshes used on the walls are recognizable (Photos by Rouhi 2015).

(IV) Reinforcement of walls horizontally: on the other hand, to provide shear resistance in the structure, the natural horizontal elements produced by local producers palm mesh was to be inserted as tension elements from within thickness, by going towards upper parts of the wall, the operated distance between palm meshes, between brick lines, were decreased (Figure 4.117 and 4.118). Meanwhile, to install natural fibers between rows of adobe bricks, a simple tool was used to stretch the meshes during their operation.

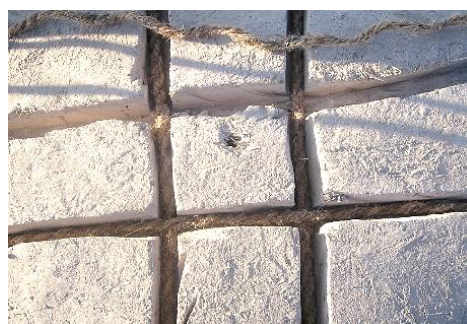
**Figure 4.119-** Creation of grooves in outer part of roof for its stabilization with palm rops (Source: archive of RPBCH, 2007-2011 AD).

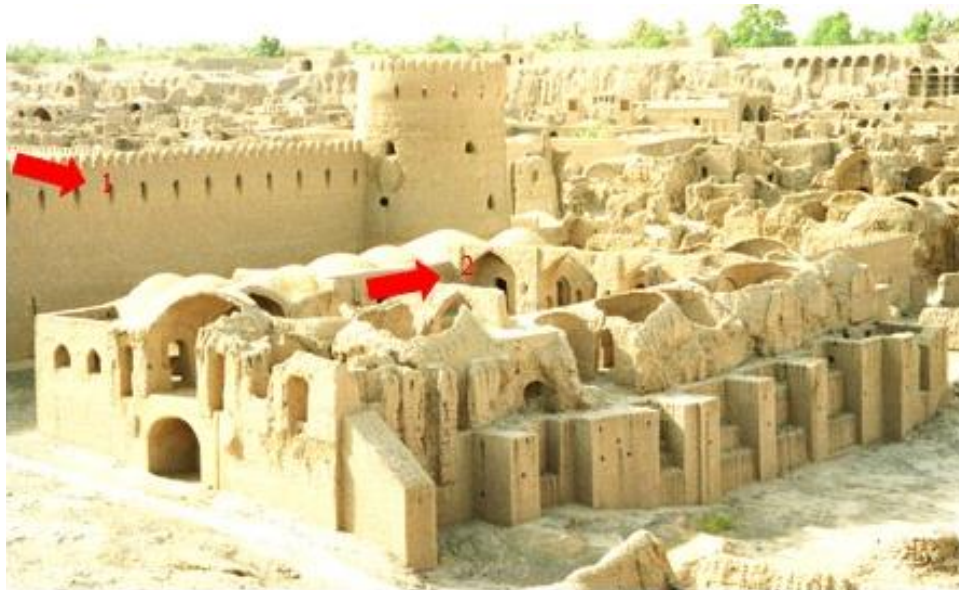
**Figure 4.124-** The Caravanserai of Bam Citadel during restoration works (Photo by Liagollen Signalman, 2001. Source: <https://www.flickr.com/>).

▪ **Conservation History before Earthquake:** There are some reports in 1978, 1979 and 1980 about conservation and restoration works in different structures of the Caravanserai, then until 1996, the restoration activities in this property was stopped. During these years, the north-west entrance, roofs and the octagonal piece had been restored. Then until 1999, the vaults and arches had been renovated; the foundation were consolidated; the troubled plasters and adobe-mud bricks had been replaced.

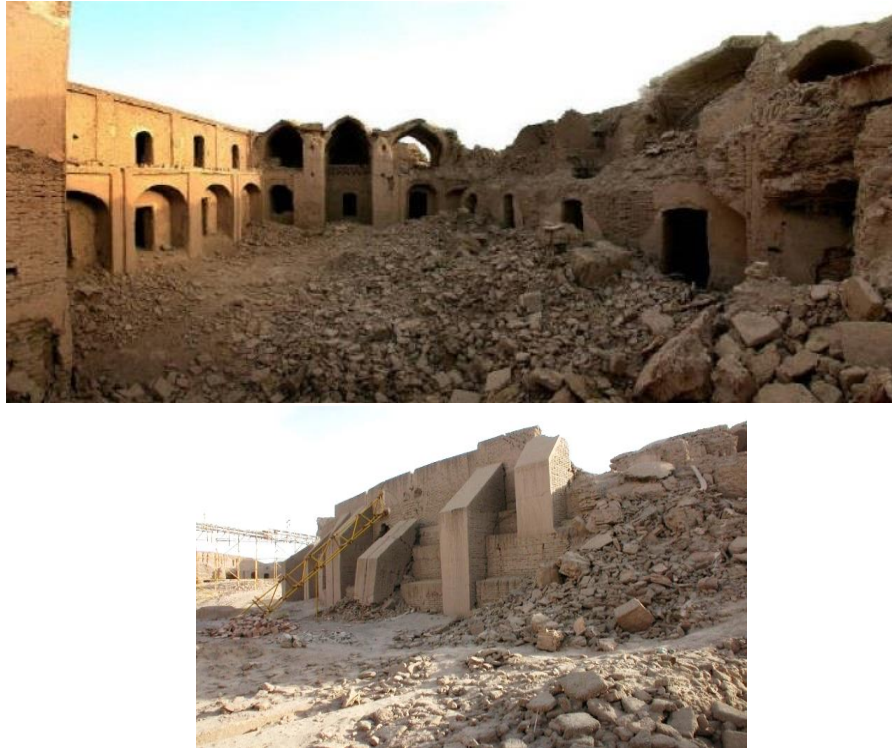
**Figure 4.127-** The ruins of the Caravanserai of Bam Citadel after the 2003 Bam earthquake. (Source: (Top) Langenbach, 2004; and (Down) Chopin, 2007. Source: archive of Bam3DCG).

▪ **Proposed Intervention Plan:** Due to lack of budget, priorities assigned and neglect of authorities, this property has been abandoned. After debris removal, there has not been executed any stabilization work for vulnerable parts, and preservation and protection of the ruins remained from erosion. Considering the fact that the most of the buildings inside the Citadel have been badly damaged by the earthquake, and the detached walls and their layers are exposed to wind and rain, the top priority for most of them is to apply a kind of coverage (either mud and straw or something else) on the exposed areas, and stabilizing the unstable parts and elements (Khakzad, 2011).

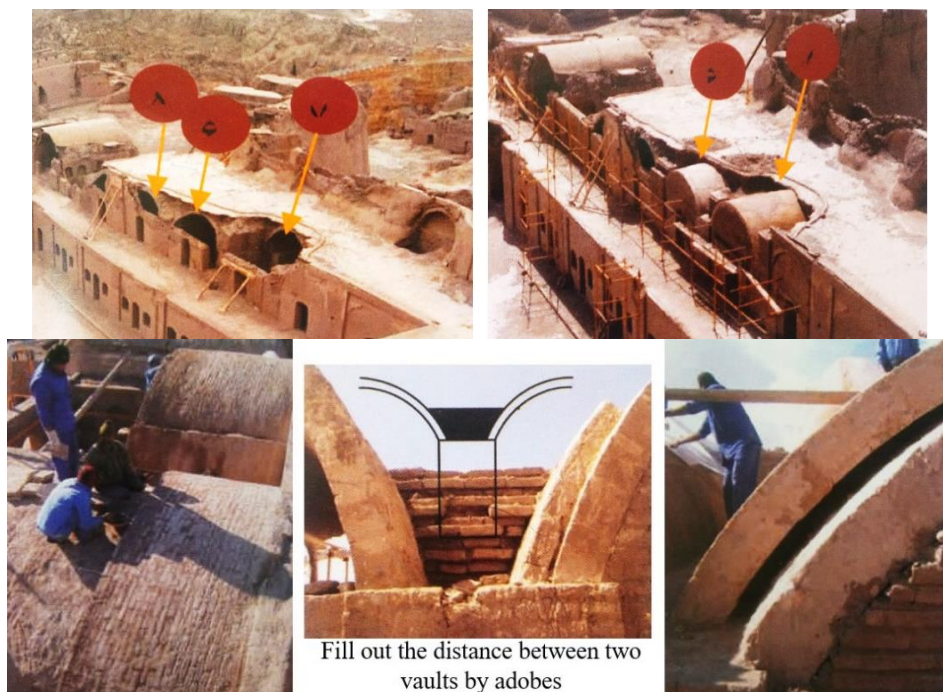
**Figure 4.154-** (Top) The restoration of vaulted roofs in the western part of Barrack by conjunction of new adobes to the old ones; and (Down) construction of connecting two vaults in ration the other for strengthening the roofs against dead load (Source: Annual Report of Arg-e Bam Research Foundation, 2008).
