**UNIVERSITÀ DEGLI STUDI DI NAPOLI FEDERICO II**  
**DiArc - DIPARTIMENTO DI ARCHITETTURA**

**DOTTORATO DI RICERCA - XXIX CICLO**

Conservation and Restoration of Adobe Architectural Heritage of Bam Citadel (Iran),  
Affected by the 26 December 2003 Bam Earthquake: Problems and Issues

Aprile 2017

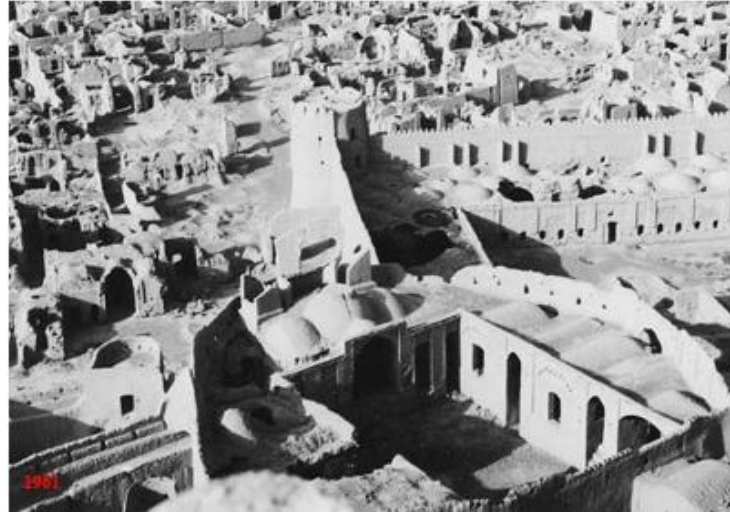
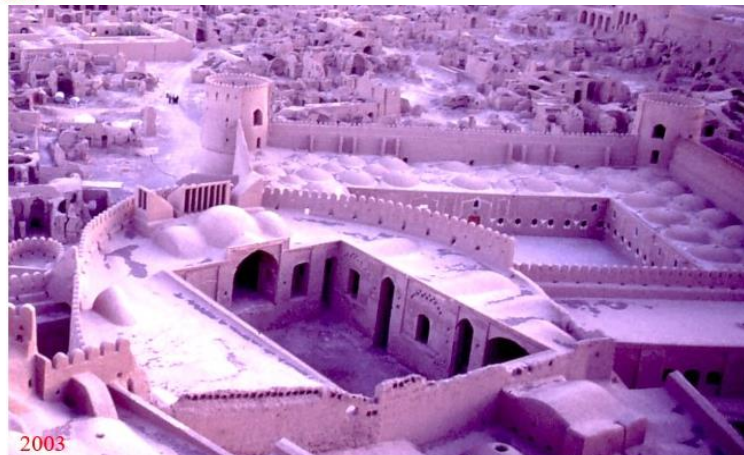
**Figure 4.158-** The progress of restoration process between years 1961 to 2003 in the Commander's House of Bam Citadel, as we can see, it is understandable that restoration works in the Commander's House had been started before Stable (Photo by Ershad, 1961. Source: archive of ICHHTO); GettyImages, 1975. Source: <http://www.gettyimages.it>); and Fabienne Louyot, 2003. Source: archive of Bam3DCG).

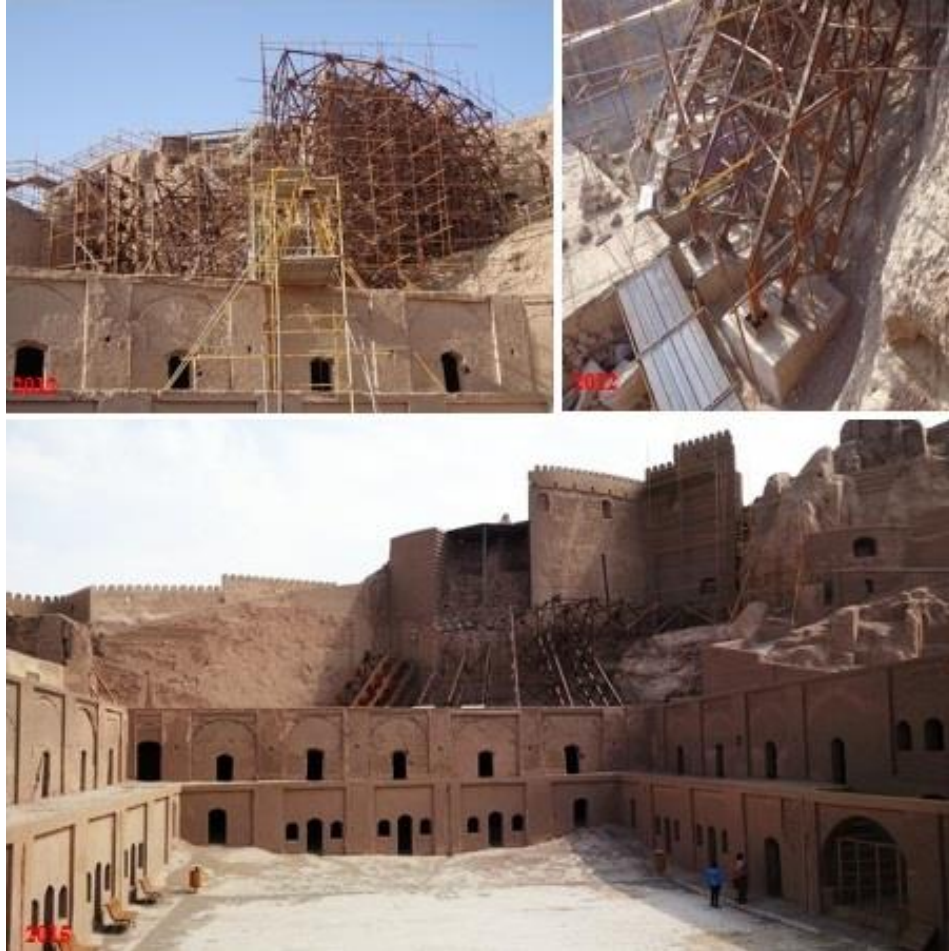
**Figure 4.168.** The southern wall of Governor's Residence consolidated by steel support system, as can be seen, from 2012 to 2015 the volume of this steel scaffolding by the progress of restoration works is decreasing (Photos by Joao Leitao, 2012. Source: <https://www.flickr.com>); and Rouhi, 2015).

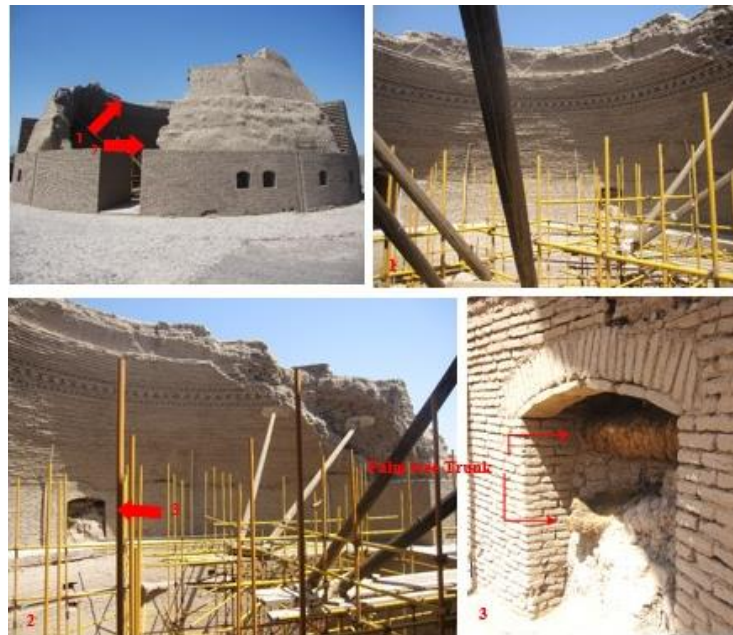
**Figure 4.172-** Damage in different parts of the Yakhdan of Bam Citadel (Photos by Rouhi 2015).

- **Physical Condition after Earthquake:** After the earthquake, this property missed the stabilization of the top of the ring of the dome and around its doorway.

- **Proposed Intervention Plan:** Until now, the vulnerable parts are stabilized by scaffolding, especially around the collapsed part of the domed roof, and minimum repair are being addressed. For now, there is no decision about reconstruction of the top of the dome.

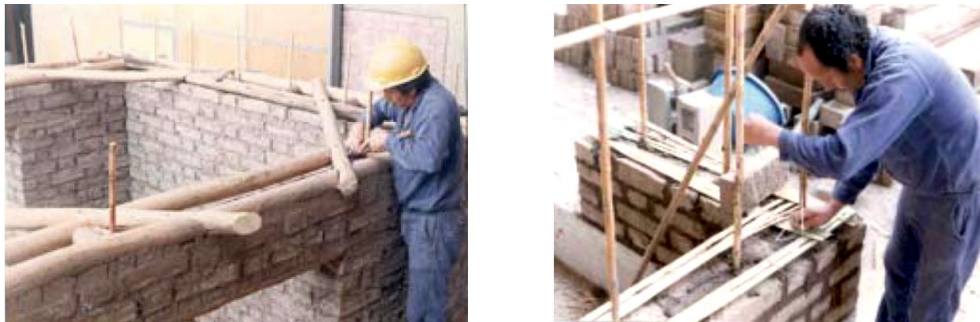
**Figure 5.3-** Placement of wooden ring beam, vertical and horizontal cane reinforcement on adobe model (Source: Blondet et al., 2002).

This type of reinforcement consists of placing an internal grid, with vertical and horizontal elements, able to bond efficiently with the structure, improving its seismic performance (Varum et al., 2014). In this model, it was pointed out that the cane reinforcement elements should be properly tied together and conveniently anchored to the adjoining structural elements. As the result of test shown, this reinforcement technique can prevent the separation of walls at corners, even during high cyclical lateral loads. The reinforcement proved to be very effective in preventing building collapse (Blondet et al., 2011). Although the reinforced model suffered significant damages, it did not collapse. In addition to a ring beam and cane reinforcement, the use of truss-like timber ties between the lintel and ring beam proved to be effective (Blondet et al., 2002). The results of the seismic behaviour of non-reinforced and reinforced adobe models are shown in Figure 5.4.<sup>454</sup>

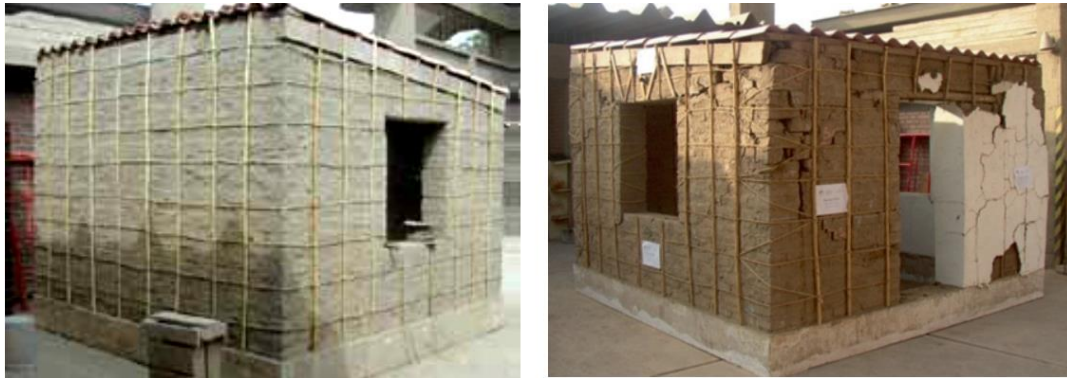
**Figure 5.5-** An adobe-building model with external vertical cane and horizontal rope reinforcement (Source: (Left) Blondet et al., 2011; and (Right) Varum et al., 2014).

In this test, the adobe model was externally wrapped with vertical and horizontal canes fixed through holes made in adobe walls in every 30-40 cm. As can be seen in Figure 5.5, except of some cracks, the model was not suffered any collapse.

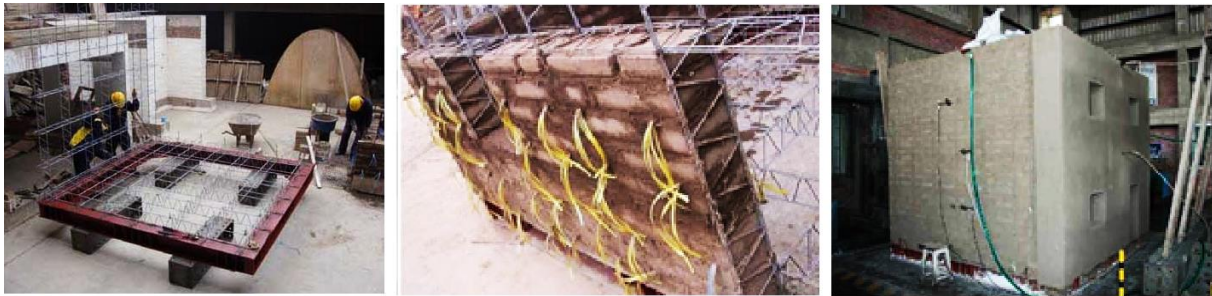
**Figure 5.10** The process of adobe model’s construction by ISM system (Source: Adell et al., 2009).

the dynamic stresses imposed by the shake table test. As Adell et al. (2009) explained about this test, “The truss-reinforcement system consists of interlaced truss-reinforcement which crosses over each other in a three-dimensional manner. The voids are subsequently filled with brick, block, adobe, mud or recycled material in order to form the walls and boarding may be set on the trusses to form the floors.” [...] “A polyethylene geomesh with 0.15 m openings was tied to the wall by the raffia strips on just two sides of the prototype. This was made with the aim of verifying the differences between the rendered and unrendered faces after testing on the displacement table.” As the test results showed, although under the largest displacement (130 mm), there cracks were seen at different parts of the model, especially along the lines of the reinforcement, they did not incur any damage that might affect the stability of the structure. Meanwhile, it was provoked that the polymeric mesh and rendering do not have any special effect on the seismic behaviour of the walls.

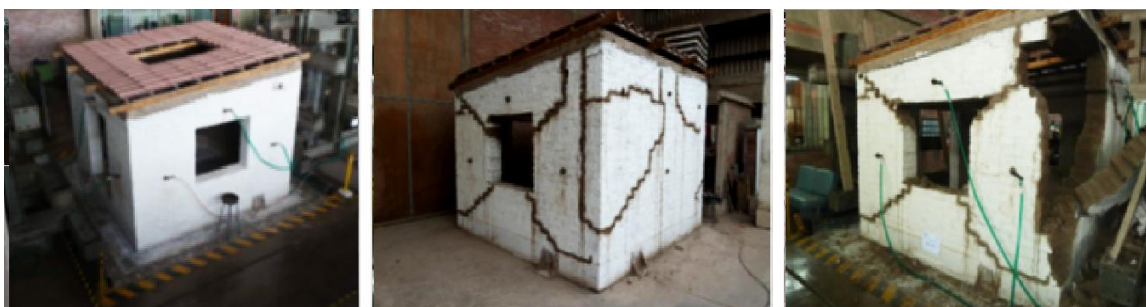
**Figure 5.13-** The adobe model before phase 1, after phase 1 and 2 (Source: Blondet et al., 2012).

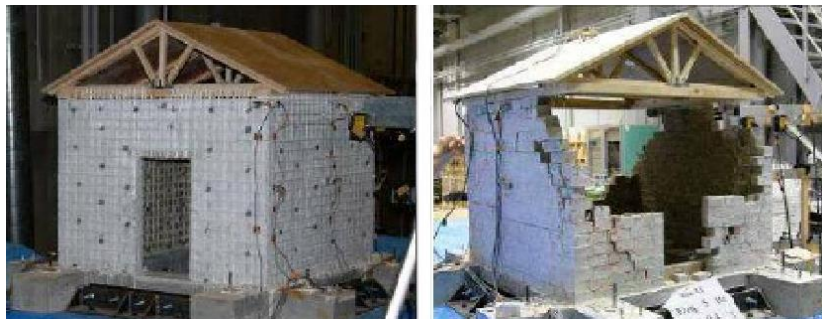
**Figure 5.15-** The result of shake table test on reinforced and non-reinforced adobe models (Source: Sathiparan & Meguro, 2013).

of PP-band reinforcement, this system is inexpensive, worldwide available, tolerates large deformations, durable, easy workmanship and has no need to special technology and knowledge. Furthermore, this material has no corrosion or insect failure effect and possesses excellent resistance to organic solvents and degreasing agent as well as electrolytic attack (Mendis et al., 2014).<sup>458</sup> Because of tests implemented, it was conducted that PP-band may potentially be used to prevent/delay brittle collapse of non-engineered structures under seismic loading (Sathiparan & Meguro, 2013). Figure 5.14 shows bending and diagonal shear tests on reinforced and non-reinforced models, and Figure 5.15 shows a full-scale adobe model reinforced with PP-bands before and after shake table test.

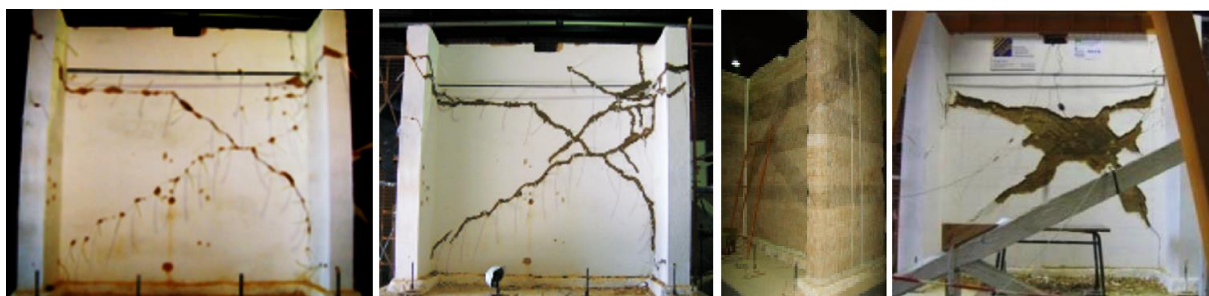
**Figure 5.16-** Respectively from right to left U-shape model after first simulated cracking, after grouting, after reinforcing with mesh-band and final damage state (Source: Figueiredo et al., 2012).

However, the model was imposed with two series of tests. During the first series of the test, the non-reinforced model was subjected to cyclic and dynamic tests, as the result, wall was faced with cracks in its façade, which these cracks have significantly reduced its strength and stiffness. Then during second series of the test, the damages have been repaired by the grouting injection of lime gum into the cracks, after that the wall was reinforced with synthetic mesh-band. As explained by Figueiredo et al. (2012), “The mesh was fixed to the wall with angle beads and angle profiles in PVC using highly resistant nylon threads on all of the wall’s concave vertices. Plastic fixing plugs with a depth of 70 cm and cylindrical base of 4 cm in diameter were used, forming a  $0.5 \text{ m}$  square mesh. The wall was then plastered with lime mortar, similar to the original wall.” After repairing and retrofitting of the cracked adobe wall, the same test that was utilized for the non-reinforced model was also implemented on reinforced model. As the result showed, the grouting injection of cracks along with mesh-band wall reinforcement significantly improved the seismic resistance of the adobe wall.

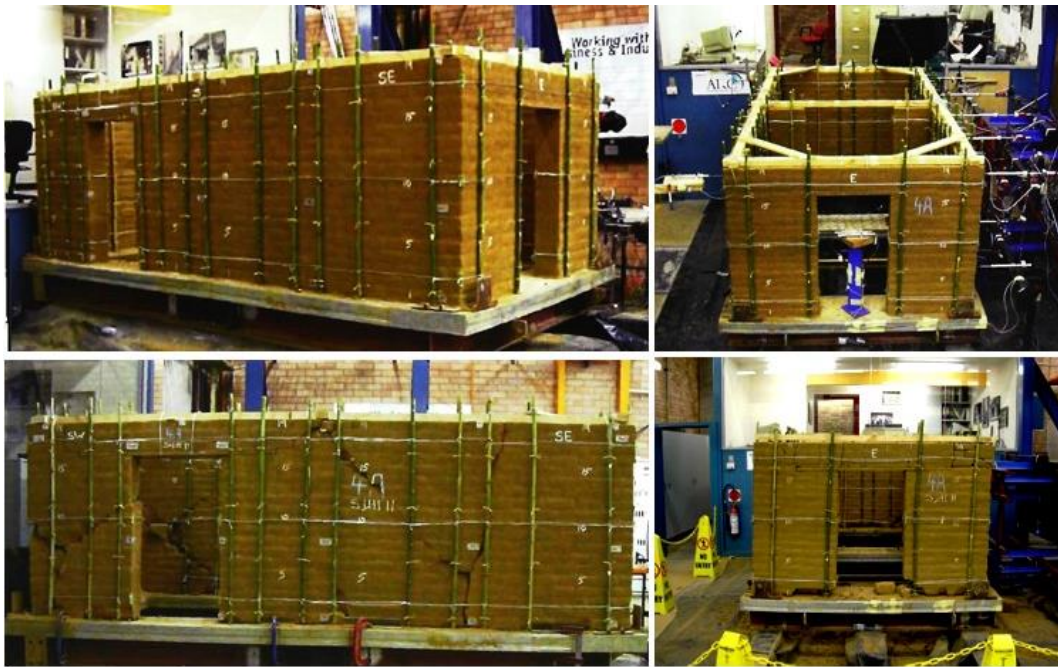
**Figure 5.17-** Specimen 4A after simulation of S8 (Source: Dowling, 2006).

on the state-of-art MTS uni-axial shake table located at the University of Technology, Sydney (UTS) (Dowling, 2006).<sup>459</sup> The main aim of the project was to find cost-efficient retrofitting methods for adobe structures in developing countries. In this project, different reinforcement solutions have been tested included: the use of pilasters/buttresses at wall corners, internal wire mesh reinforcement, internal/external bamboo rods, chicken wire, string and ring beam, details of models tested can be seen in Table 5.4. The models had been built with adobe blocks (150 mm ×150 mm ×50 mm) and 12-13 mm thick mortar joints. In these tests, the U-shape walls were considered as non-load bearing walls, the weight of adobe roof is not applied. In addition to those experimental tests carried out shake table, a model house was reinforced in a similar manner to 3f U-shaped adobe wall, (Figure 5.17), the testing sequence of this test is exposed in Table 5.4.

Simulation	Intensity	Damage grade	Observation
S1	10%	0	No damage observed
S2	25	0	No damage observed
S3	50	0	No damage observed
S4	75	1	Rocking of E shear wall. Separation at base. Minor cracking from lintel above door (E wall).
S5	100	2-3	Major rocking of E shear wall. Major cracking in E shear wall. Minor cracking in all other wall panels.
S6	125	3	Sever rocking of E shear wall. Sever cracking in E shear wall. Moderate cracking in all other wall panels.
S7	100	3	Progressive additional damage in all wall panels. Severely damaged. Collapse prevented.
S8	Shakedown	4	Progressive additional damage in all wall panels. Severely damaged. Collapse prevented.

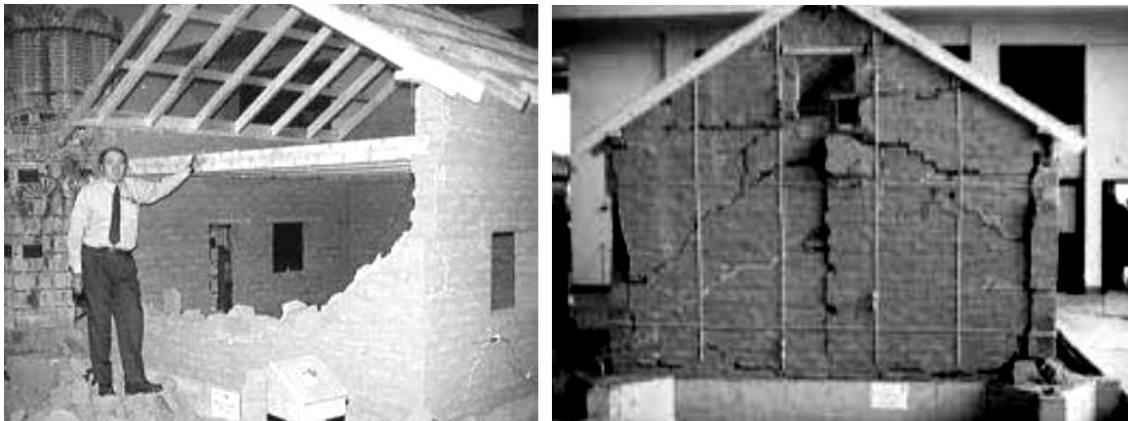
**Figure 5.20-** East wall in Model 10 test VIII (left), and Model 11 test VIII (right) (Tolles et al., 2000).

10	1.2 (7.5)	ALL	None (control model)	VIII
11	1.2(7.5)	NE	Partial wood diaphragm—upper strap at attic-floor level, lower straps, and vertical straps.	No collapse
		SW	Partial wood diaphragm—upper strap at attic-floor level, lower straps, and vertical center-core rods; no lower strap on west wall

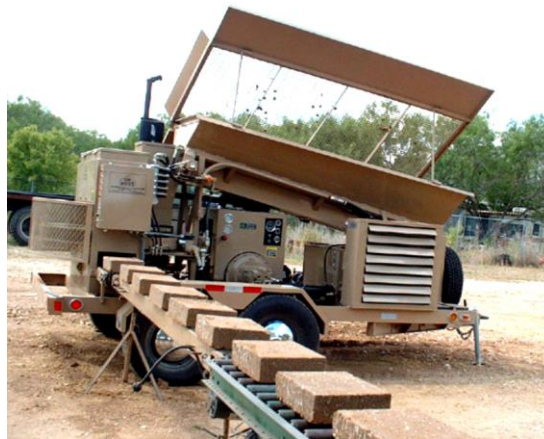
**Figure 5.21-** A mixer with a conveyer-belt system feeds a large-size commercial pressed-earth-block machine operation, made by AECT Compressed Earth Block machines (CEB/Adobe) company (Source: <http://aectearthblock.com>).

Furthermore, the deployment context of the adobe bricks production for use in conservation and restoration process is being done manually so that the use of new mechanical technique can effectively reduce the possible errors during the material composition and adobe molding. Nowadays, there are some mechanically innovative techniques through which by the use of motorized hydraulic brick press produces 5,000 to 20,000 bricks per day by machines that may reduce the fallacy of their materials composition and their molding under an appropriate uniform pressure, see Figure 5.21.

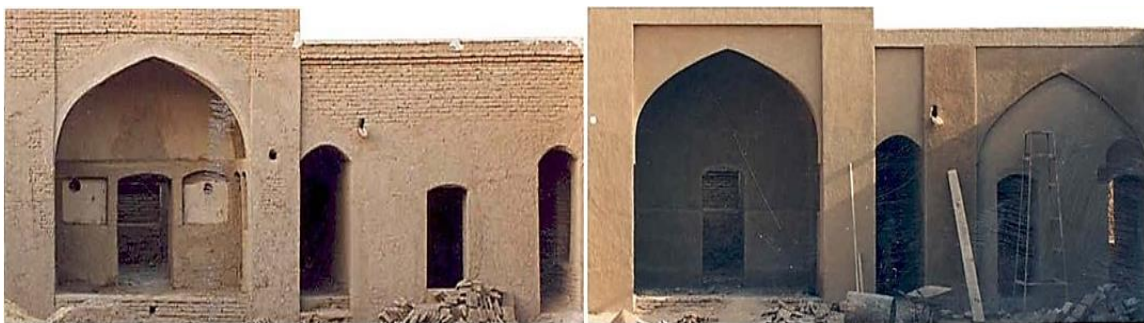
**Figure 5.22-** The northern part of Mirza Naem School before and after adobe surface coating, before earthquake (Source: personal archive of Prof. Tayari, between 1993-1995 AD).

Since adobe surface coatings are continuously exposed to environmental deterioration factors (e.g. rain, wind and temperature fluctuations), every effort should be taken to recoat the surface with the same material that originally covered the adobe surface. In this process, after the deteriorated parts are scraped off, the surface is cleaned and made slightly wet. Then by the same techniques, the renewed parts should be patched as closely as possible to the original ones. It is a common error to assume that instead of mud surface coating, harder and stronger materials like lime plaster and portland cement should be used for rendering the adobe surface. In this case, if serious deterioration has not been observed on the adobe surface, the use of these materials during restoration work will likely cause far greater damaging.<sup>471</sup> In addition, the deterioration caused by water, which is the result of the penetration of water and its capillary action between adobe coatings and walls can be aggravated in contact with lime or cement. Furthermore, during repairing and replacing of the surface coatings of curved roofs with a fresh layer of adobe mud over an existing surface, high care should be given to temporarily support of the roofs, because adobe materials are heavier when they are wet than after they are recoated. If they are not supported, the roofs may collapse or deflect. Furthermore, despite renewing adobe surface coatings, other measures such as better slopping of roofs, providing efficient drainage system and installing downpipe in critical part of the structure can prevent granular disintegration of the adobe surface coating.

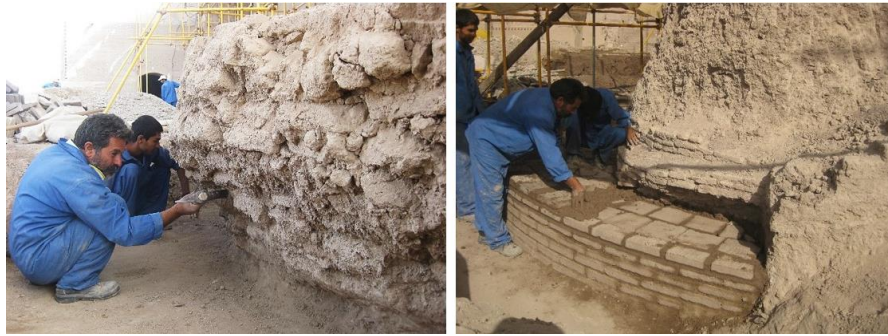
**Figure 5.23-** Substitution of Adobe bricks in the west tower of the second entrance gate of Bam Citadel (Source: personal archive of Miss. Jafarizadeh, 2010).

actually prohibited, because they frequently contain a high percentage of salt. Depending on the level of deterioration, the locally deteriorated and disintegrated adobe bricks are replaced with new ones and are patched in place. During replacing the old bricks, the deteriorated parts must be well scraped out, cleaned and if necessary covered and/or supported by suitable tools. In addition, in order to restore the integrity of the wall portion and to obtain a monolithic behaviour, adequate connections should be provided between adobe bricks. Furthermore, during the restoration work, the new bricks and intervention spaces should be lightly wet to increase the cohesive bond.

Note: Although repairing and replacing of adobe bricks have many advantages, substitution of adobe bricks can restore the original function of structural element and generally the global behaviour of the historic adobe structure. Depending on the size of substitution and materials used, they might be reversible and they fulfill the minimum intervention principle. Apart from these advantages, this method can have some disadvantages that must be taken into account: it is mostly invasive and irreversible technique, and non-well patching of adobe bricks may cause non-dependent behaviour of the structure.

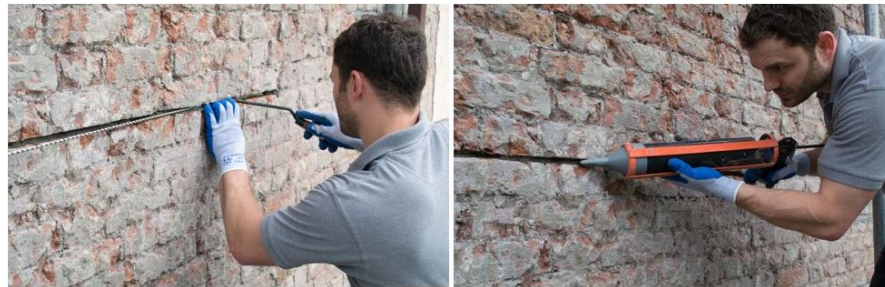
**Figure 5.25-** Bed-joint reinforced repointing with metal rods (Source: <https://www.permagard.co.uk/advice/how-to-repair-cracks-in-walls>).

As a common reinforcement technique in historic masonry structures, the bed-joint reinforced repointing is performed when the rate of deterioration in adobe wall reaches a critical level, especially close to the adobe foundation that needs more stability, where the operation of the repairing and replacing of the adobe bricks cannot restore the desirable stability. Meanwhile, this technique can be used between mortar joints for stitching of cracks in the adobe walls. The operation in this technique is that along with transverse direction on one or both sides of the wall, the reinforcement rods are inserted between mortar joints, and then all steps mentioned in structural repointing are followed. Generally, the bed-joint reinforced repointing can enhance the stability of adobe wall against both vertical and horizontal loads, more especially during the deformations applied by the seismic motions. This technique can reduce the tensile stresses in resistant elements, and increase the ductility and the ability to dissipate energy of the structure.

Note: structural repointing and reinforced repointing have many advantages: they can restore or improve the stability of adobe walls through increasing the interconnectedness of adobe bricks; they are effective in prevention of water penetration through mortar joints; depending on the compatibility of mortar used, they can be recognized as a reversible technique; they can be used even in irregular adobe walls, etc. Apart from these advantages, the use of these techniques can have some disadvantages that must be taken into account: the incompatibility of mortar joint used can accelerate the decay of adobe units; the rods used in bed-joint reinforced repointing may lead to corrosion, unless they have corrosion resistance properties etc.

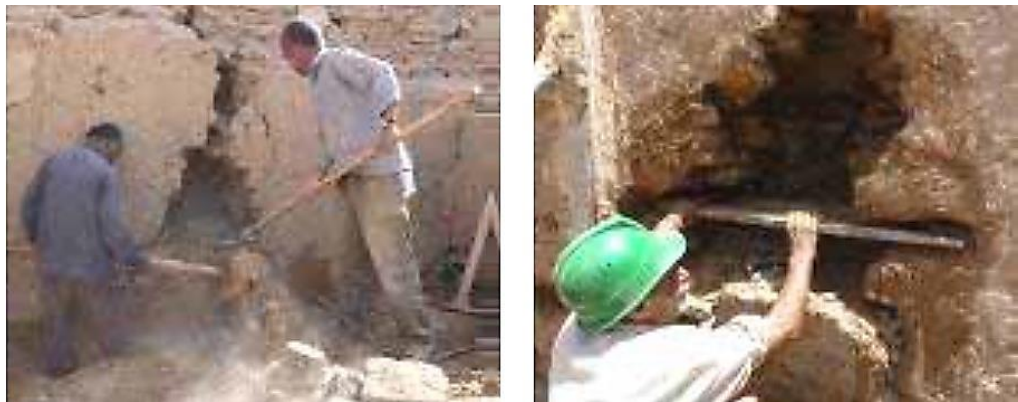
**Figure 5.26-** Stitching of large crack in Tabai House of Ardakan (Source: archive of ICHHTO, 2010).

Stitching is one of the common techniques for fastening large cracks in masonry structures. This technique is an innovative-engineered technique to restore the structural continuity, tensile strength across the cracks, reestablish compression, and stabilize the structure by the locally junction of two independent wall sections (large cracks), which have the potential of detachment under the dynamic loads. Unlike grouting injection that has difficulty in insertion of metal tie in a drilled hole and its grouting, the stitching of large cracks has less hassles. In this technique, after removal of two or three adobe courses on both sides of a crack, stitching by means of the placement of the U-shape or flat metal, wood or plastic sockets supposedly fixed to the wall is performed. Then, the empty space is filled with new adobe bricks, and in other parts of cracks the operation of grouting injection is implemented to prevent the penetration of water within the adobe wall. Sometimes due to the existence of very large cracks in adobe walls, no option remains except for destruction of the wall and its reconstruction.

Note: stitching of large cracks has many advantages: it can improve the connections of adjacent cracked walls; it can partially return the original strength and ductility of the adobe wall; it can control the development of the cracks, etc. Apart from these advantages, the use of this technique can have some disadvantages that must be taken into account: depending on the type of materials used, it might be irreversible and obstructive, and also harmful for the original fabric.

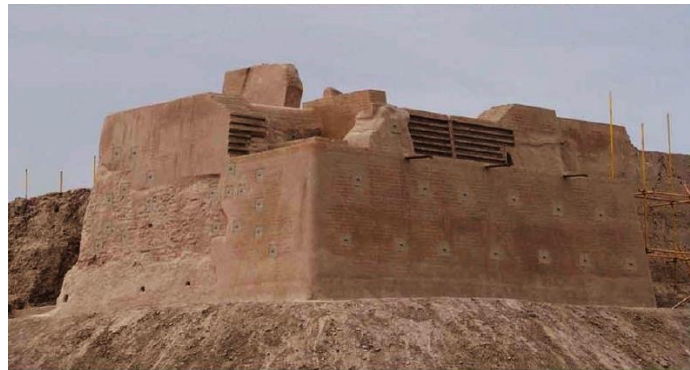
**Figure 5.29-** The anchorage of Tower No. 1 of Bam Citadel by the Italian group (Source: Porta & Santoro, 2010).

Needling and anchoring as a deep internally light or non-post-tensioned intervention is implemented to prevent the probability of cracks and to improve the stability and shear behaviour of the adobe walls with large thickness (e.g. adobe fortification). In this partially irreversible intervention, the anti-corrosion metal rods are inserted into holes (diameters ranging from 4.0 to 8.0 mm) drilled in body of adobe walls, and then they are externally bolted on end steel, wood or plastic plates. In order to minimize localized stress damage, before bolting of the metal rods, the holes should be grouted with compatible materials. Depending on the condition of the walls, restorers may suggest different number of metal rods and different designs for their placement (e.g. vertically, horizontally and transversally). An example of this method is carried out by Italian groups in Tower No. 1 and Sistani house of Bam Citadel.

Note: the needling and anchoring of adobe walls has many advantages: its insertion along both length and width can increase the stability of adobe walls; it can improve the global behavior and integrity of the adobe walls, etc. Apart from these advantages, the use of this technique can have some disadvantages that must be taken into account: the non-corrosion resistance of rods inserted may cause deterioration problems; it is mostly an irreversible technique; over time, it may lose its effectiveness; its operation during drilling, insertion and grouting may be invasive.

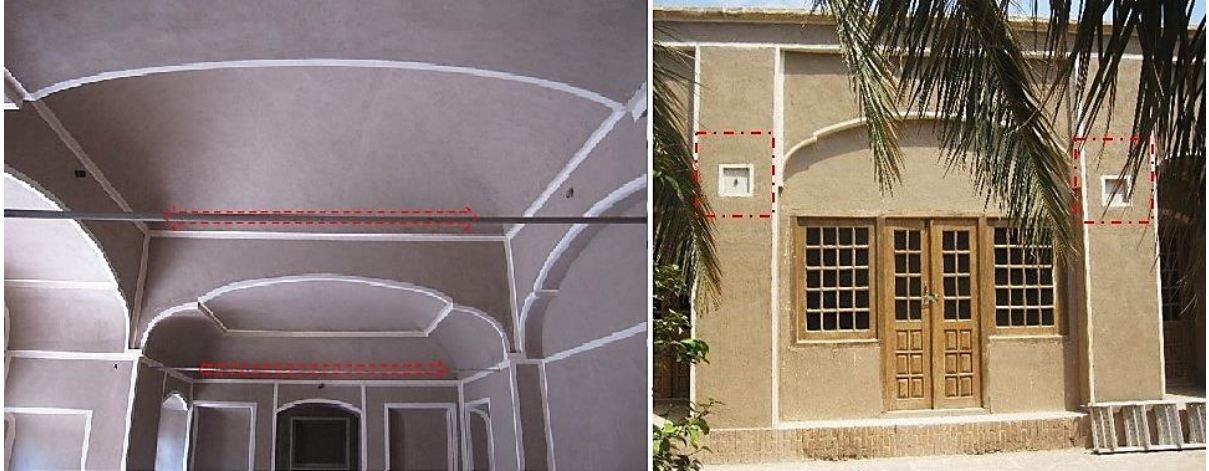
**Figure 5.34-** Internal reinforcement of wall-roof with tying and anchoring of tie-rods in Sistani House of Bam Citadel (Photo Rouhi, 2015).

The insertion of lightweight tensile reinforcement, with some degree of pre-stressing to bond elements together, gives the masonry of historic buildings greater earthquake resistance without altering the structural system (Feilden, 1987). A common seismic retrofitting measure in large masonry arches, vaults and domes is the insertion of tie rods in upper spans of piers between two arches and their anchoring on metal, wooden or plastic plates. This system increases the deformability of the roofs and reduces the possible failure at conjunction between walls and roofs. Tolles (2006), as part of the GSAP, has designed an intervention technique for the connection of adobe walls with its sides' flat walls, see Figure 5.33. In figure 5.34, two other internal reinforcement of wall-roof connection applied in Monuments of Bam Citadel are shown.

Notes: both techniques of tying and anchoring of adobe walls externally and tying and anchoring of adobe walls-roof internally have many advantages: they are effective in compensating the weakness of adobe structural elements in tension; they generally need minor alteration; they can limit the possible detachment of the adobe connections and can ensure the stability and integrity of the structural elements. Apart from these advantages, the use of these techniques can have some disadvantages that must be taken into account: if tying elements are not selected properly, they may lead to corrosion problems; they may be obtrusive and change the appearance; they are mostly irreversible techniques.

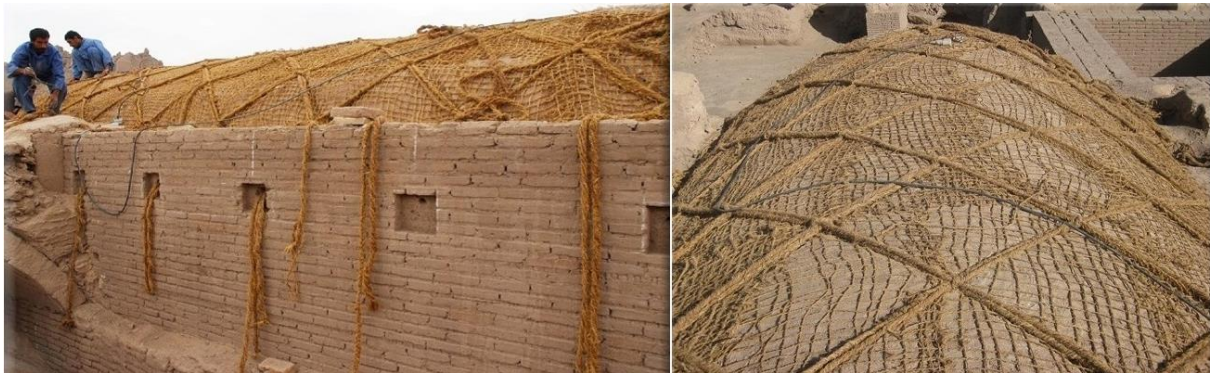
**Figure 5.35-** Tying of wall-roof with use of palm fibres in Bam Citadel (Source: archive of RPBCH, 2010).
