UNIVERSITÀ DEGLI STUDI DI NAPOLI
FEDERICO II

PhD Thesis in

**Integration of field investigations and remote
sensing techniques for the assessment of
landslide activity and damage**

Del Soldato Matteo

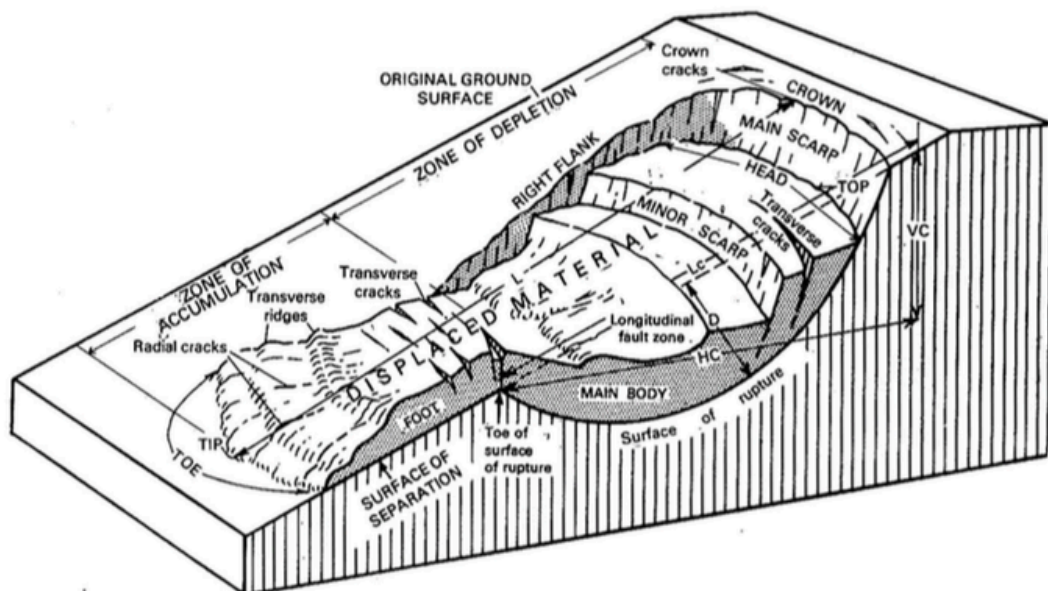
Fig. 2.2 - Block diagram of ideal complex slide-earth flow (Varnes, 1978).

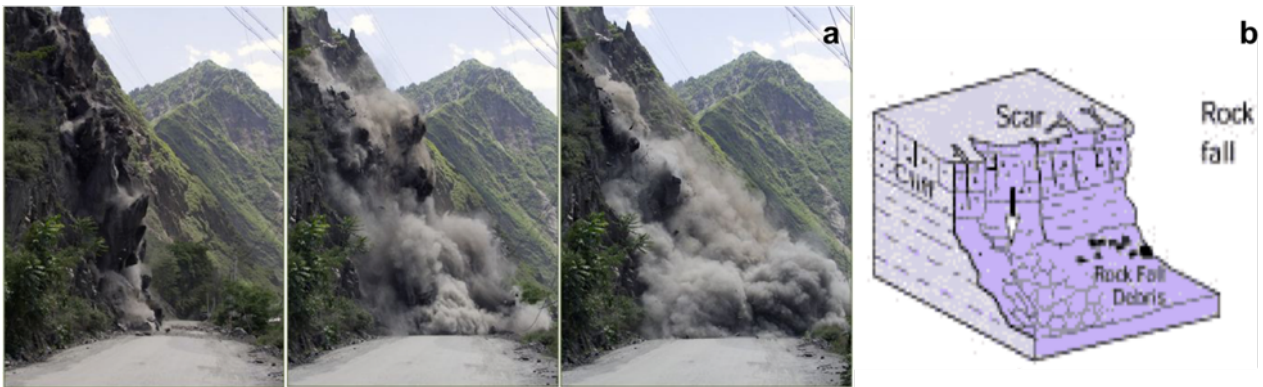
Fig. 2.6 -Example of evolution of a rock fall (Lynn Highland, <http://blogs.agu.org/landslideblog/2011/10/13/a-gallery-of-landslide-images/>) with explaining scheme of the phenomenon (b) (Hung et al., 2014).

Falls (Fig. 2.6) are due to the detachment of soil or rock from steep slopes along surfaces characterized by little or no shear displacement. This movement mainly occurs by falling, bouncing or rolling of rock fragments or ice, and it may be also caused by tensile and buckling failures, sometimes preceded by small sliding or toppling that separate the displacing material from the undisturbed mass. The typologies of detachment are distinguished by the slope angle of the involved slope: above 76°, falling occurs; between 76° and 45°, bouncing arises; with slope angle values less than 45°, the mass movement is characterized by rolling. Usually the falls are movements involving a limited volume of rock occurring along steep slopes. The main triggers are differential weathering, excavations, stream erosions, vibrations or undercutting.

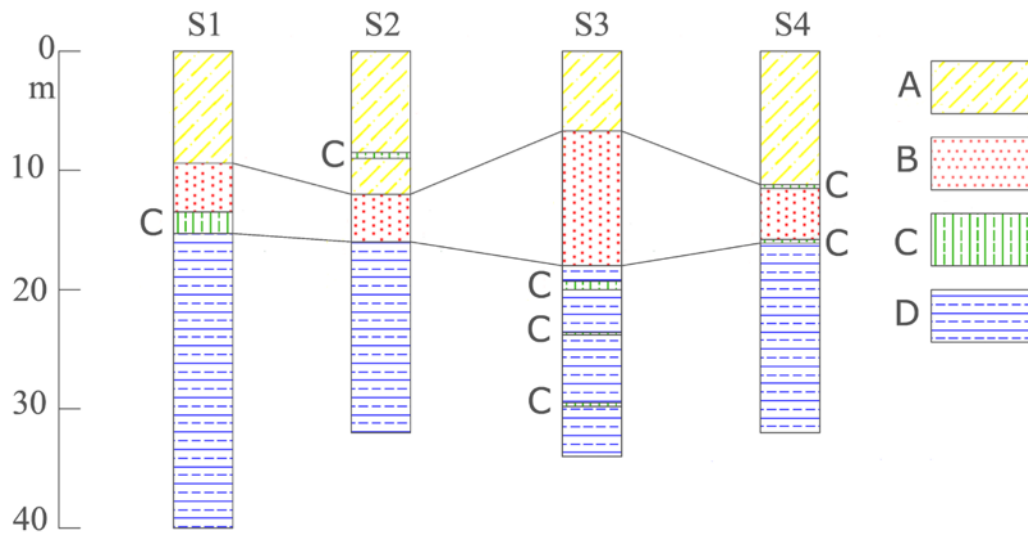
Fig. 3.4 - Engineering-geological interpretation of the data acquired in the boreholes S1, S2, S3 and S4, modified from Calcaterra et al. (2008) and Del Soldato et al., under review_a. A - hard rock fragments and clays; B - clays and sands; C - limestone level; D - marls and clays.

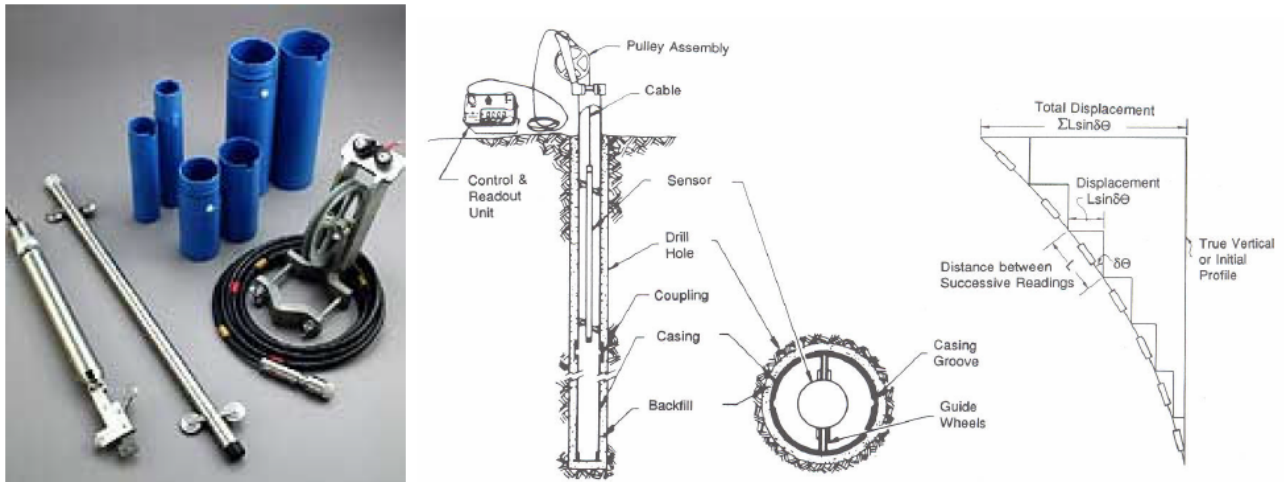
Fig. 3.5 - Picture and scheme of the inclinometer installed to monitor the displacement affecting the CL-PO landslide.

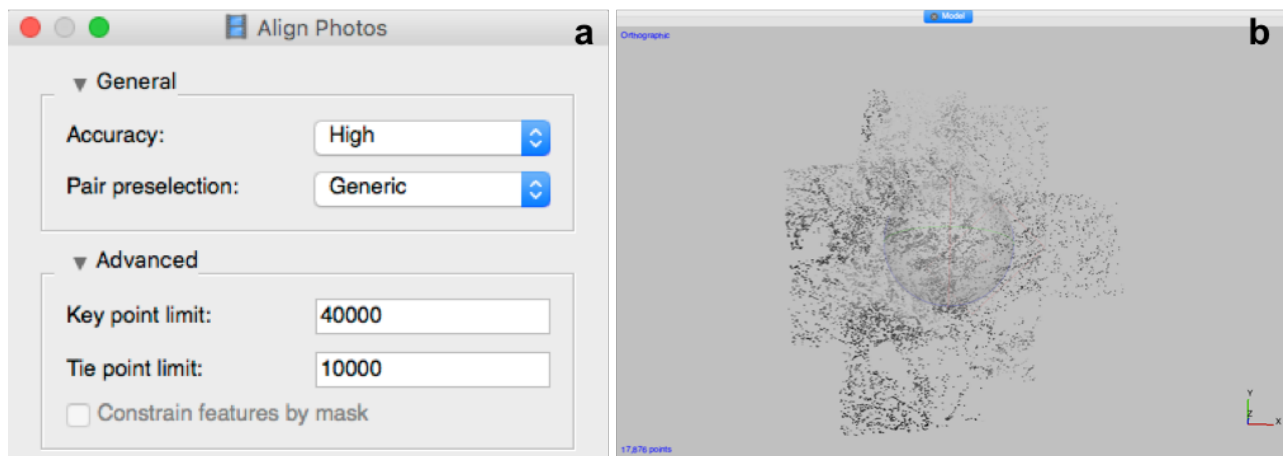
Fig. 4.2 - a) Screenshot of the setting for the suitable alignment for historical aerial photos, when the camera position is unknown. **b)** Sparse cloud generated after the alignment of the images.

The provided result of the first phase is a sparse point cloud of the overlapped area with the relative position in the “space-image” of the processed photos (**Fig. 4.2b**).

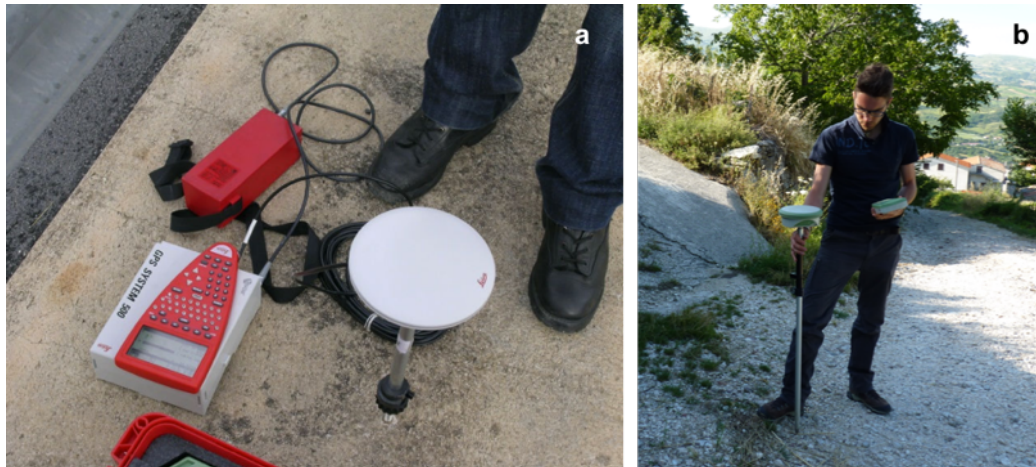
Fig. 4.17 - GPS sensor (a) and an example of its application during a field campaign survey in Agnone (b).

To better understand the movement of several areas, sometimes not visible by remote sensing techniques, involved by a landslide and to monitor their evolution, a Global Position System (GPS) survey can play a key role. Furthermore, this approach can be applied over time repeating measurements in the same control points and allowing the evaluation of their displacement. A GPS sensor (**Fig. 4.17**) is composed of a console to manage the measured points and an antenna that has to put up on a rod with note height (i.e. one or two m). The system allows to perform occasional measurements, that have to be repeated over time, in addition to real-time measurement based on the aim of the studies, i.e. small or large scale analysis. This approach, with respect to the terrestrial instrumentations (e.g. terrestrial geodetic sensor) can work in any condition of visibility and weather. On the other hand, GPS requires a certain satellite "covering", at least four satellites have to be visible from the receiver, of the monitored area to reach good precision.

To reach good precision during the survey the console has to be connected to internet, by means of the use of a mobile phone, to calculate as good as possible the correct position by the triangulation method. In this way, it is possible to reach errors of ± 0.05 m. The three dimensional coordinates (latitude, longitude

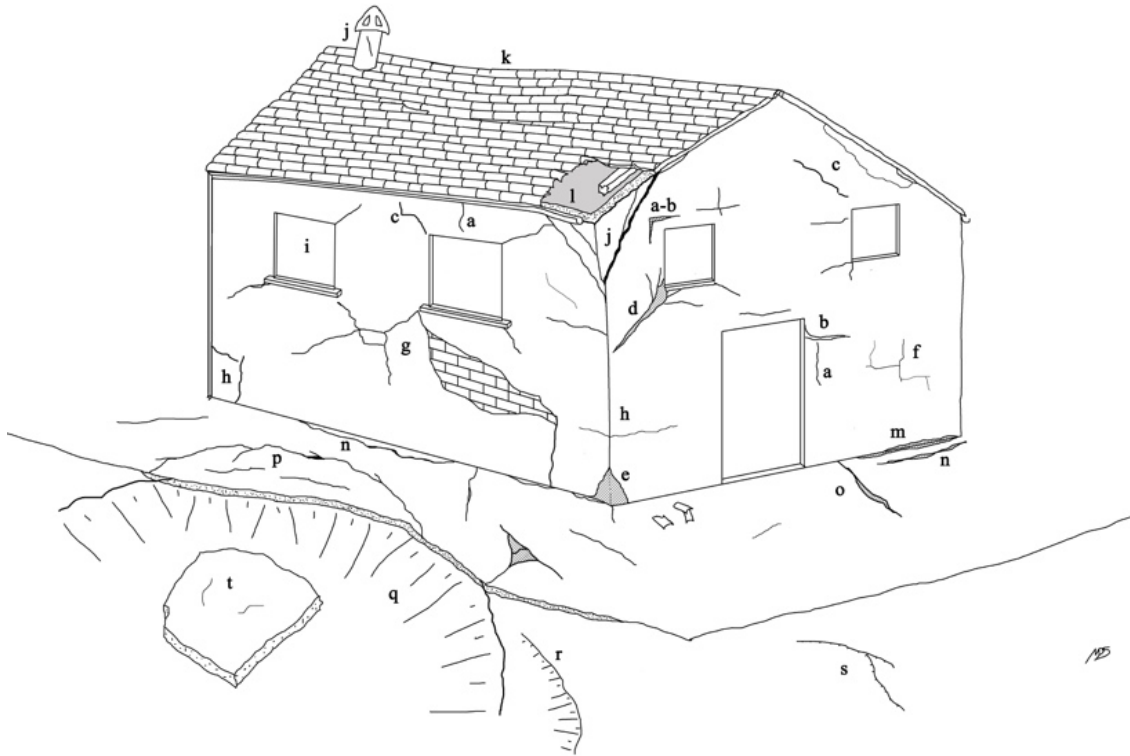
Fig. 5.1 - Referring scheme of the damage which could affect structures and grounds in a landslide-prone area: a) thin and open vertical cracks; b) thin and open horizontal fractures; c) diagonal tension cracks; d) severe open damage; e) local crushing with or without loss of material; f) hairline fissure in plaster; g) loss of plaster enclosed by cracks; h) horizontal and vertical damage close to the intersection of walls; i) distortion of services as doors, windows or chimneys; j) unstable wedge in the intersection of walls severely affected by open cracks; k) bended roof; l) collapse of part of the structure (e.g. roof); m) open and thin fractures between the external façades and the sidewalk; n) open (sometimes filled by soil and grass) and thin parallel damage in sidewalk; o) open (sometimes filled by soil and grass) and thin perpendicular fractures in sidewalk; p) damage due to the propagation of the landsliding effects on horizontal structures; q) extensive ground cracking with minor and major scarps; r) fracture retracing the scarps of the landslide with tension cracks in soil; s) thin fissure in ground surfaces; t) piece of horizontal structure fractured and collapsed along the scarp of the landslide (from Del Soldato et al., under review_b).

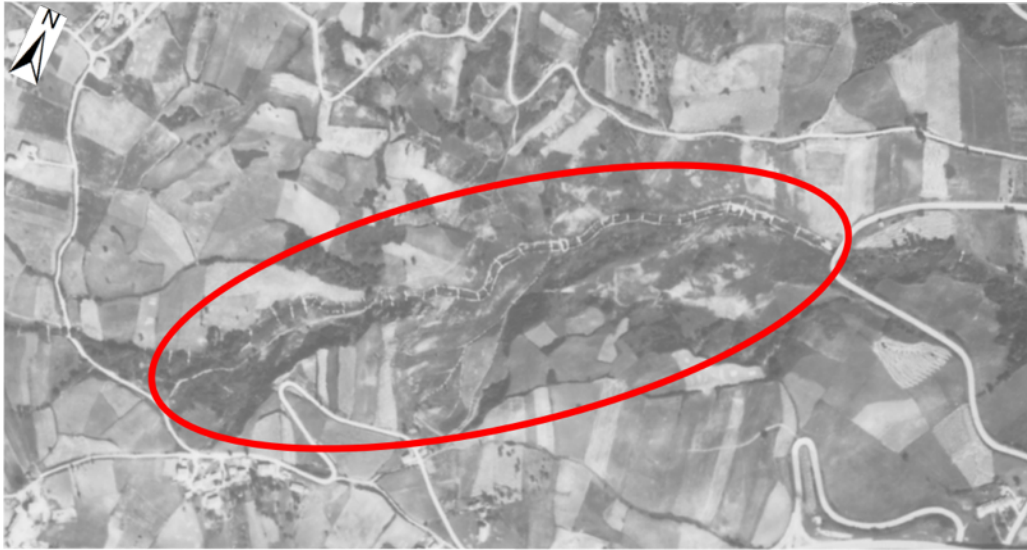
Fig. 5.10 - Orthomosaic of the CL-PO landslide referred to 1991 with highlighted in the red circle the fulfilled works between 1986 and 1991.

Considering the present contour of the landslide, the right lobe involved in an old event occurred before 1945, year of the first set of examined images of this area, is recognizable. It shows an important region with hot colour, indicating areas where increment of volume occurred. This is due to the analysis conducted starting from the 1945 set of images shot after an important landslide. In this way, the volume recorded as increment in that area can be probably related to some interventions executed successively between 1986 and 1991, as recognizable by the respective set of historical aerial photos (Fig. 5.10).

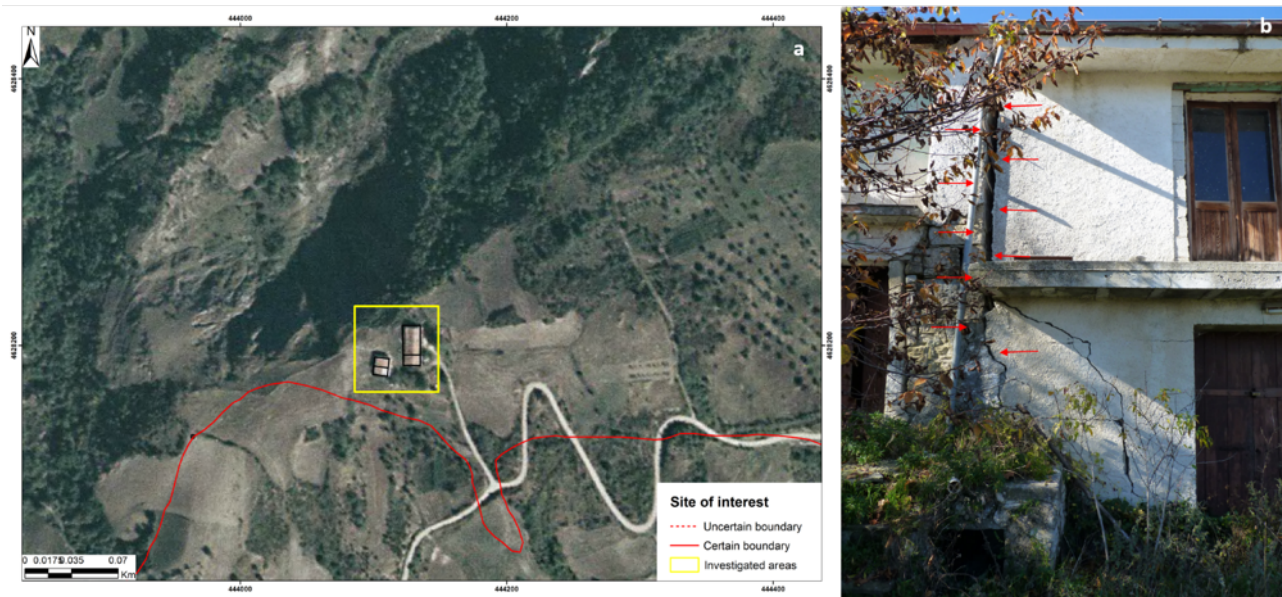
Fig. 5.25 - Localization of the structures of the Area 4 and their proximity to the closer landslide (a). Open cracks visible between two adjacent constructions (b).

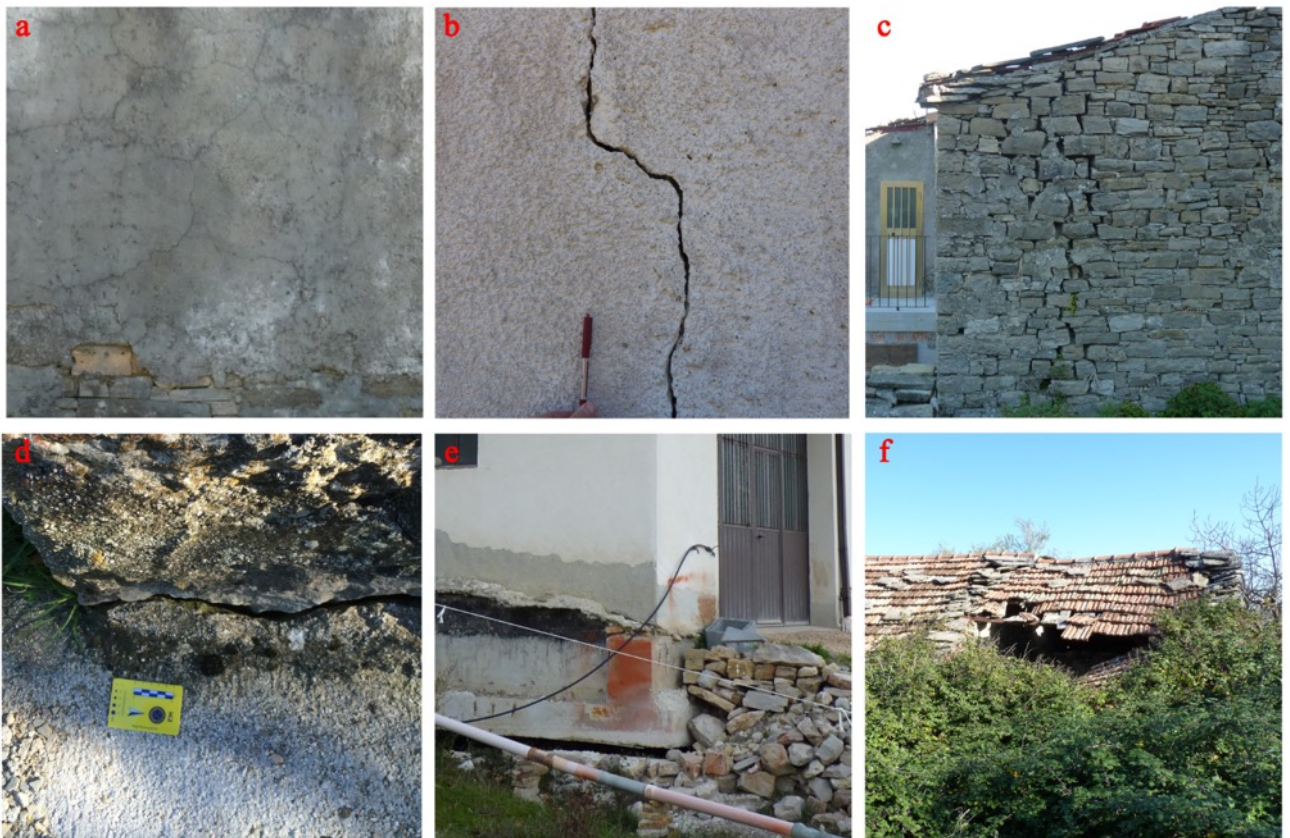
Fig. 5.26 - Example of cracks and rupture identified on structures. a) hairline cracks on plaster of masonry wall; b) open crack on reinforced concrete walls; c) open crack of masonry building walls; d) open crack between wall and external sidewalk; e) open crack between external wall and ground surface; f) collapsed roof in a masonry building (Del Soldato et al., under review_a)

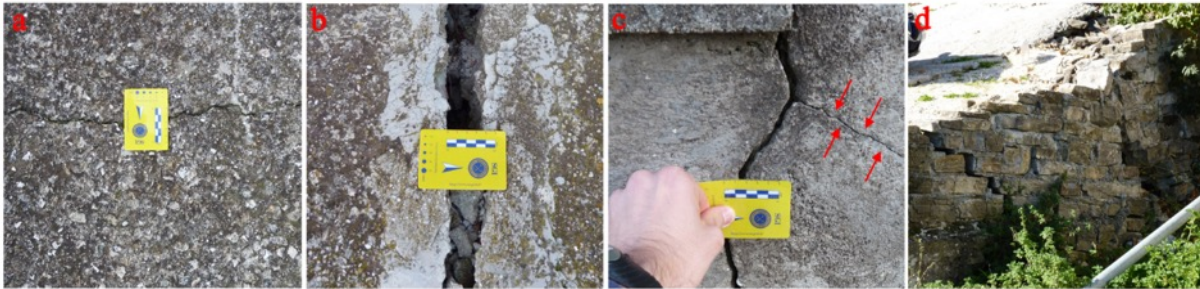
Fig. 5.27 - Fine (a) and open (b) cracks recognizable on pavement of sidewalks slab; hairline (highlighted by means of red arrows) and open fractures on concrete (c) and masonry walls (d).

In concrete sidewalks and walls, the following elements were investigated:

- hairline cracks (Fig. 5.27a and the red arrow in Fig. 5.27c);
- open cracks (Fig. 5.27b, c and d).

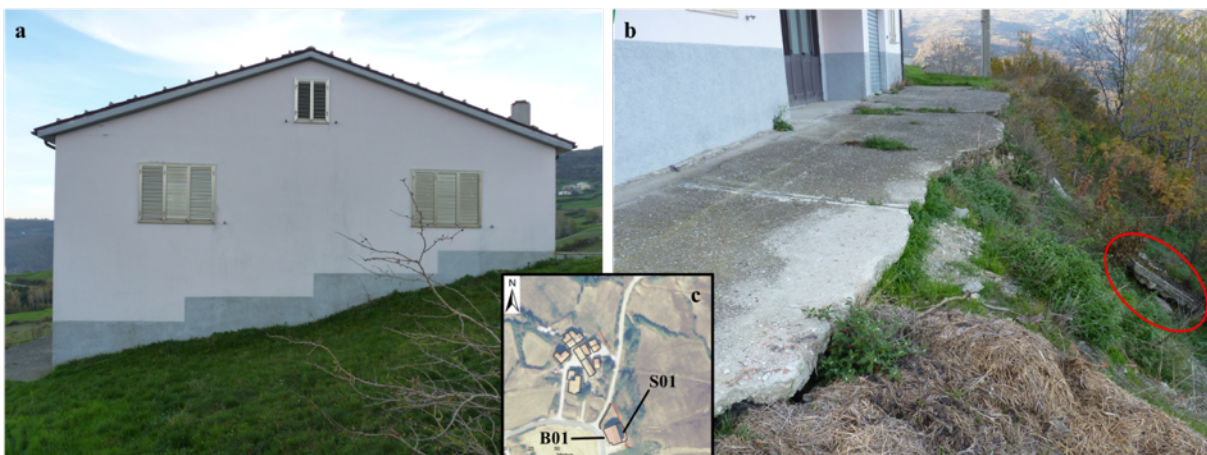
Fig. 5.34 -North façade (a) of the building (B01) located on the crown of the landslide with in front a several damage concrete sidewalk (b) partially collapsed (red circle).

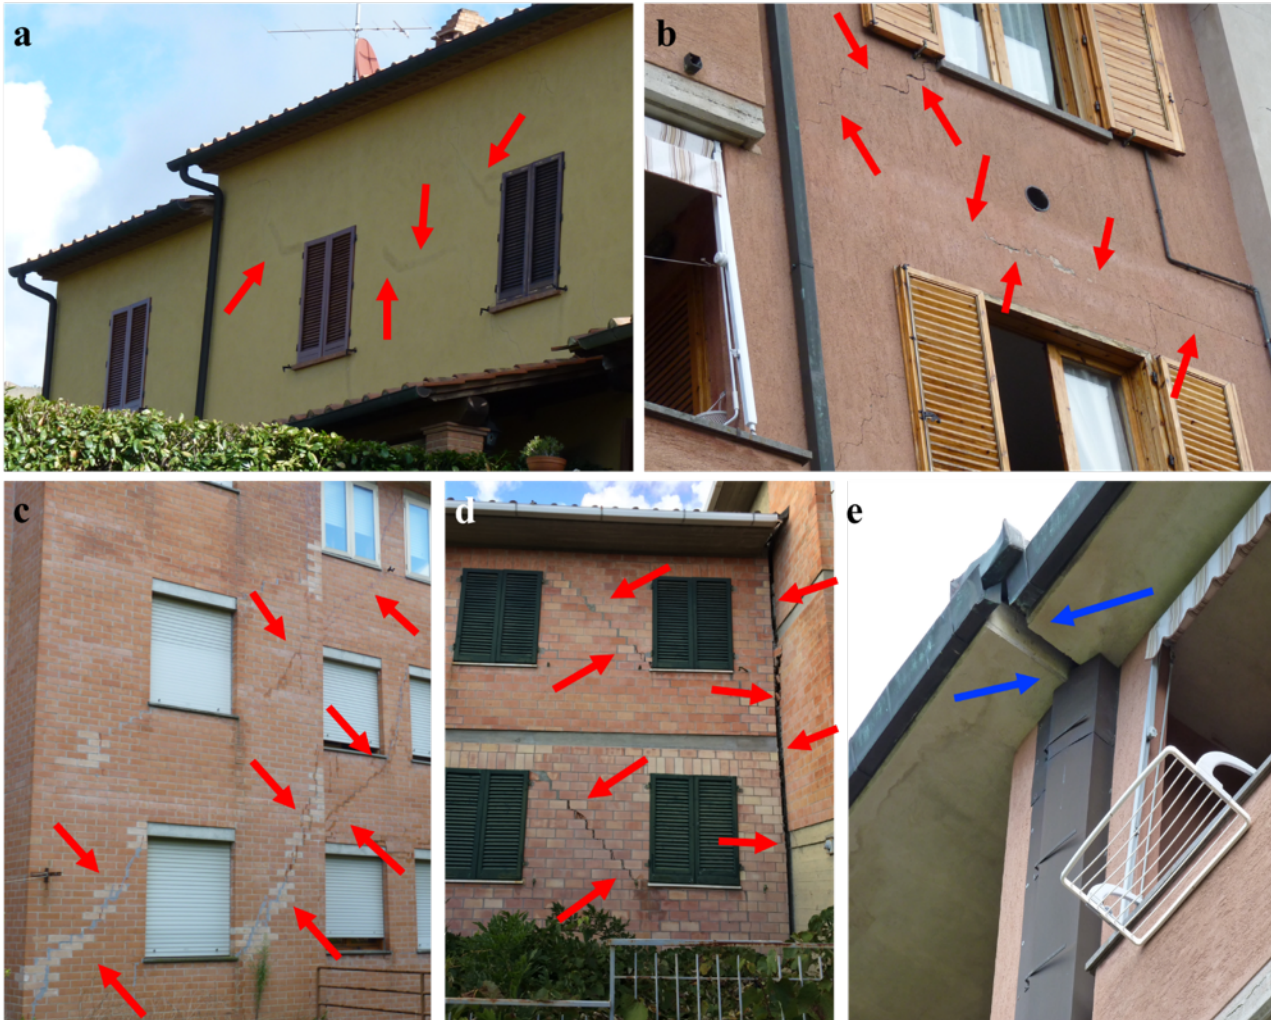
Fig. 5.62 - Different types of damage (red and blue arrows) recognized during field surveys on buildings in the southwestern sector of Volterra. a) plaster cracks restored; b) weak and moderate fractures on plaster; c) numerous severe fractures; d) important cracks plunging about 45° and open fractures between the two structures; e) important tilting between two parts of the same buildings.

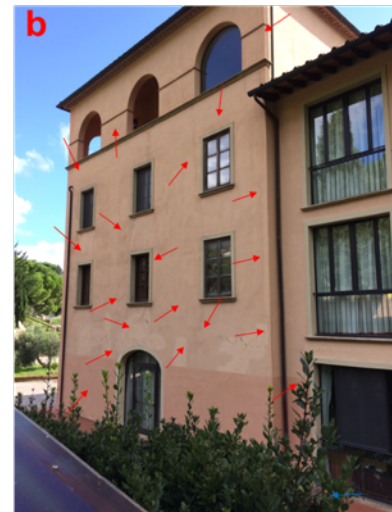
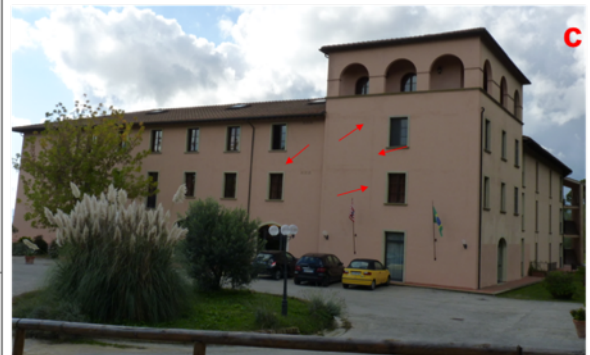
Fig. 5.63 - Sample of the recording scheme (Del Soldato et al., under review_b) compiled (a), with two images (b and c) of the investigated buildings, used for the recognition of the damage affecting the several surveyed structures in the southwestern sector of Volterra.

During the field surveys the recording scheme suggested in the new developed approach (**Fig. 5.2**) was used to reveal damage affecting the buildings of the study area (an example in **Fig. 5.63** of a building sited close to the *Area3*). The use of this scheme, as mentioned before, was useful to survey different damage, cracks, fractures and tilting affecting a construction to categorize their severity singularly and, in a second moment, to assess their effect on the entire construction.

Observations: The right side shows some visible damages and the back façade was no accessible. Pictures shot: P1100149 - P1100150 - DMG211016151651 - DMG211016151646
