UNIVERSITÀ DEGLI STUDI DI NAPOLI FEDERICO II
Dipartimento di Ingegneria Civile, Edile e Ambientale

Dottorato di Ricerca in Ingegneria dei Sistemi Civili
XXXII ciclo

Innovative and non-invasive industrial systems for the
characterization of the damp content and the recovery
of the historical walls affected by rising damp

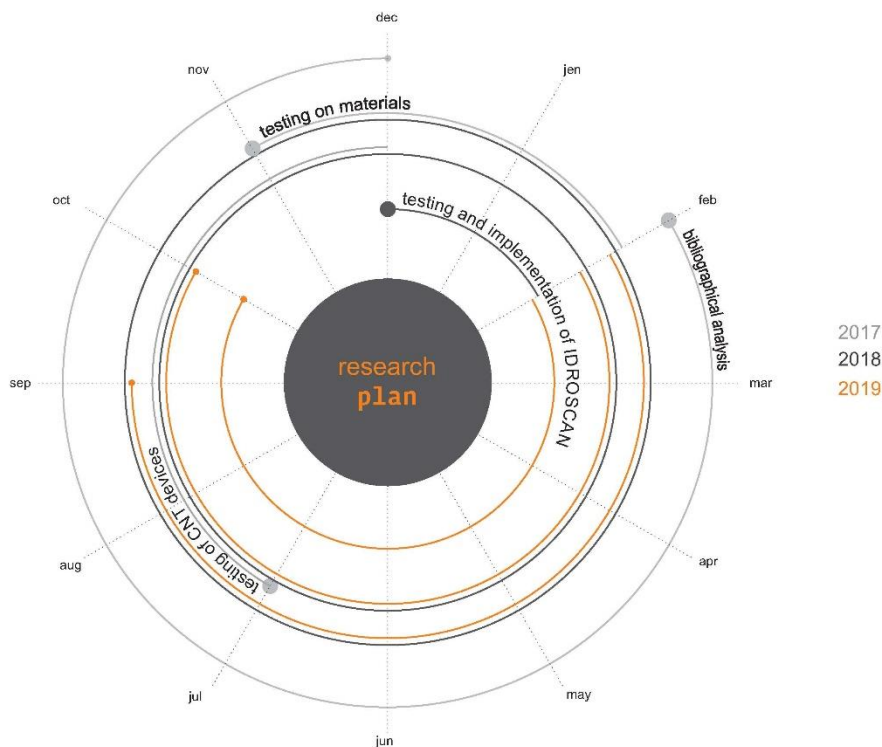
Fig. 1.1 - Research plan

In order to achieve the identified goals, the research was developed by providing, in addition to a bibliographic and documentary study of the state of the art, the execution of direct tests on materials and devices, carried out partly in the laboratory and partly on site (Fig. 1.1):

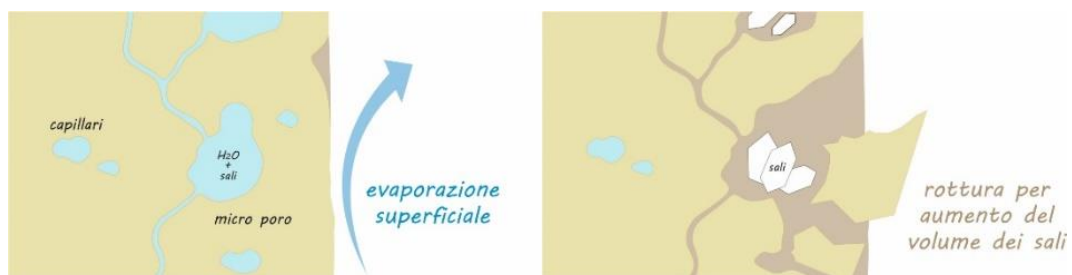
The phenomenon is activated due to the capability of porous building materials to absorb, with only contact, the water from the foundation soils and to allow its migration within the entire masonry structure. In its ascent, the fluid progressively occupies the volume of the capillary ducts and reaches the high sections then, under a difference of pressure and temperature with the external environment, moves on the free surface of the wall and evaporates to the outside. Without the aqueous solution, the salts contained in it crystallize by increasing in volume; this results in stresses that produce swelling, detachments and degradation phenomena at the evaporation section, that can be superficial (plaster) or internal (masonry). (Fig. 2.1)

Fig. 2.1 - Surface degradation phenomenon at hygroscopic salt deposits

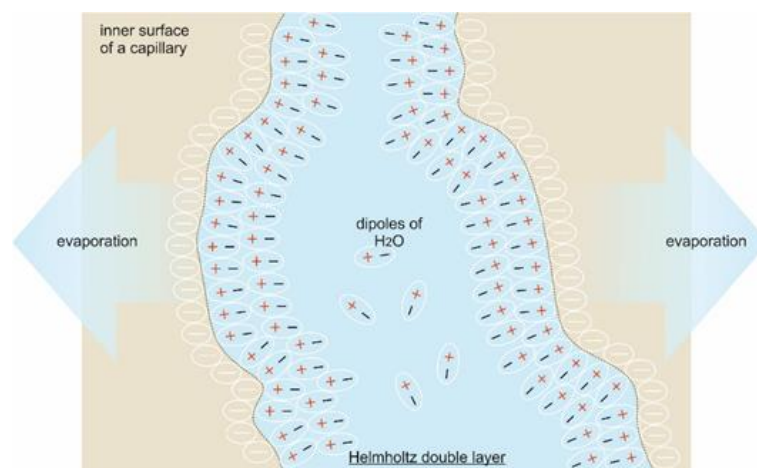
Construction materials are generally rich in Silica, a semi-metal semiconductor second only to oxygen for abundance in the Earth's crust and, therefore, present both in natural stones and in the clay, which is the main component of artificial stone materials. The isotope of Silica makes the wall capillaries behaving as an electrified surface. The water, under the action of the electrical potential produced, behaves like an ionic solution in a condition of non-equilibrium, directing the molecules with the positive pole towards the walls of the capillaries, negatively charged, and forming with them ionic bonds. The distribution of the charges at the interface between solid and fluid can therefore be outlined using the model of the *double layer of Helmholtz* (Fig. 2.4).

Fig. 2.4 – Helmholtz double layer model

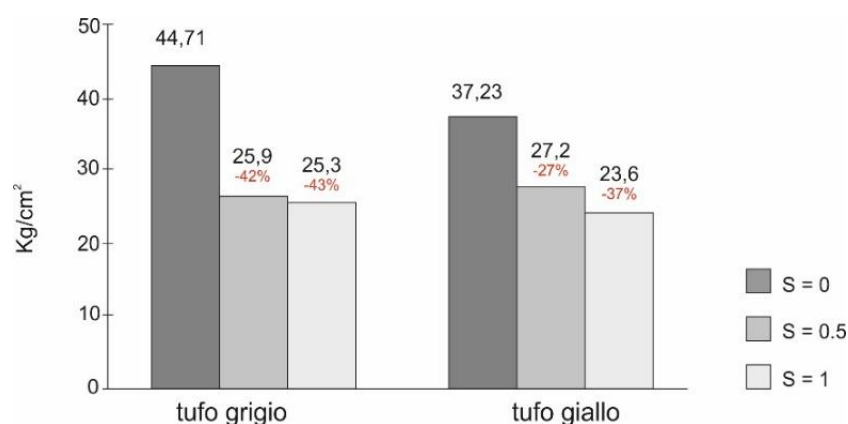
yellow tuff, Campania grey tuff, Puglia white tuff, light and dark tuff of Rome, light and dark tuff of Viterbo. The cube samples with 100 mm side were first dried (saturation conditions $S=0$) and then subjected to single axial compression with application of the load controlling the related deformations, according to UNI 9724-3⁹ standard. The types of Neapolitan yellow tuff and the Campania grey tuff have been tested also under conditions of complete saturation ($S=1$) and saturation at 50% ($S=0.5$).

The results of the tests showed a reduction in the mean compressive strength which, under saturated and semi-saturated conditions, reached a value 40% lower than the resistance of the samples tested under dry conditions. (Fig. 2.6)

Fig. 2.6 - Valutazione della resistenza meccanica del tufo con diversi gradi di saturazione

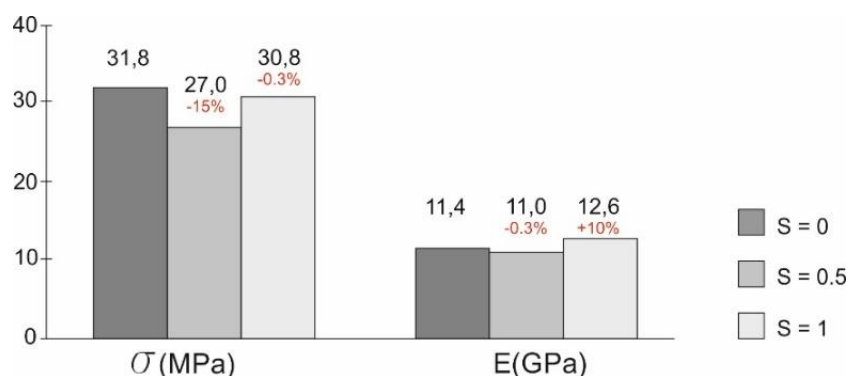
Similar tests have been done by researchers at the University of Bologna¹⁰ on brick bricks; in this case both individual elements and samples of wall have been tested under dry and wet conditions, packed with lime-based mortar and cement mortar. (Fig. 2.7)

Once again, there was a reduction in the compressive strength of the bricks in saturated conditions, even if less than what had been achieved in the tests made on tuff.

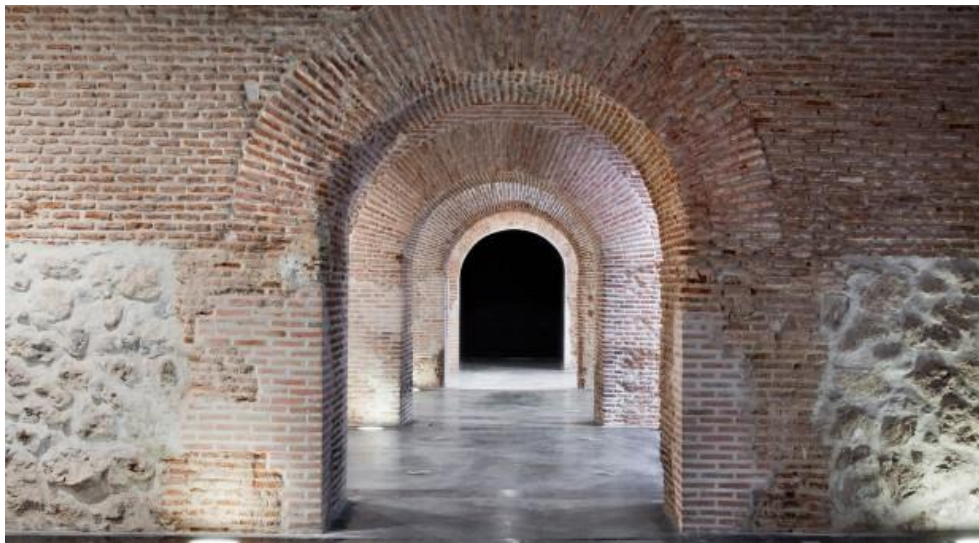
The building consists of a supporting masonry structure that rests on continuous foundations. The complex has two levels below the ground floor, *sotano* -1 and *sotano* -2. The deepest is known as the zone of the *bovedas*, that is of the vaults, just because it is characterized by barrel coverings in brick that unload on reinforced walls, between the abutment, with chaotic textures in limestone (Fig. 3.14).

Fig. 3.14 – Detail in the zone of *bovedas*.

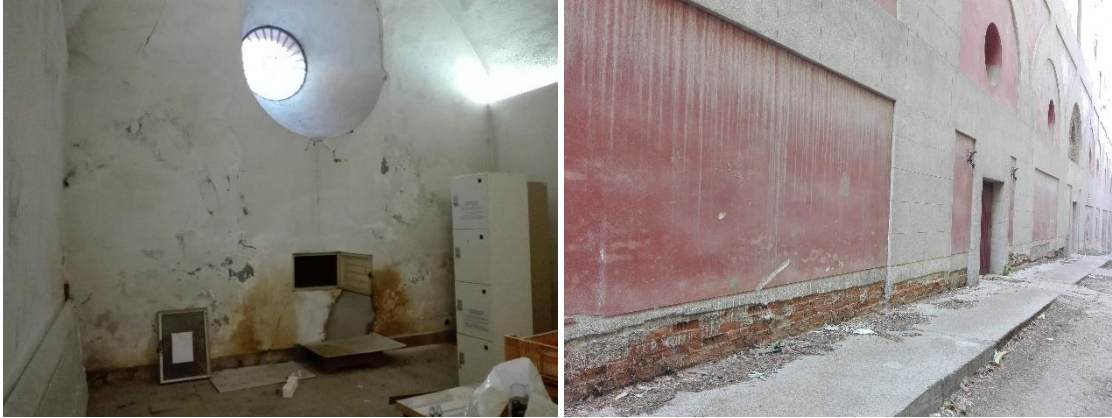
The first diagnosis did not highlight the phenomena of humidity because, in the framework of previous restoration works, in these rooms counter-walls and counter-vaults of ventilation were made to prevent the degradation of the documents contained in the archives. Nevertheless, the expedient of the ventilation channels was not an effective remedy to the solution of the problem which, instead, was clearly manifested to the outside (Fig. 3.17).

Fig. 3.17 – Interior with air ventilation channel detail (left) – external facade (right)

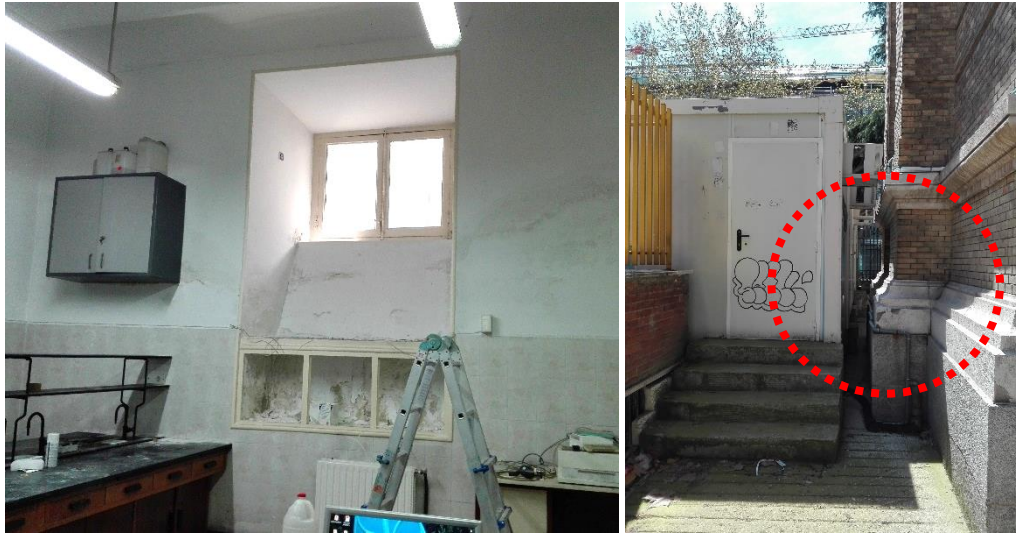
The combination of all parameters justifies the presence of the damp front limit at heights of 2,20 m, much greater than the normal operating conditions of a brick masonry.

Fig. 3.24 – Identification of the area of intervention

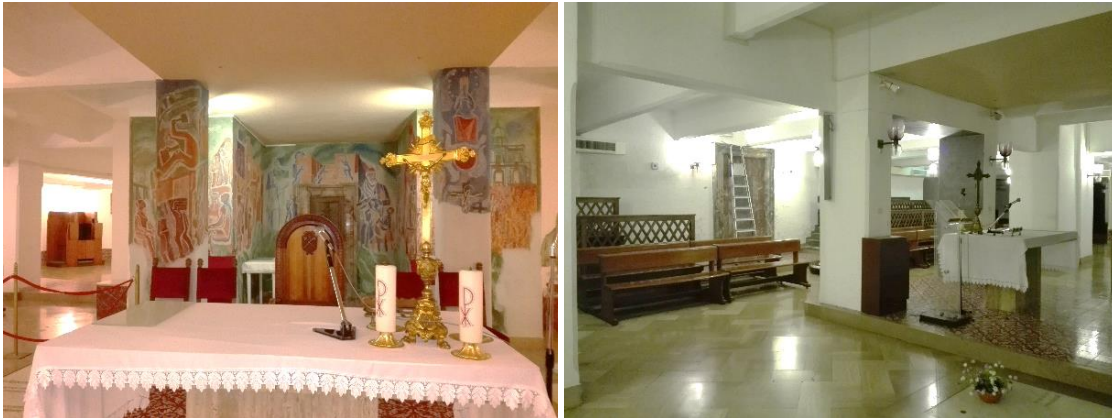
The installation of the CNT device system was carried out just in front of the altar of the Crypt, on the wall near to a passage closed by a dark marble (Fig. 3.27).

Fig. 3.27 – The Crypt altar (left) – The installation wall (right)

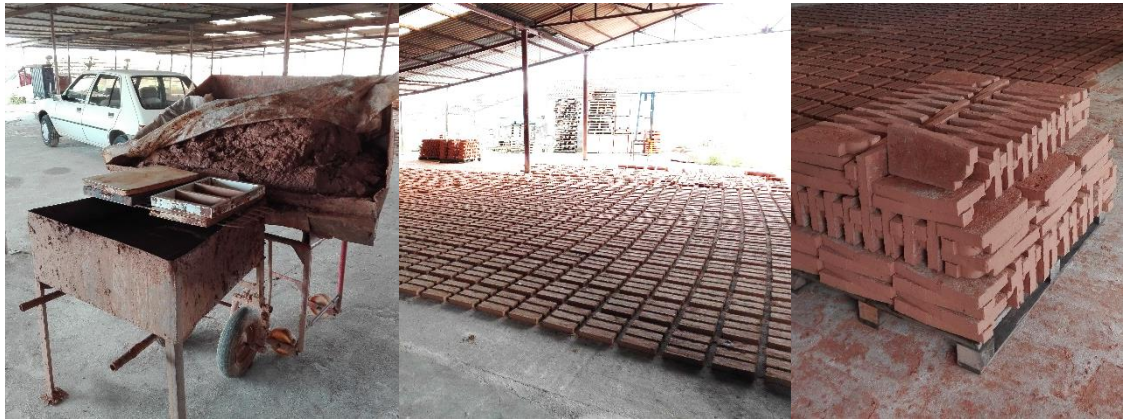
method, and for this they have been coded in the test with the acronym M (modern method). The shapes of the bricks and special elements are obtained by making each time special formworks to reproduce faithfully the elements of the building to be replaced in the restoration (Fig. 4.1).

Fig. 4.1 - Brick construction and air-drying phases

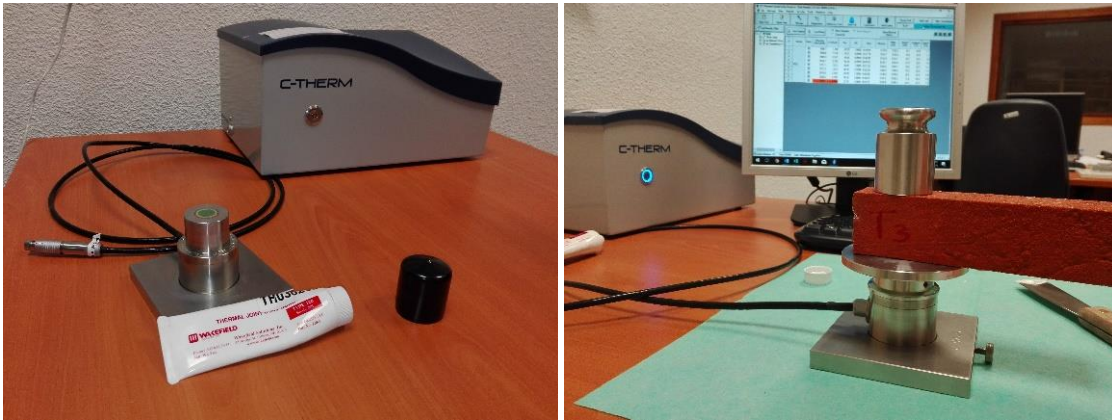
Fig. 4.3 – Equipment used for measuring thermophysical properties

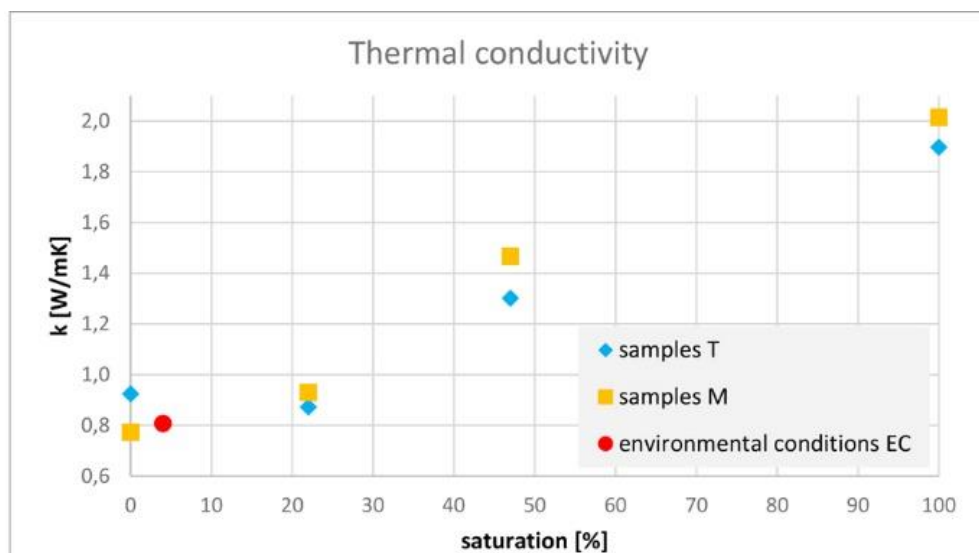
Fig. 4.4 – Thermal conductivity values at different saturation degrees

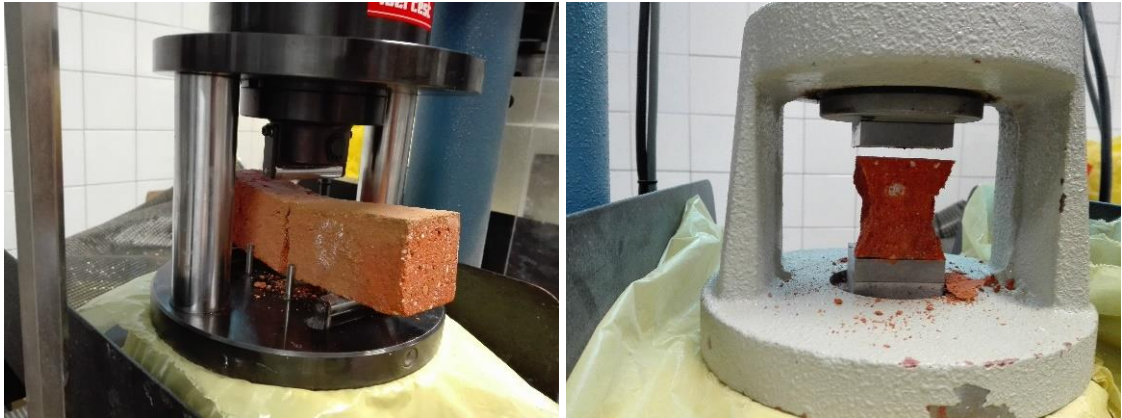
Fig. 4.5 – Equipment used for bending and compression mechanical strength tests

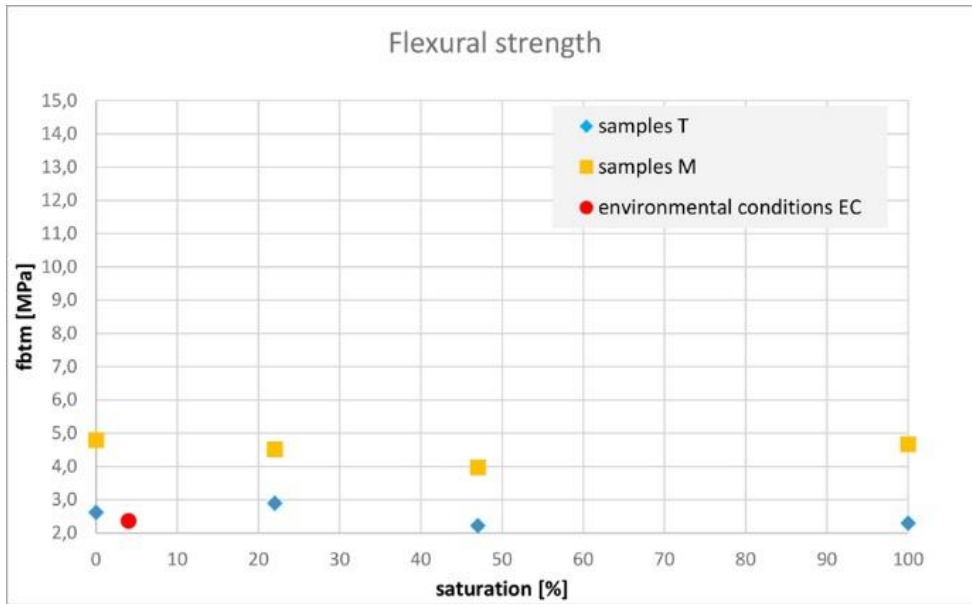
Fig. 4.6 – Flexural strength values at different saturation degrees

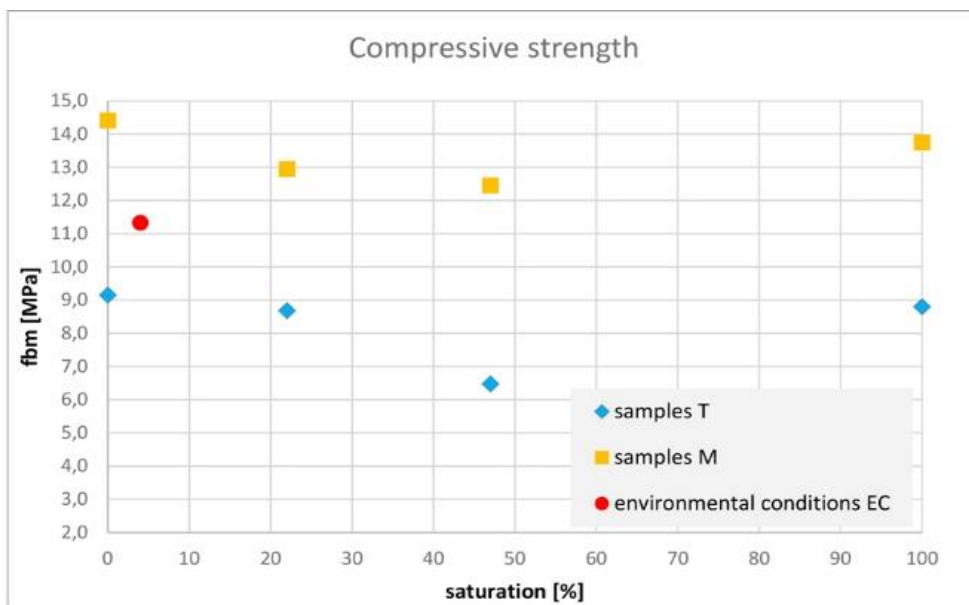
Fig. 4.7 – Compressive strength values at different saturation degrees

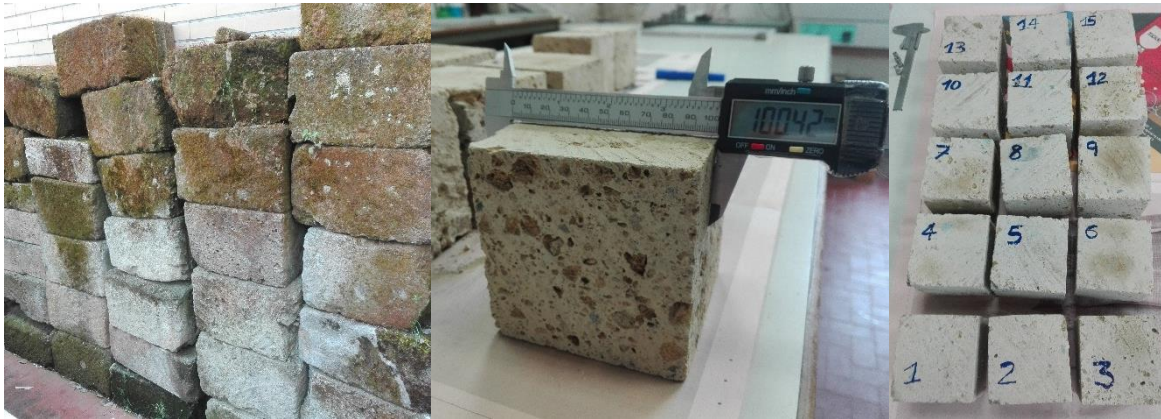
Fig. 4.8 – From left: material before cutting, dimensional check of samples, cataloguing of specimens

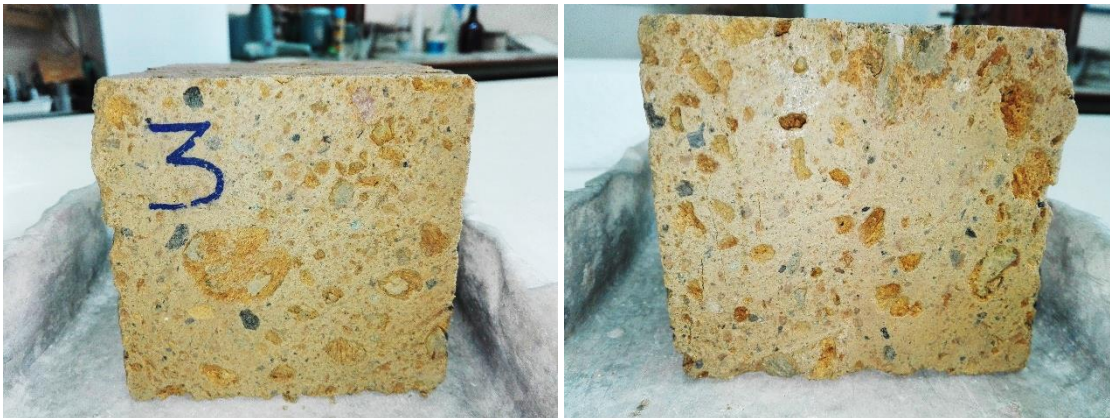
Fig. 4.12 – Sample TGN₃ before compression test (left) and after compression test (right)

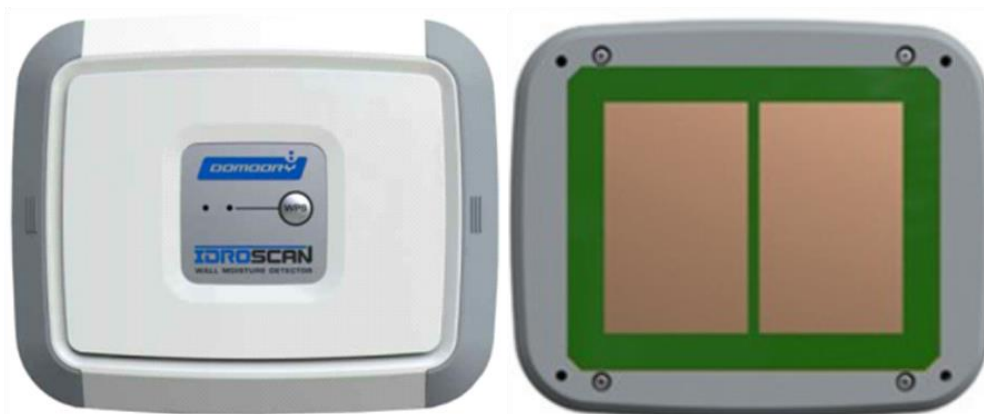
Fig. 5.1 –IDROSCAN® probe

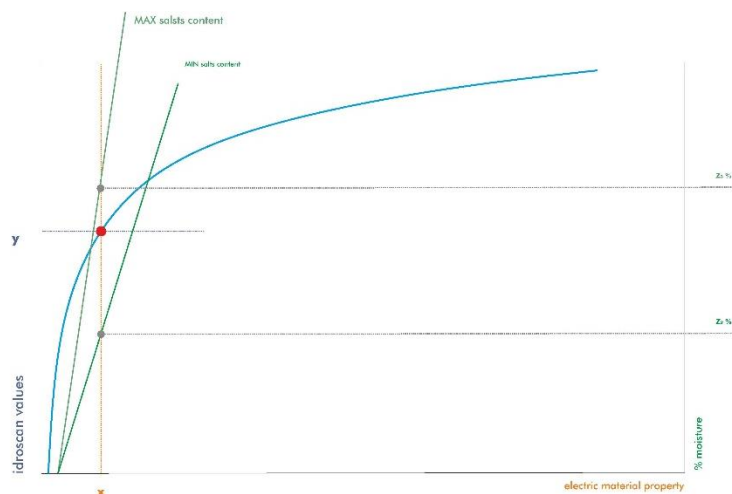
Fig. 5.2 – IDROSCAN® curves

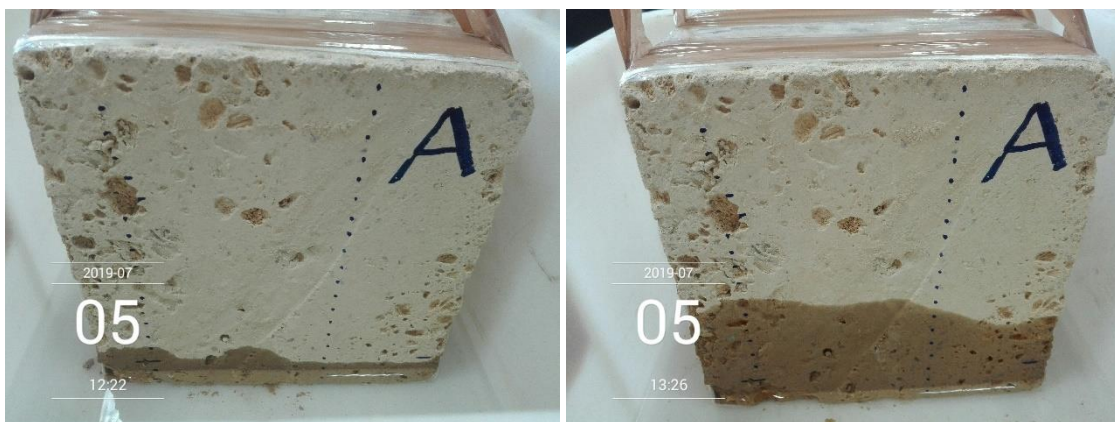
Fig. 5.4 – Conditioning of the A test piece for capillary ascent

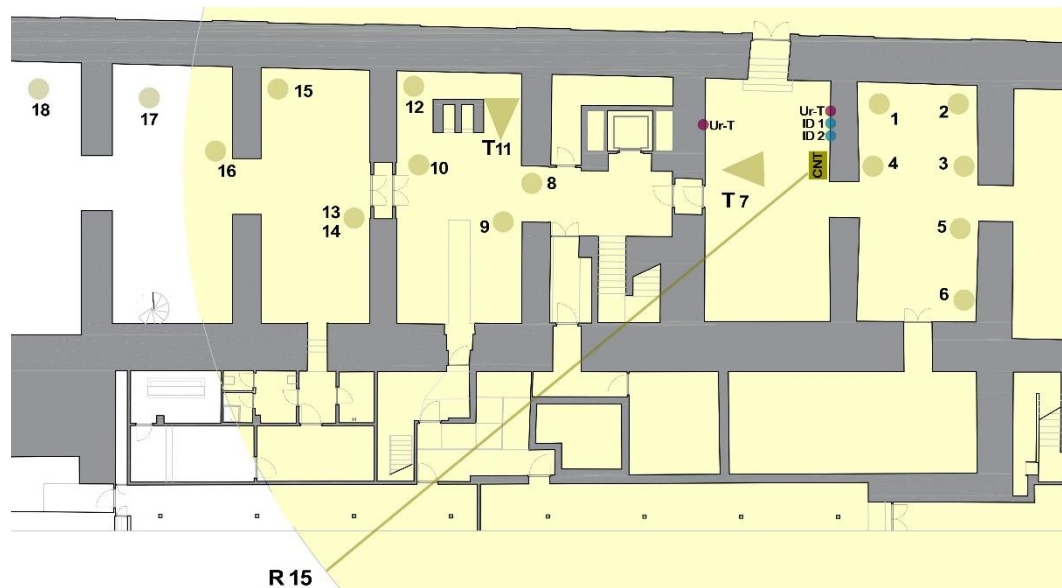
Fig. 6.4 – Location of the device and of the points where the thermographic images were acquired

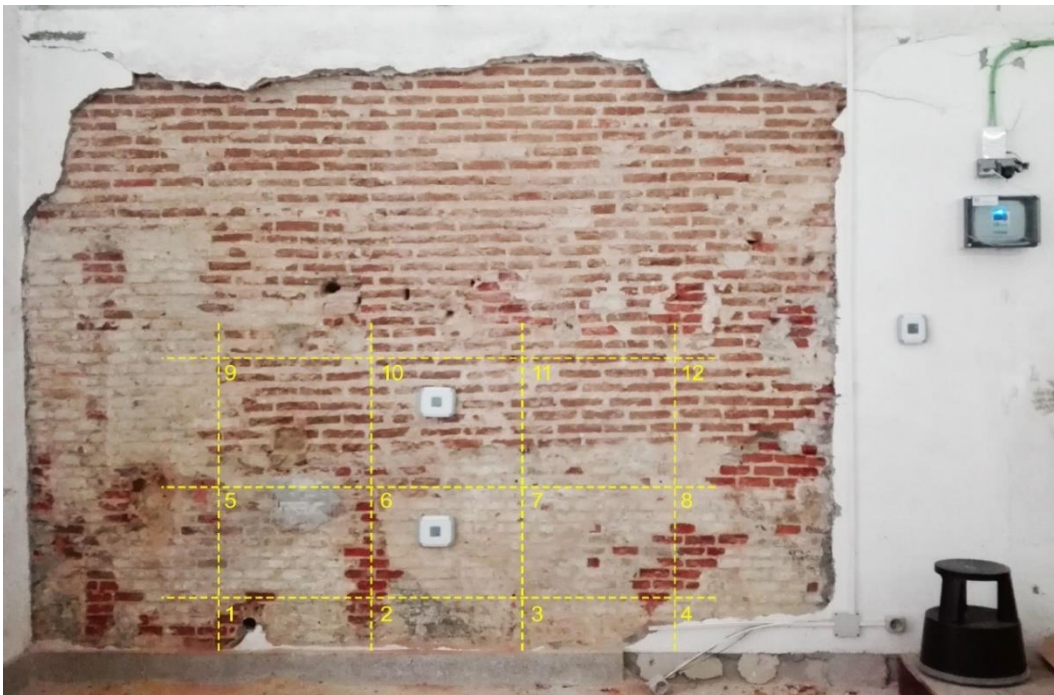
Fig. 6.7 – Sampling points for weighting tests

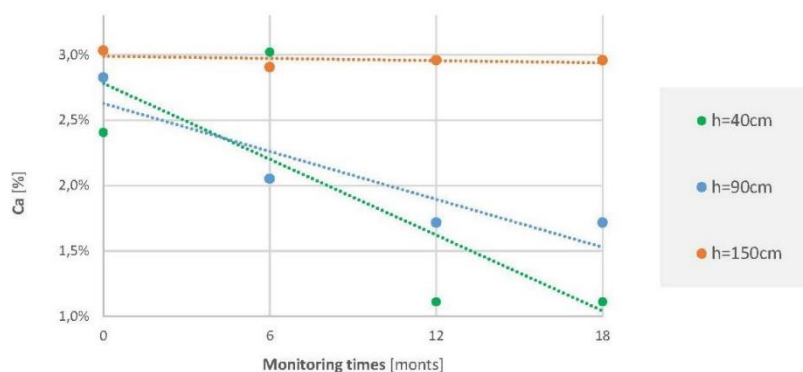
Fig. 6.8 – Variation of moist content corresponding to the sample's heights

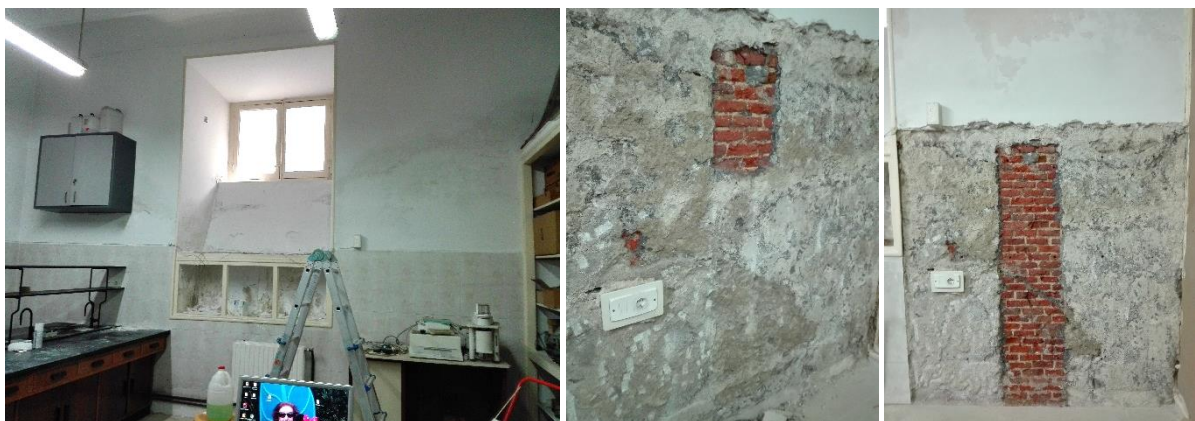
Fig. 6.10 – The wall before and after the removal of the plaster

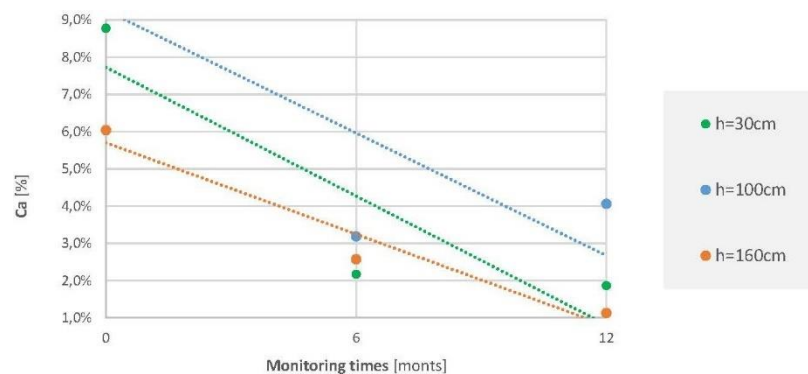
Fig. 6.15 – Variation of moist content corresponding to the sample's heights

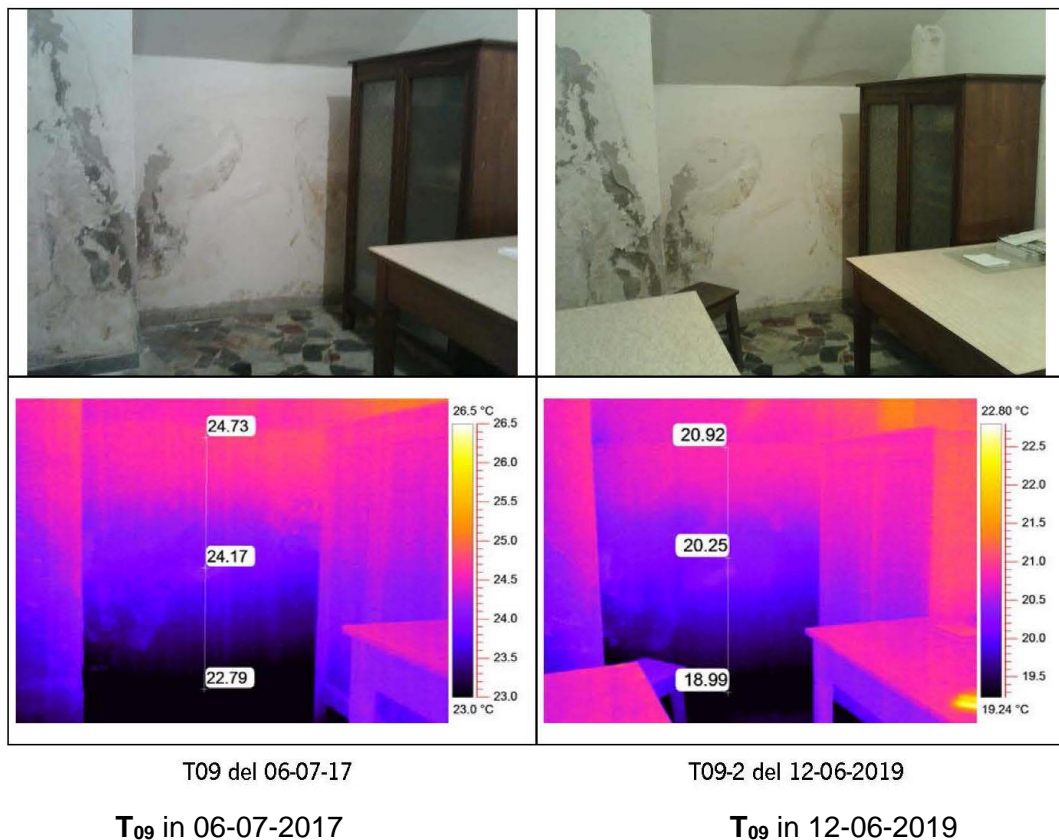
Fig. 6.19 – Comparison between IRT images T₉

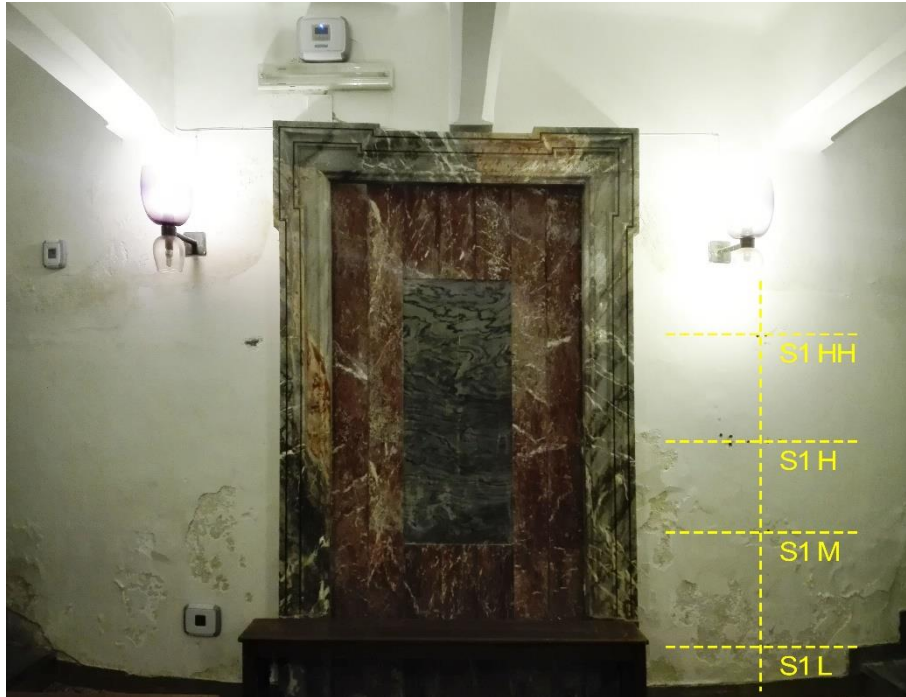
Fig. 6.20 – Sampling points for weighting tests
