# Degradation effects on structural safety of masonry walls

Ph.D. Thesis presented  
for the fulfillment of the Degree of Doctor of Philosophy  
in Ingegneria Strutturale, Geotecnica e Rischio Sismico  
by  
Felice Saviano

March 2023

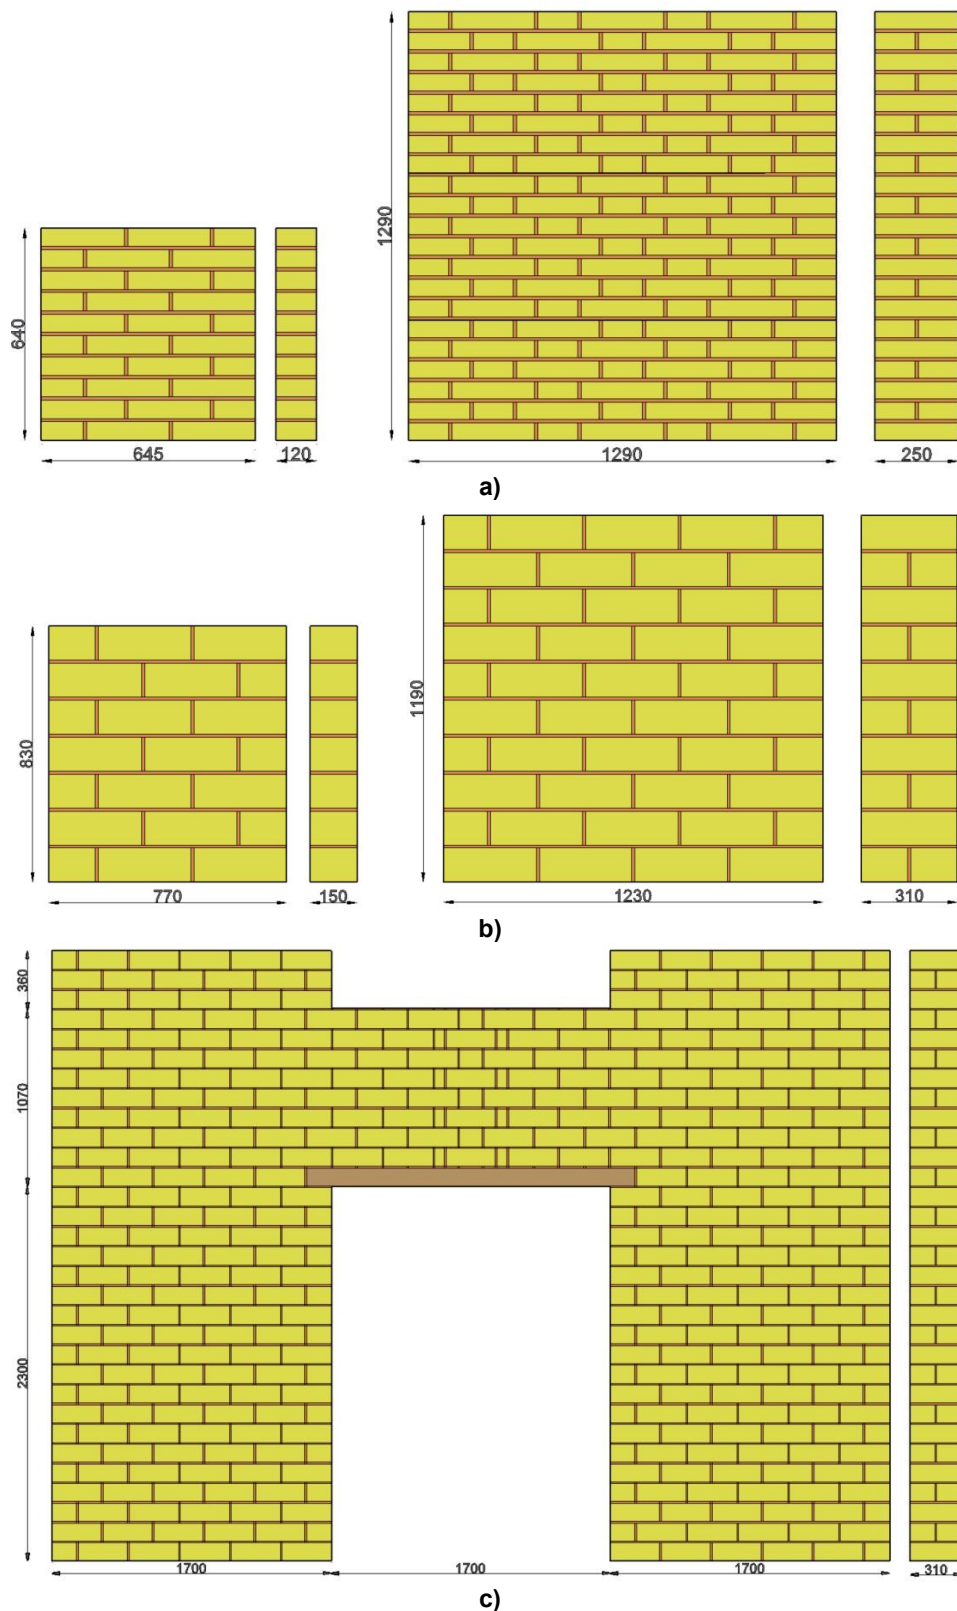
**Figure 1. Dimensions of the specimens and masonry bond pattern for: a) brick masonry subjected to uniaxial and diagonal compression loads with single-leaf and double leaf respectively; b) tuff masonry subjected to uniaxial and diagonal compression loads with single-leaf and double leaf respectively; c) tuff URM tested under in-plane and out-plane loads.**

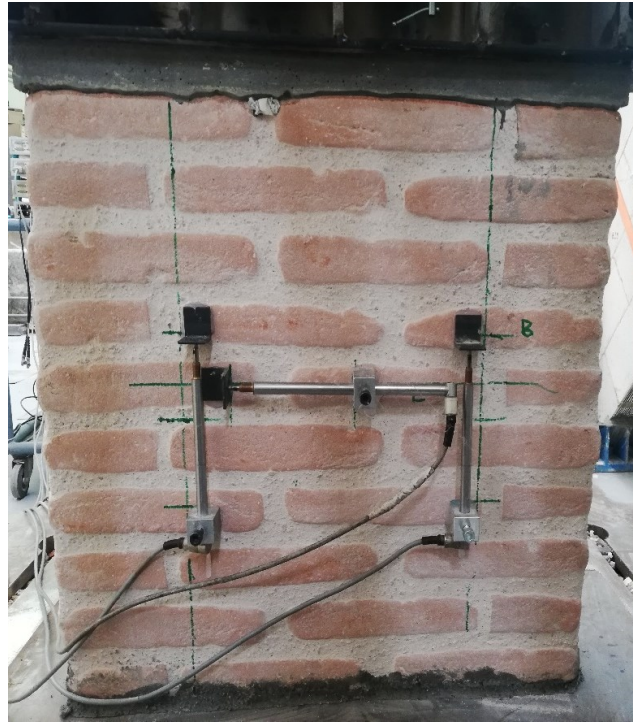
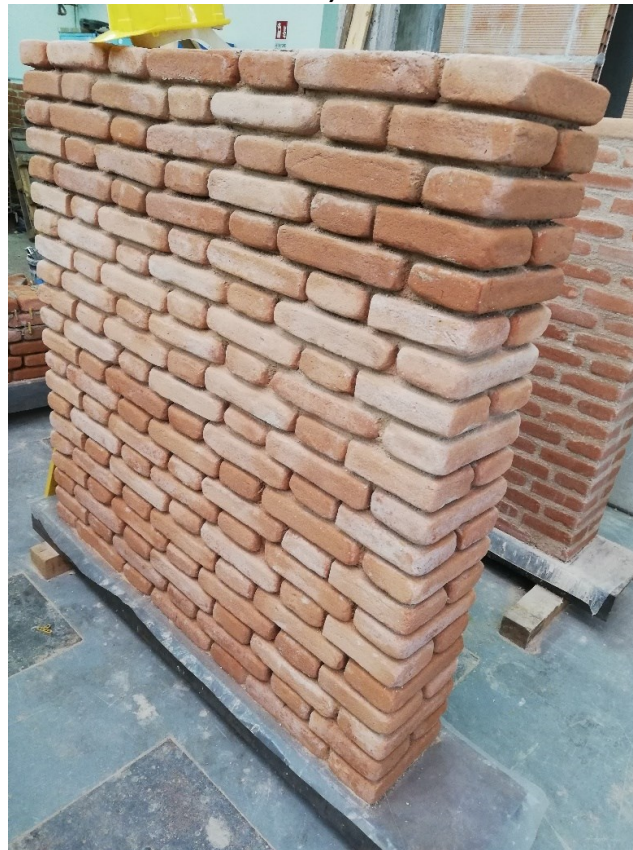
**Figure 2. Pictures of specimens to be tested under (a) simple compression and (b) diagonal compression**

The specimens tested under simple compression were characterized by a single-leaf masonry assemblage with overall size equal to 645x640x120 mm<sup>3</sup>, in agreement with other experiments carried out in the past [23] and 10 masonry layers (Figure 2.a). By contrast, the specimens tested under diagonal compression were fabricated according to a double-leaf masonry pattern with overall size equal to 1290x1290x250 mm<sup>3</sup> in agreement with standard ASTM [24] and other studies [25], [26]. Regarding the masonry fabrication, the bricks were wetted in water before their installation in contact with the mortar. The specimens with artificial degradation (abbreviated as ‘deteriorated specimens’ hereinafter in contrast to ‘intact specimens’ with fully mortared joints) were made of partially filled mortar joints, as shown in Figure 2.b. In those specimens, the amount of mortared joint area can be deduced according to the ratio

$s/t$  between the full width of the mortared joint ( $s$ ) and the total thickness of the wallet ( $t$ ). The fabrication of deteriorated specimens was carefully controlled so that  $s/t$  was equal on average to 33% and 24% in specimens to be tested in simple and diagonal compression, respectively.

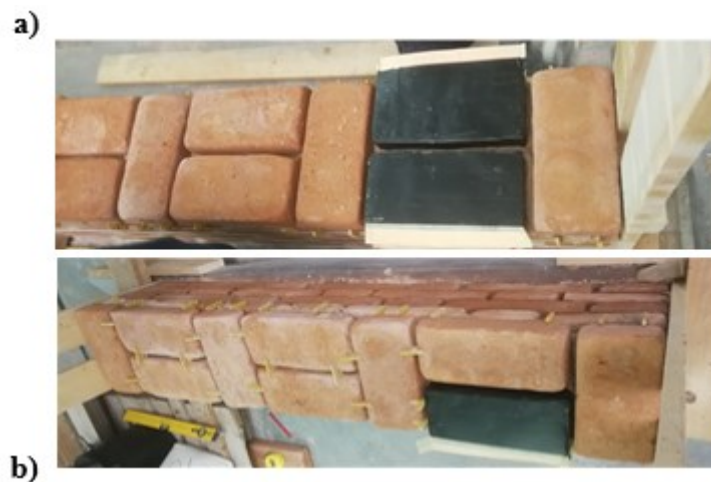
**Figure 3. Smart bricks pattern for diagonal compression test: a) Intact; b) Deteriorated**

A beam of high strength and stiffness, used for testing procedure, has been placed on the top of the specimen made perfectly flat by the application of a layer of mortar, to remove surface roughness and ensure a uniform distribution of the load and a smooth contact surface during the uniaxial compression test. For each of the two specimen configurations (i.e., intact and deteriorated), strain-sensing piezoresistive bricks denoted as 'smart bricks' in previous papers [27]–[29] were integrated in the specimens to assess their ability to monitor the stress/strain progress for structural health monitoring (SHM) applications. The specimens with smart bricks are labelled with final letter 'm'. Intact specimens included three smart bricks in both front and rear leaves of the masonry, whereas only the front leaf of deteriorated specimens was equipped with three smart bricks (Figure 3).

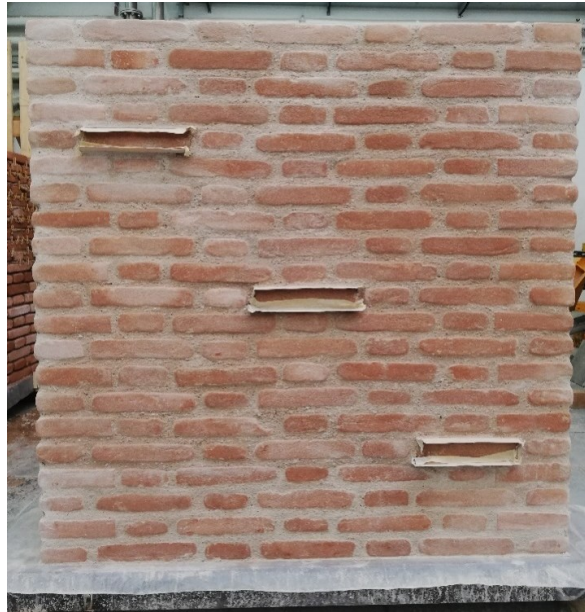
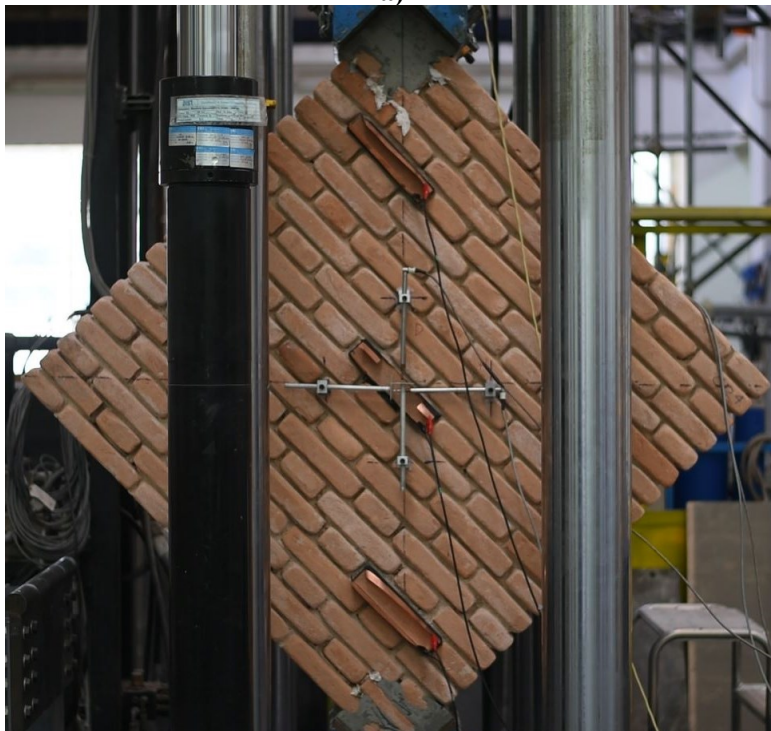
**Figure 4. Masonry bond pattern for diagonal compression test with smart bricks for configuration: a) intact; b) deteriorated**

The novel sensors are made of fiber-reinforced clay-based material mixing fresh clay with stainless steel micro fibers to supply the intrinsic piezoresistivity of the clay matrix. So smart bricks provide variations in their electrical outputs when mechanically strained under compression loads. A detailed description of smart brick operating principle can be found in [27], [28], [30]. (Figure 4).

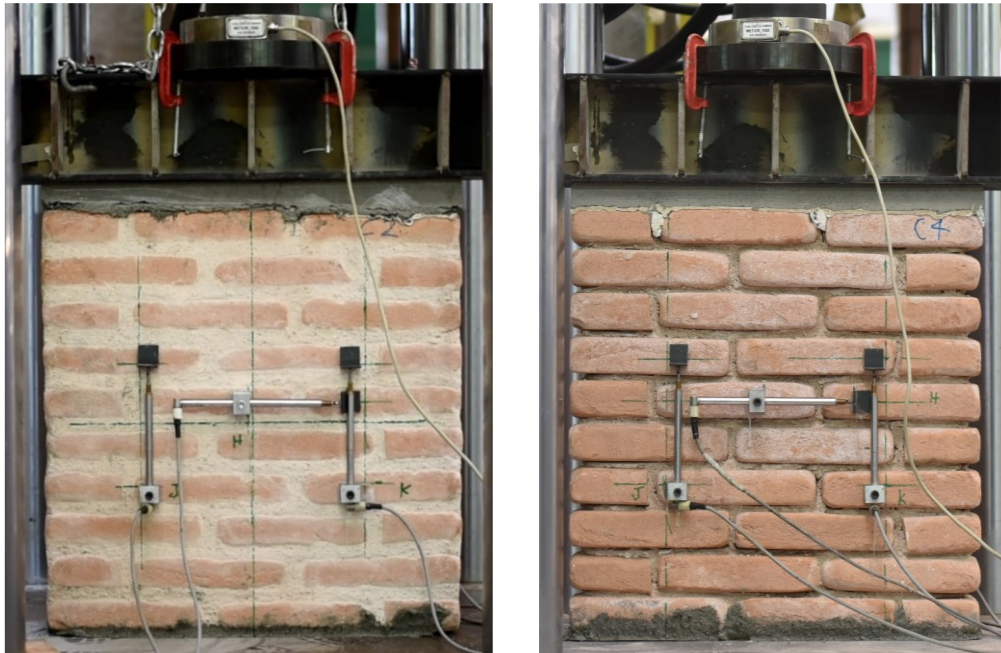
**a)** **b)**  
**Figure 5. Experimental setups of specimens subjected to simple compression in configuration (a) intact and (b) deteriorated.**

According to previous investigations, measurement devices were installed in the central region of both specimen sides so that measurements were not affected by local effects on top and at the bottom of the specimen. Deformations were measured by three inductive linear variable differential transformers (LVDTs) as follows: two LVDTs per side were parallel to the loading direction, and the other was orthogonal to the

loading direction. All LVDTs were connected only to bricks, according to provisions by EN1052-1 standard [31].

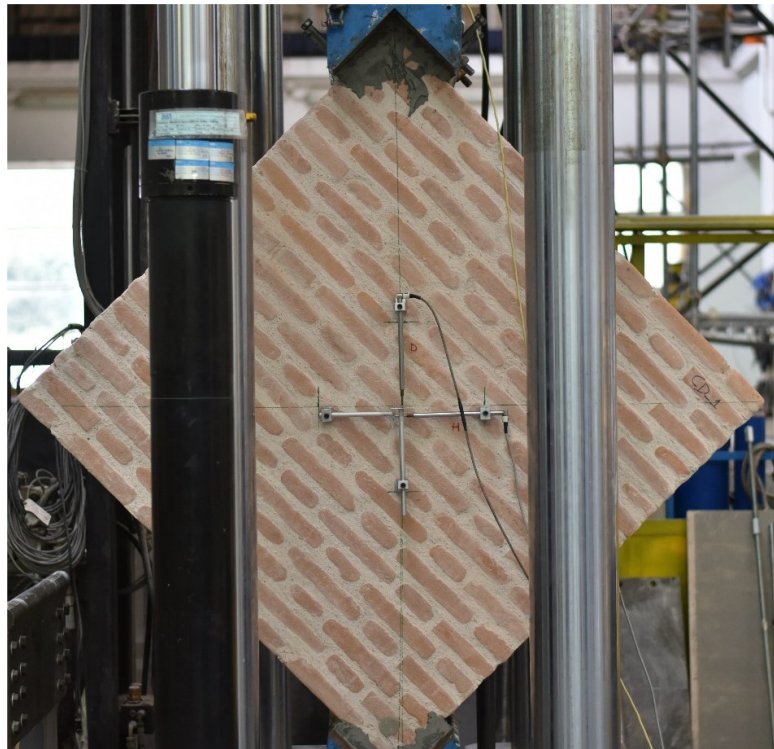
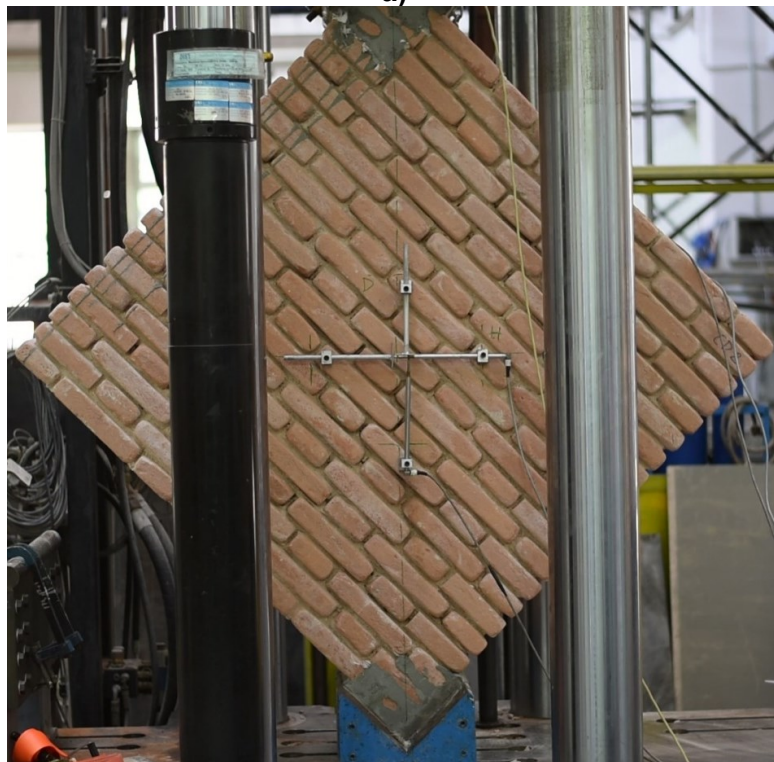
**Figure 6. Experimental setups of specimens subjected to diagonal compression in configuration (a) intact and (b) deteriorated.**

Diagonal compression tests were carried out to investigate the in-plane shear behaviour of different double-leaf specimens with the same type of masonry assemblage. Diagonal compression tests, indirect type test compared to shear-compression test, are preferred compared to the latter, because the former is simpler to realize with limited cost and duration for set-up procedure, but on the other hand their interpretation is more uncertain with different approaches available in literature to calculate mechanical parameters of masonry used in analytical models.

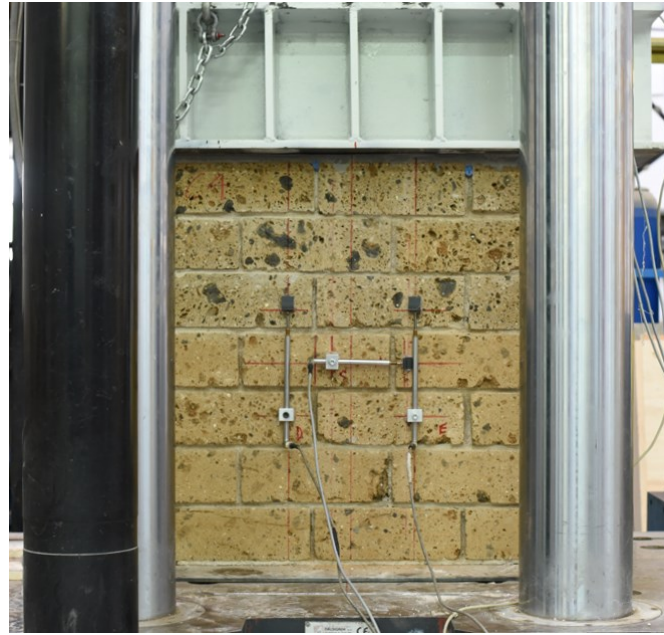
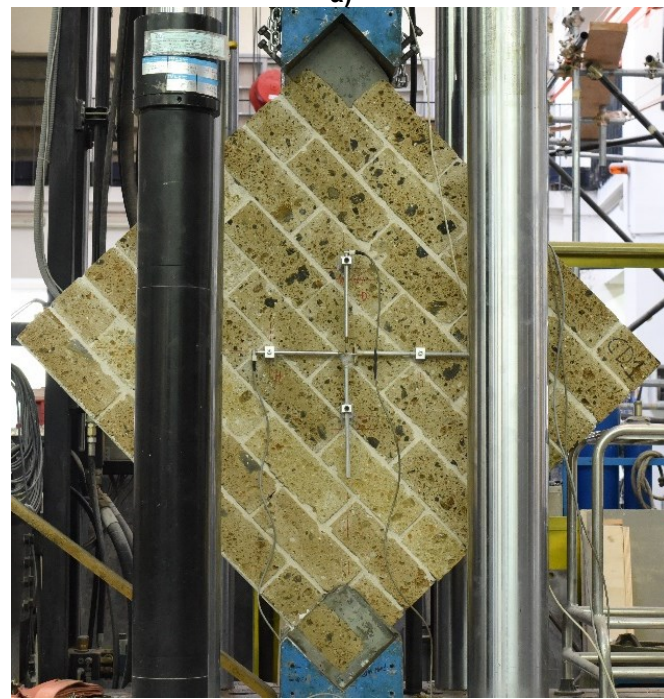
**Figure 7. Pictures of specimens to be tested under (a) simple compression and (b) diagonal compression**

The specimens tested under simple compression were characterized by a single-leaf masonry assemblage with overall size equal to 770x830x150 mm<sup>3</sup>, while the another one double-leaf masonry assemblage with overall size equal to 770x830x310 mm<sup>3</sup>, in agreement with other experiments carried out in the past [23] with 10 masonry layers (Figure 7.a). By contrast, the specimens tested under diagonal compression were fabricated according to a double-leaf masonry pattern with overall size equal to 1190x1230x310 mm<sup>3</sup> in agreement. with standard ASTM [24] and other studies[25], [26]. Regarding the masonry fabrication, the bricks were wetted with water before their installation in contact with the mortar. The specimens with artificial degradation (abbreviated as ‘deteriorated specimens’ hereinafter in contrast to ‘intact specimens’ with fully mortared joints) were made of partially filled mortar joints, as shown in Figure 7.b. In those specimens, the amount of mortared joint area can be deduced according to the ratio  $s/t$  between the full width of the mortared joint ( $s$ ) and the total thickness of the wallet ( $t$ ). The fabrication of deteriorated specimens was carefully controlled so that  $s/t$  was equal on average from 36% to 10% in specimens to be tested in simple compression and from 20% to 10% for the ones tested in diagonal compression.

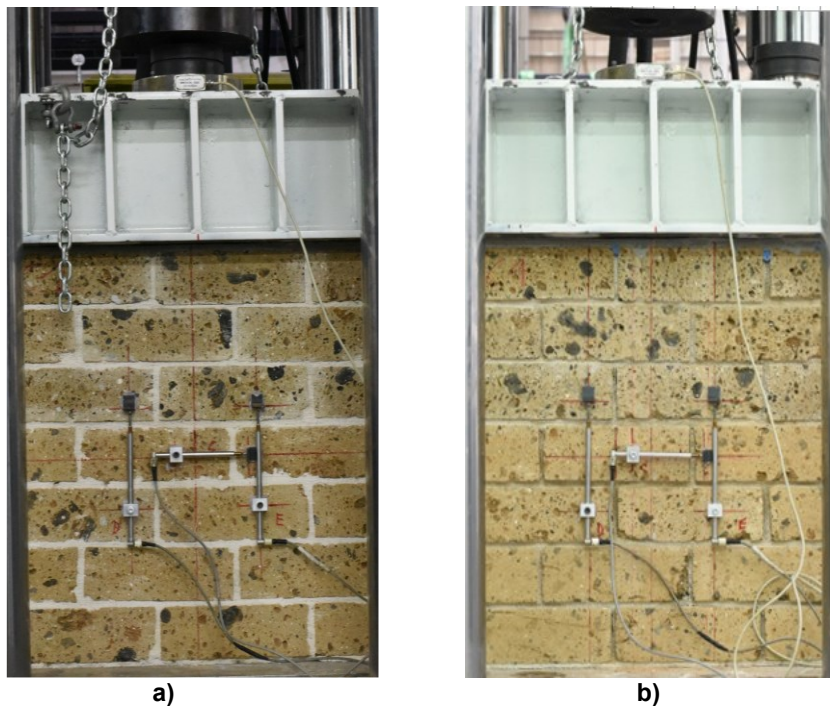
**Figure 8. Experimental setups of specimens subjected to simple compression in configuration (a) intact and (b) deteriorated.**

Deformations were measured by three inductive linear variable differential transformers (LVDTs) as follows: two LVDTs per side were parallel to the loading direction, and the other was orthogonal to the loading direction. All LVDTs were connected only to tuff, according to provisions by EN1052-1 standard [31].

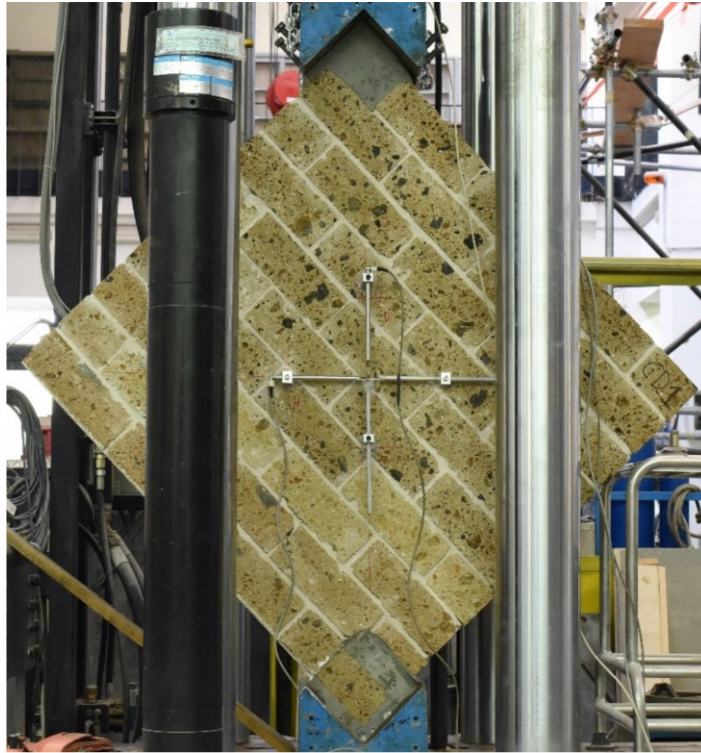
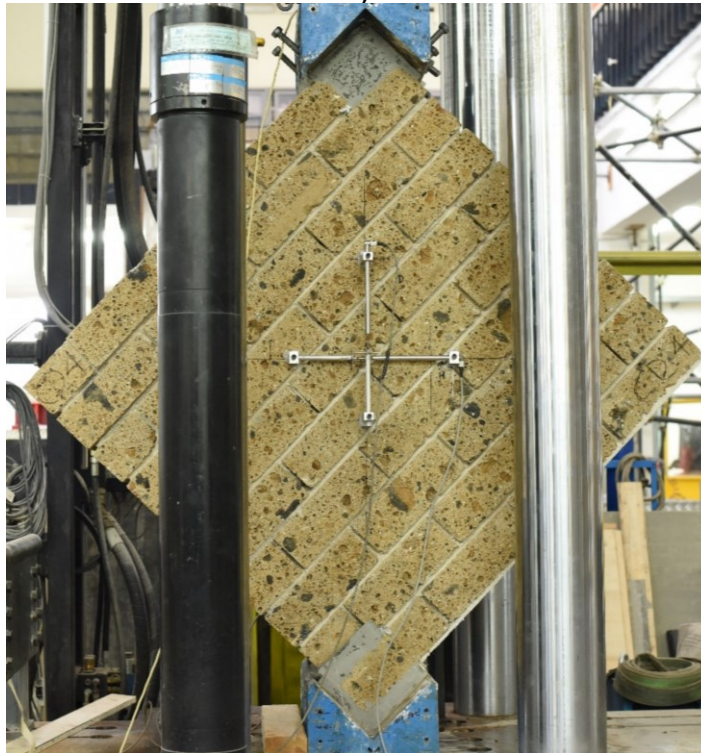
**Figure 9. Experimental setups of specimens subjected to diagonal compression in configuration (a) intact and (b) deteriorated.**

On each side, relative vertical and horizontal displacements were measured by linear variable differential transformers (LVDTs) with gage length  $g = 400$  mm, not to have localized effects in the centre, bearing in mind that ASTM E 519-07 does not provide standard gage lengths for LVDTs.

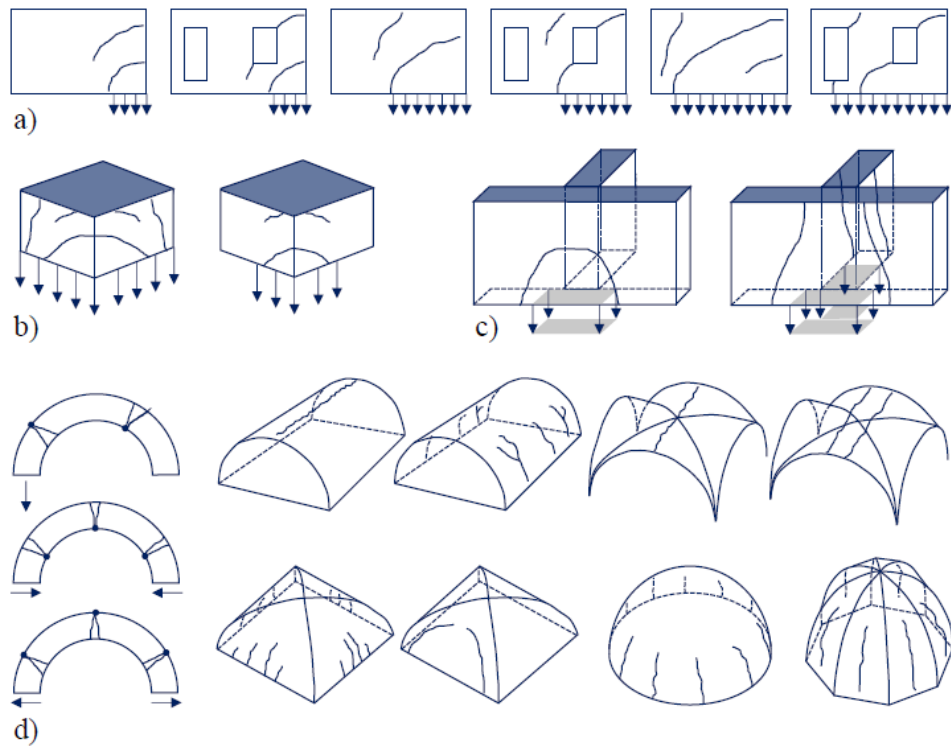
**Figure 10. Damage patterns for masonry structures subjected to settlements: (a) Façade with and without openings; (b) buildings corner connections; (c) T-connections; (d) arches, vaults and domes.**

It was observed that masonry structures subjected to foundation movements usually develop typical failure patterns when they are affected by ground movements at the base, depending on the portion of the structure involved in the movements, the type of differential settlement pattern. Figure 10 shows a series of typical damage patterns for specific masonry types, such as façades, corners, connection, arches and vaults [35].

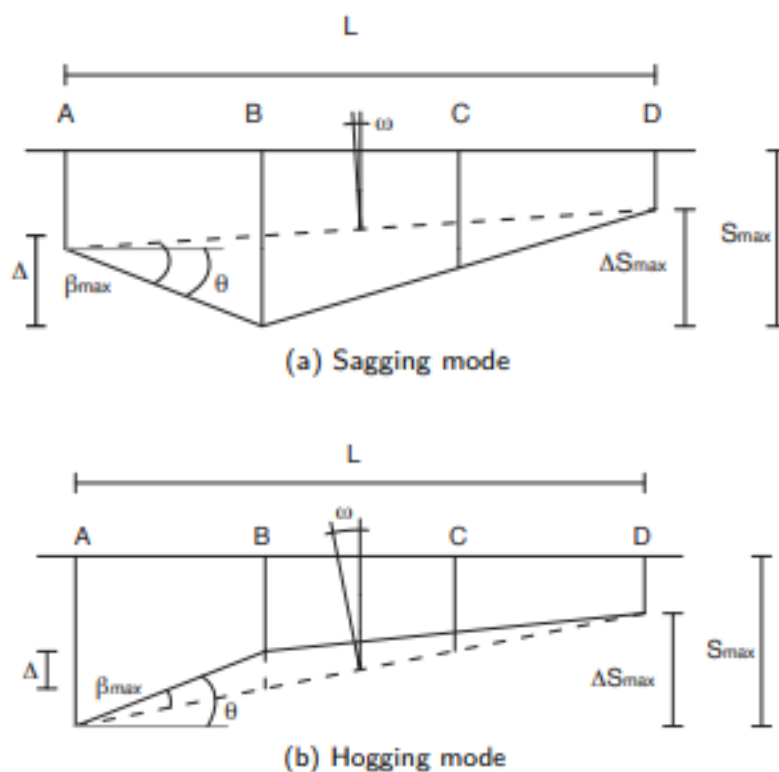
**Figure 11. Deformation mode due to settlement**

The most likely deformation modes are the hogging and sagging mode (see Figure 11).

The former is characterized by sides of the building with greater slump than the average, while in the latter mode, greater slump is at the centre of the building.

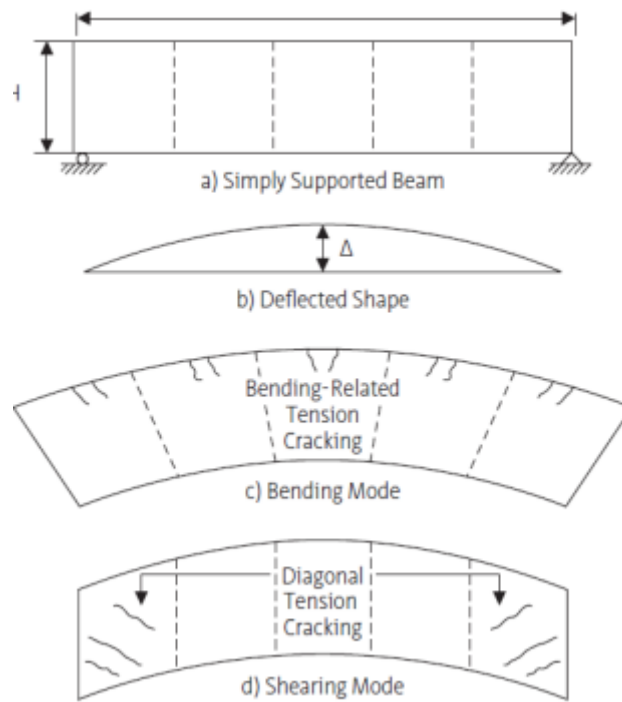
**Figure 12. Overview of deformations in buildings and related damage. Boscardin & Cording [38]**

Building deformation can be specified in more detail into several modes, such as shear and bending deformation as well as elongations and shortening (Figure 12).

Generally, a combination of deformation modes occurs simultaneously. When settlement affects the building, tensile strains occur due to bending deformation and diagonal strains due to shear deformation, generally both at the same time.

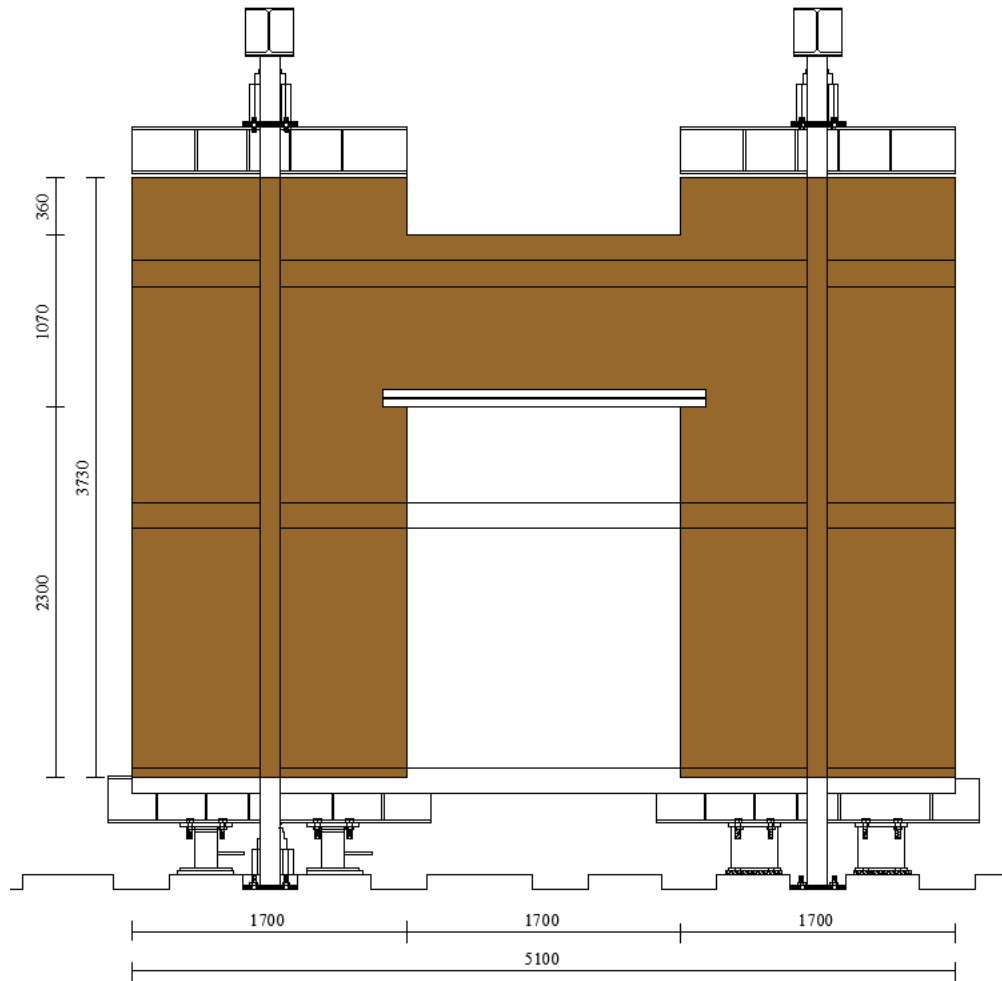
**Figure 13. Dimensions of tested URM (in mm)**

The wall was globally 5.10 m long, 3.73 m high, and 0.31 m thick, composed by two piers connected by a spandrel panel. Both piers and spandrel panel had a length of 1.70 m, whereas the height of the latter was equal to 1.07 m including the wooden lintel, that has a bond length of 150 mm at both sides of the spandrel (Figure 13). URM can be seen as a representative part of a building type structure, so the presence of the other overlying storys, is assumed through the transferred load from three masonry layers constructed over the spandrel. The brickwork is arranged in a stretchers bond pattern with all stones laid as stretchers and half-bats at the beginning or at the end of alternate courses .

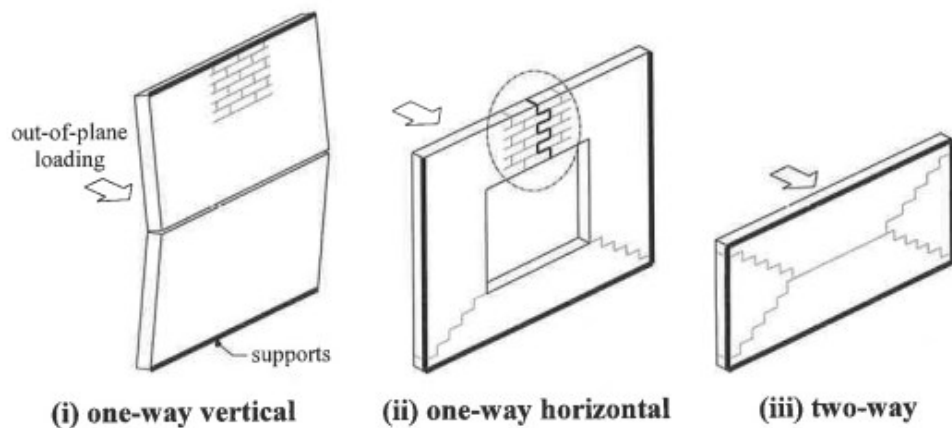
**Figure 14. Out of plane bending mechanism [40]**

According to the support condition, if the upper and lower edges of the wall are restrained between rigid supports, such as walls built inside a reinforced concrete frame, then significant in-plane arching can develop resulting in increased load capacity. (Figure 14.i). A wall fixed only on vertical sides and with reduced restraint along its base will undergo one-way horizontal bending (Figure 14.ii). For all other factors being equal, these walls generally show greater capacities than vertically spanning walls. For walls with at least two adjacent supported sides, two-way bending will occur (Figure 14.iii), further increasing the capacity.

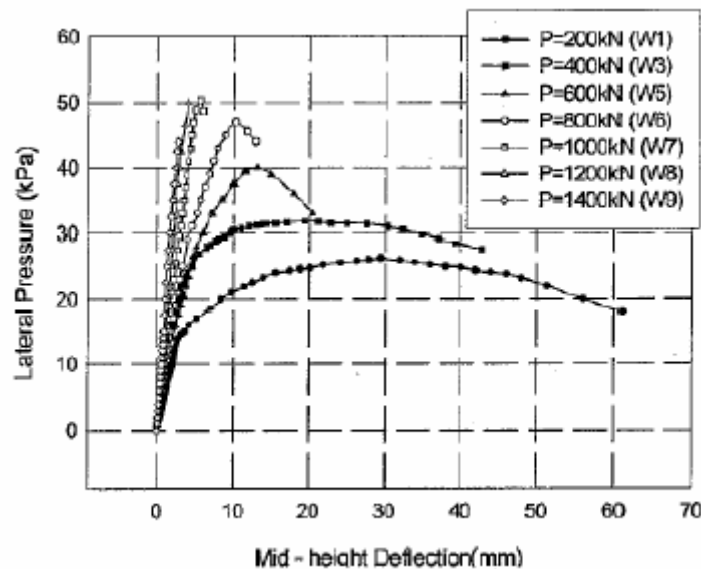
**Figure 15. Mid-height deflection vs. lateral pressure measured in reinforced masonry walls (Liu et al [44]).**

As pointed out by Liu et al [44], in Figure 15 the increase of the axial load increases the out-of-plane strength but also reduces the ductility.

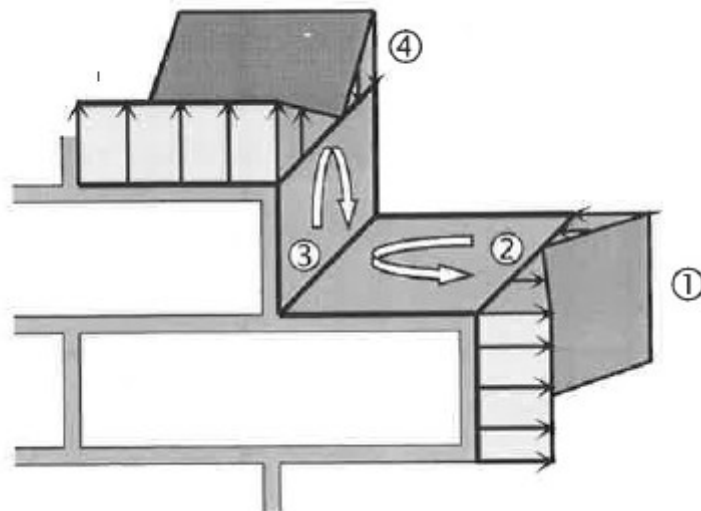
**Figure 16. Failure mechanisms contributing to flexural strength.[40]**

Four kinds of joint failure mechanisms, namely bending and torsional failure of bed and head joints, majorly contribute to the force capacity of wall, along a diagonal crack line, as happened in the intact test (Figure 16, Figure 17) :

- 1) the flexural tensile strength of the head joints ;
- 2) the torsional capacity of the bed joints;
- 3) the torsional capacity of the head joints;
- 4) the flexural tensile strength of the head joints ;

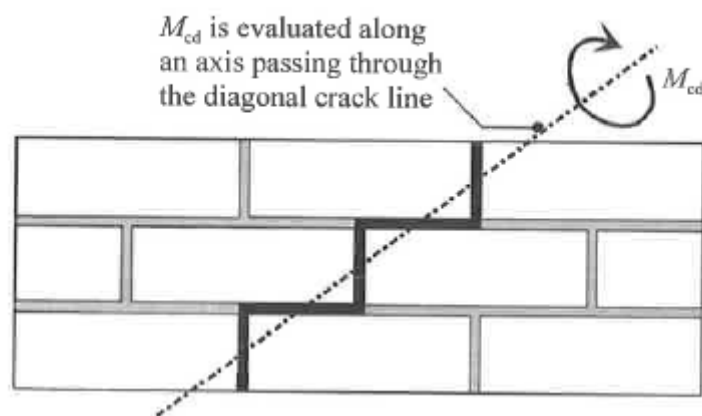
**Figure 17. Bending moment along an axis passing through a diagonal crack line[40].**
