Faculty of Engineering Seismic Retrofitting and Restoration of Historical Buildings Using Innovative Materials: the Case of Carmine's Bell Tower in Naples

PH.D. THESIS

Seismic Retrofitting and Restoration of Historical Buildings Using Innovative Materials: the Case of Carmine's Bell Tower in Naples

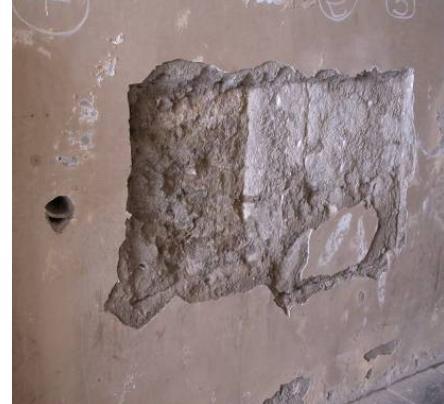
Fig.6d. Removing of plaster on the wall adjoining the church

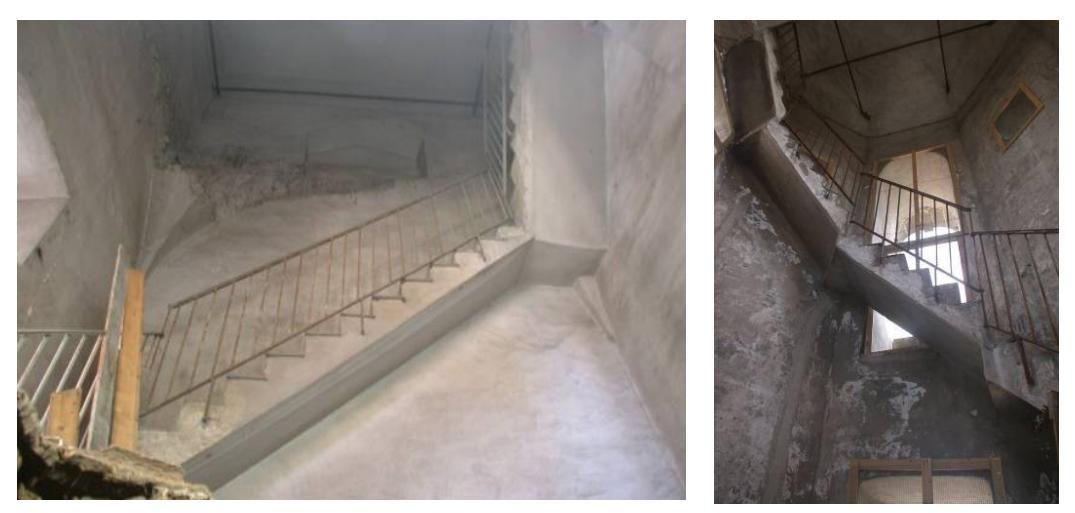
Fig.11. View of the reinforced concrete stair

After the Second Worl War, the Bell Tower presented several damages and it was necessary to reconstruct a structure allowing the access to different levels. From the first to the last level the original wooden stairs have been replaced by RC stairs with slabs (Fig.11) well inserted (thickness about 250.0mm) into the masonry walls.

A diffuse system of steel reinforced inclined mortar injections was realized to
better join the RC stairs to the masonry walls. This stairs probably does not follow a pattern similar to the original wooden staircase. Infact, by comparison with types of towers of the same era, the access to different levels was garantited by vertical wooden stairs that went to higher levels probably through openings in the vaults of masonry.

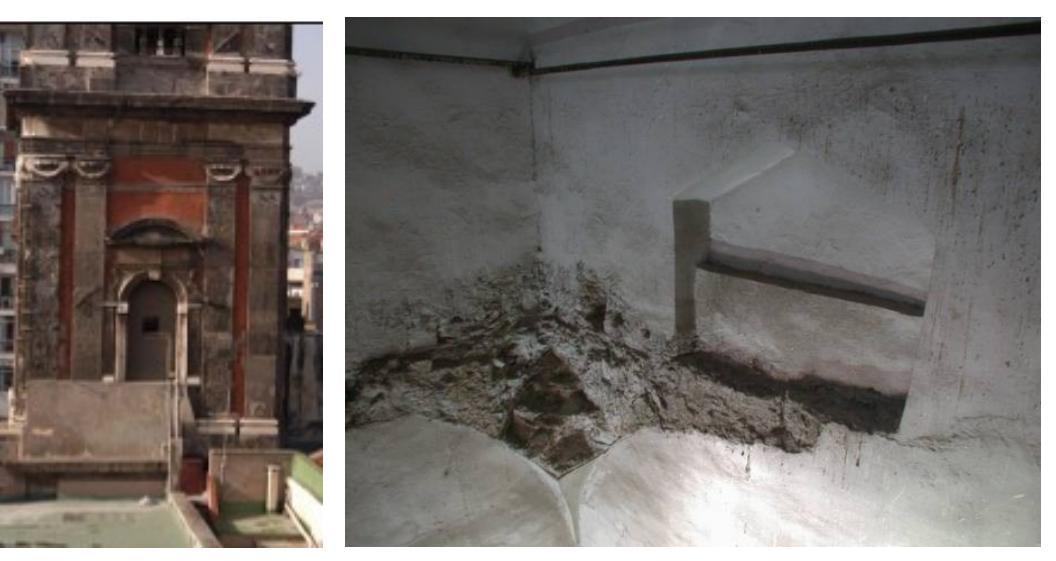
In addition it was found from the superficial investigation of matter that some original walls of the perimeter of the Tower are lined with tuff bricks. Probably this was required for the realization of RC stairs. Most of these interventions are not documented and so it is not simple to find their rationale as for the presence of reinforced concrete pads in some points of the walls and the elimination of the original masonry vaults of the floor (Figs.12a-b).

Fig.12a. Exterior concrete slub

Fig.12b. Inside view of the Tower: remains of the demolished vault

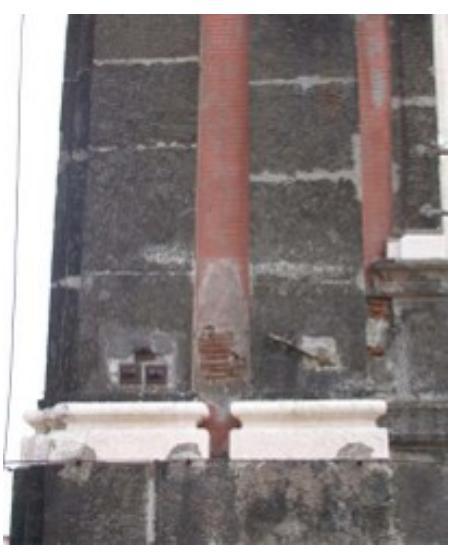
Fig.18. Anchoring plates of strands and bars

Some recent interventions, at the end of the 1970's and the 1980's, to remedy damages caused by previous seismic actions, consisted in application of steel chains additional to the existing ones. In fact some systems of steel bars at the upper levels go back to the end of the XIX century, while the strands and the bars through the stairs (Fig.17) were located in the 1920's-1930's, before the construction of the RC stair in 1950's and the demolition of existing vaults and wooden floors. For the strand, only the anchoring plates are visible from the outside (Fig.18), since the cables runs through the walls, while the steel bars (diameter 30.0-50.0mm) are visible from the inside of the Bell Tower and their anchoring systems are generally made of vertical bars or outside semi-horizontal bars. A lot of them are ineffective at the anchorage or present a diffuse superficial corrosion and probably are not efficient anymore.

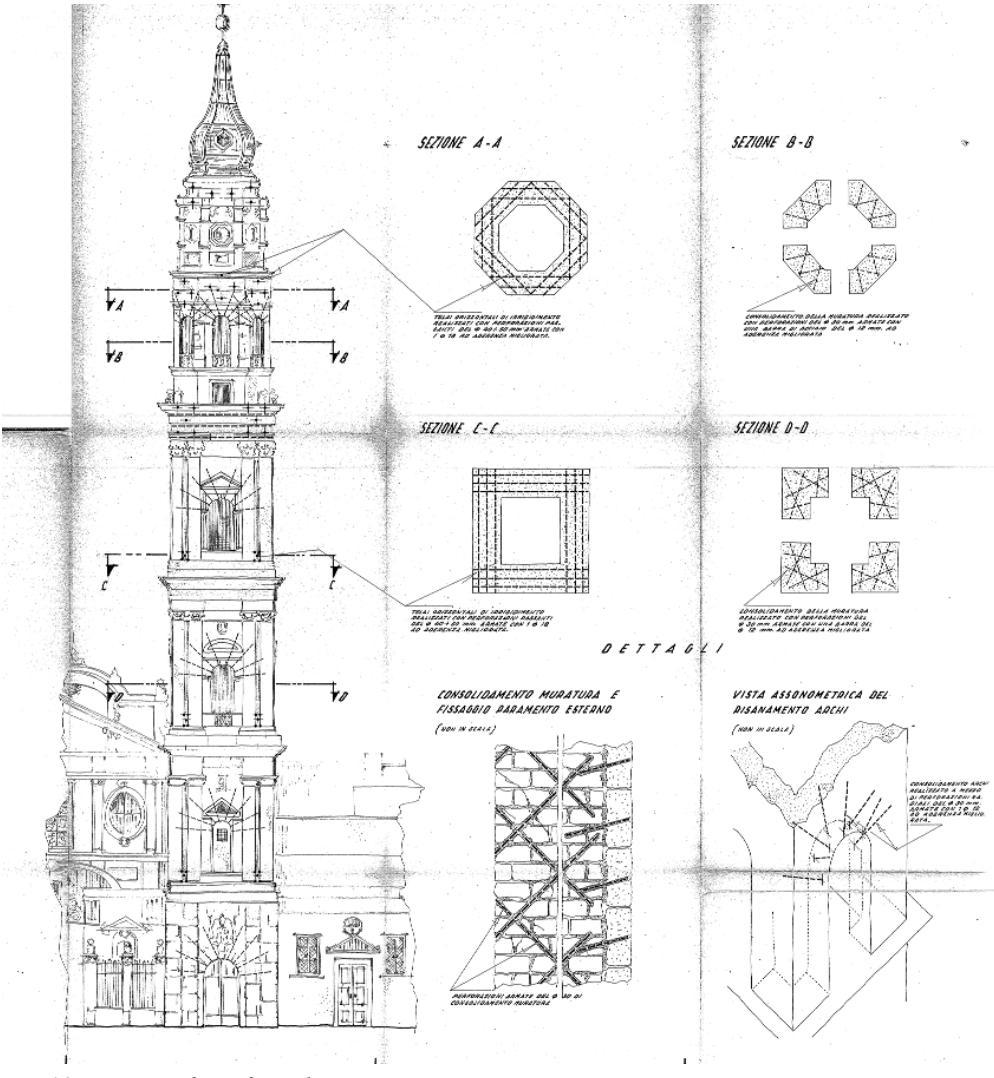
Fig.19. Project of reinforced injection

the 1980's, certified the ineffectiveness of these chains and the need to intervene in the same area with the reinforced stitching to make the belfry and the part below unitary and monolithic. After the earthquake of 1980, mortar injection reinforced with steel bars were realized in the corners of most floors lower than the fourth level to increase the connection between walls and improve the monolithic behavior of the structure. Only qualitative indications about the position and the realization of this type of interventions have been founded as illustrated in Fig.19.

Those interventions are documented in the Archives of the SuperIntendency as mandatory because of the increasing of the earthquake damages and are simply classified as "highest urgency" interventions, without any documented project. Consequently the structural damages in the Bell Tower justifying these interventions are unknown. Furthermore it can be assumed that in the past a certain level of disconnections amongst walls was assessed, requiring the improvement of the rigidity of the box structure through insertion of steel bars connecting opposite walls and injections in the corners. Anyway the visual assessment of the corrosion of strands and bars, worsened by the proximity of the structure to the sea, leads to consider some of these interventions not effective any more.

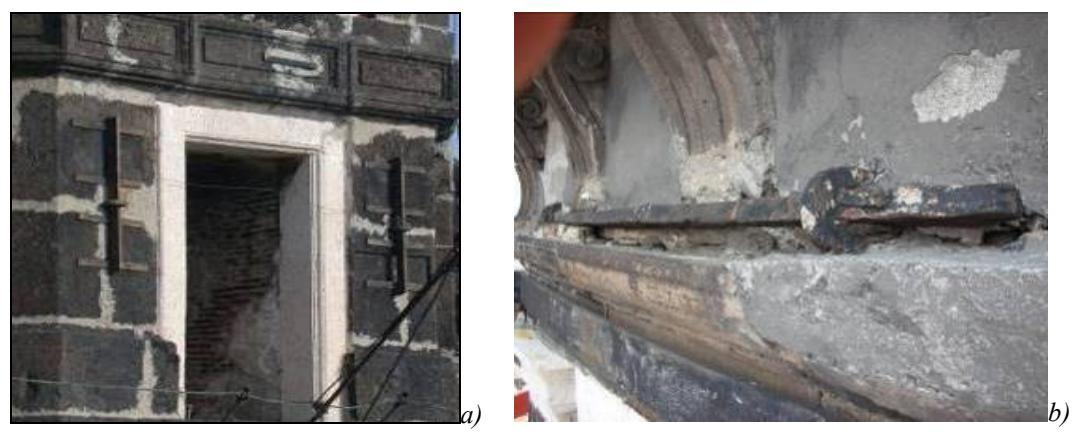
Fig.25. Anchorage of bars: a) vertical; b) horizontal

They are characterized by different types of anchorage systems such as horizontal or vertical elements for bars (Fig.25a-b) or a plate for strands passing through the walls and not visible from inside (Figs.26). Separately from the different anchorage system, the driving principle in the design of the steel ties was to realize, at each level, a connecting system made of four orthogonal ties parallel to the walls. The steel chains at +56.0m have an internal system to preload in tension the bars and external steel plates as anchorage. The presence of several steel ties and reinforced injections realized in the past to secure the global behaviour of the Bell Tower is a clear indication of the potential that local phenomena could be activated in the structure due to ineffective

connections amongst its walls. The survey pointed out that many of them are presently ineffective due to either a damaged anchorage or a diffused superficial corrosion that has strongly reduced their resisting area making them close to being ineffective

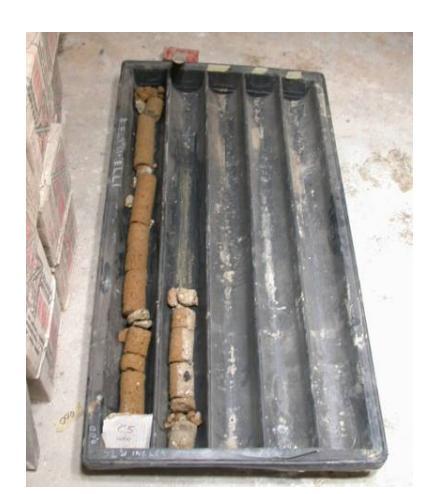
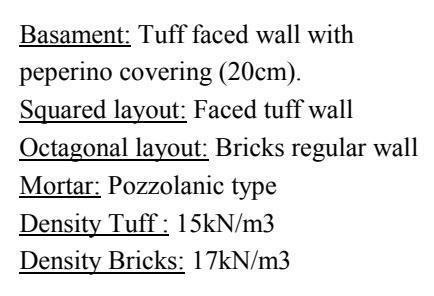
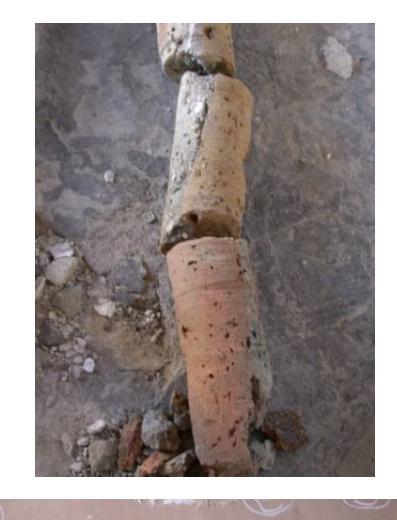
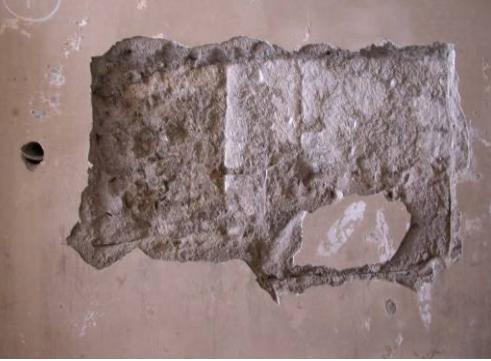
Fig.13. Test cores examples

Experimental tests on specimens of a similar yellow Neapolitan tuff (Ceroni et al., 2004) [3] gave compressive strength of 3.7MPa and secant Young modulus of about 1800MPa. In particular the C2 log was accomplished at the ground level along the wall of Tower facing the church to clarify the connection between the two structures. The sample showed the presence of piperno with a thickness of 20cm at a distance of 92cm from the internal edge of the wall. The use of this material, generally applied in the past as outer facing, confirms the hypothesis that the side of the Bell Tower adjacent to the church was originally separate from it. As shown by the historical sources and from iconography of the seventeenth and eighteenth century and as reported in the images of Joli and Petrini (Figs.4-5 Chapter III).

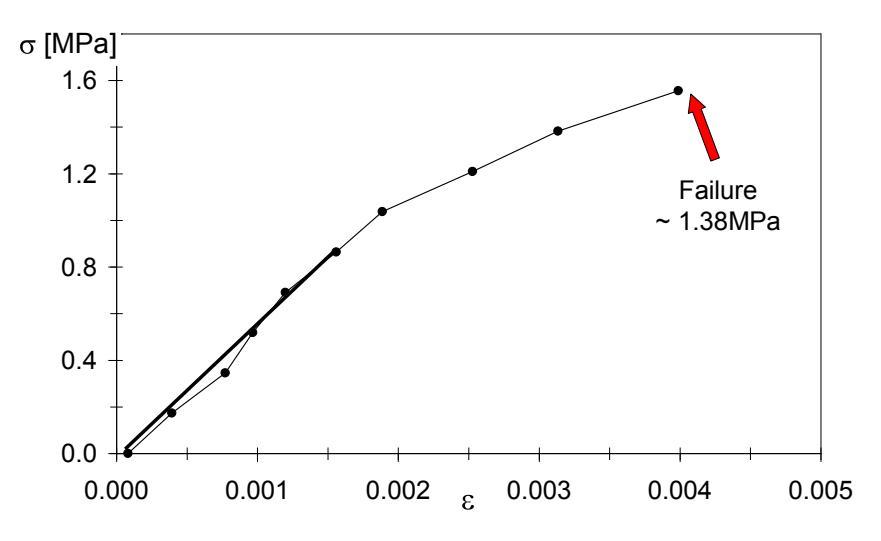
The stress-strain relationships obtained by double flat-jack tests are reported in Figs.16a-b for the faced tuff and the investigated clay brick masonry, pointing out, after the first charge-discharge cycle, the linear trend until local failure happened. The values of compressive strengths, f_m, given by the three double flat-jacks are reported in Table 2, together with the elastic modulus, E, calculated as secant modulus between 0 and a stress equal to one-third of the ultimate strength. The elastic modulus given by the flat jack MD2 is anomalous, probably because it was realized in a inhomogeneous masonry portion. On the contrary the flat jack MD3 gives a value of elastic modulus similar to the tuff, evidencing that was realized in a tuff curtain closing an original opening of the clay brick wall. Since these tests on masonry take into account the properties of the constituent materials (mortar, stones) and texture (thickness of mortar, size and positioning of blocks), the elastic modulus and strength are lower than those of the stones (for tuff masonry, the mean compressive strength measured by MD1 and MD2 is 1.47MPa versus 2.6MPa of the stone measured by the compression test).

Fig. 16a. Stress-strain relationship in faced tuff (MD1)

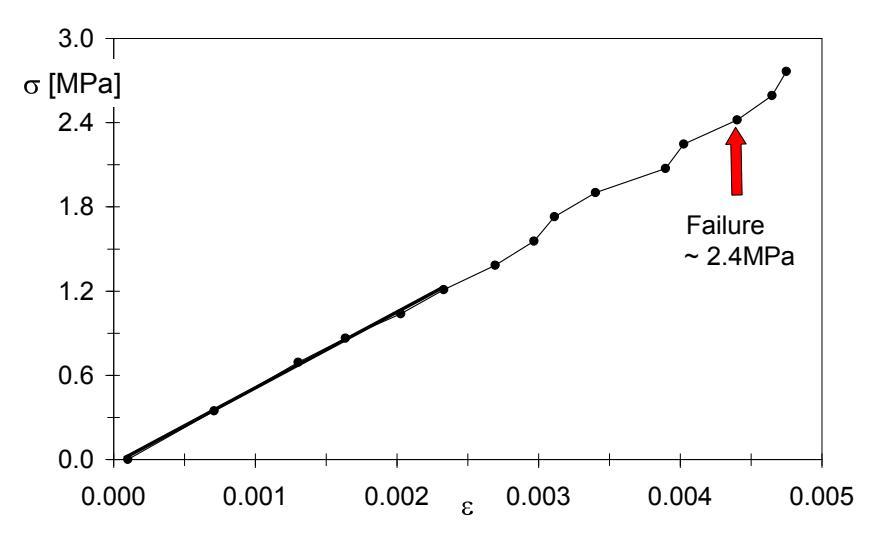
Fig. 16b. Stress-strain relationship in faced tuff in clay bricks-tuff (MD3)

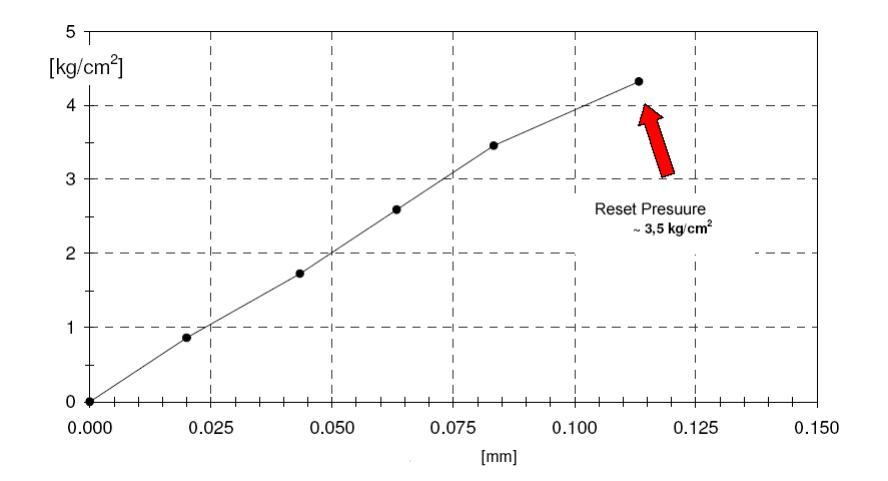
The flat jack MS8 gives an anomalous value. This value is not very significant because was realized in a very discontinuous portion of masonry, in the division wall between Tower and Church, where the individuation of the perimeter of the two structures is not clear. A simple evaluation of the dead loads with the values of density estimated through the in situ tests (i.e. 11-12kN/m3 for tuff and 16kN/m3 for clay bricks masonry) allowed us to obtain the theoretical values of compressive stresses. These results are reported in the last column of Table 4 and are very near to the effective ones, with exception of MS8. The flat-jacks showed that the maximum stresses were registered at the basis of the Tower, pointing out a correct progressive reduction of the wall thickness along the height. Fig.22 shows the relation stress-displacement as determined in a single flat jack test.

Considering the results of the single and double flat-jacks, the vertical stresses were under 25% of the compressive strength, showing that for the permanent vertical loads the Tower appears to be in good condition. The experimental stresses relieved in situ can be directly compared with the results of numerical static analysis adopting linear-elastic behaviour of materials.

Fig.22. Relation stress-displacement as determined in a single flat jack test

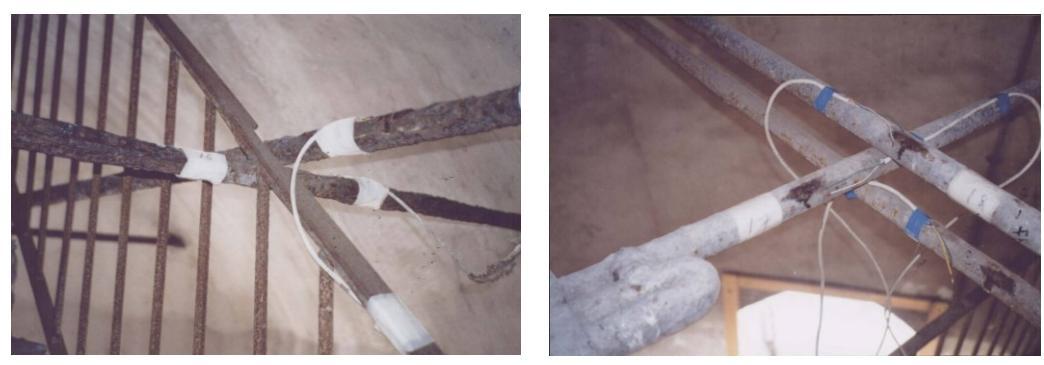
Considering the corrosion of some steel chains, the effectiveness of the ties were tested by measuring the strain levels of steel by vibration sources. To measure the strain levels of steel, 22 tie rods were monitored. In particular, after applying a strain gauge on each of the chains in question, a small incision with a diameter of 0.8mm and a depth of 1.0mm was made close to the strain gauge. On the basis of the principle of tension release, the tensile stresses of each chain were calculated with the strain gauge measurement (Fig.23). The measured strains show that most of them bear tensile stresses varying between 27MPa and 99MPa and eight chains are very low stressed. In Fig.24 is reported the

Fig.23. Measurement of steel tie-rod strain 15,16, 17, 18 and 19

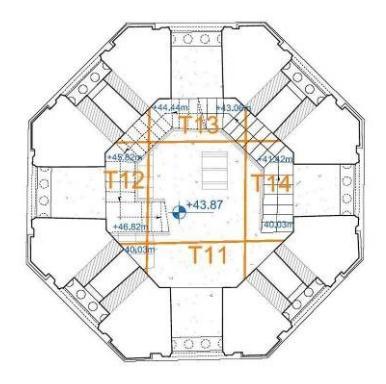
Fig.24. V level +43.87*m*

position of some chain that have been analyses at the fourth level. Some of the chains that have been investigated have also corrosion problems that in some cases lead to a local failure of the anchorage (Fig.25) making the tie action ineffective.

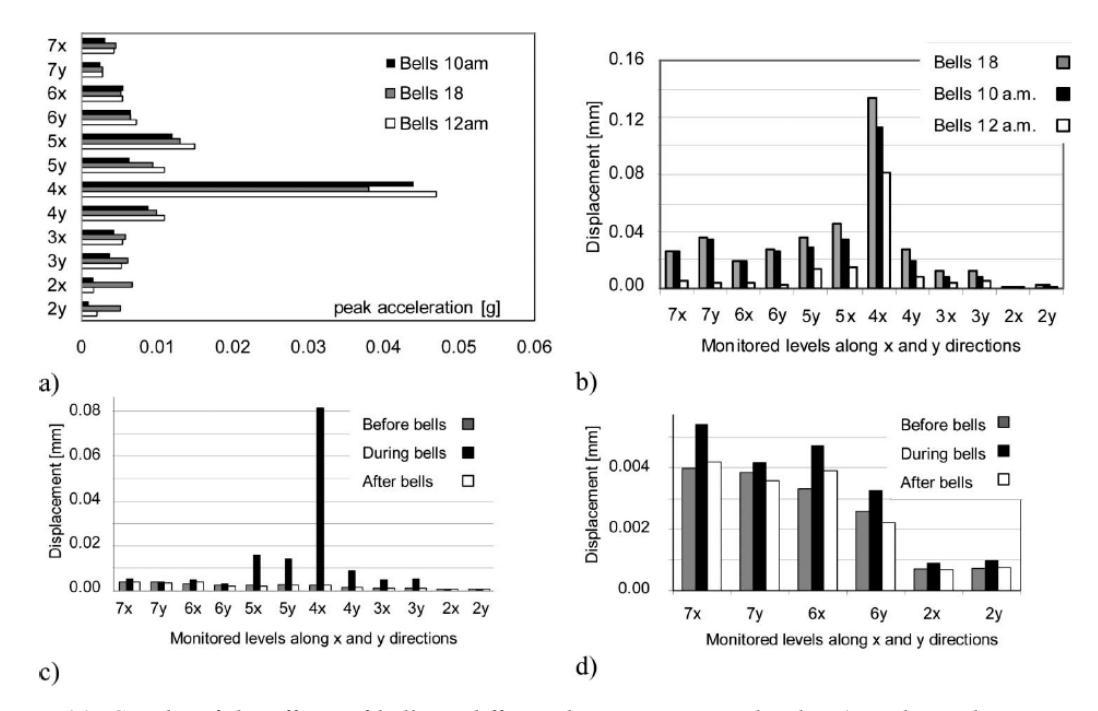
In particular in Figs.31a-b, the peak acceleration measured by sensors and the displacements, calculated by integrating acceleration, for six instrumented levels (from second to seventh) are reported when the bells ring at three times (10a.m, 12 noon, 6p.m). Graphs show that for each level the bell swinging at 6p.m. is the most significant in terms of displacement, followed by that at 10a.m and then at 12 noon (Fig.31b), whereas in terms of peak acceleration the impulse decreases from 12 noon to 6p.m. (Fig.31a).

Furthermore, effects are observed by the sensors applied at the levels where the bells are positioned especially in x directions (fourth level, +30.0m, sensors 4x in Fig.31a) and at the nearest ones (third and fifth levels, sensors 3x, 3y, 5x, 5y). In particular at the level of the bells (fourth level, +30.0m) the maximum displacement when the bells ring at noon increases approximately 35-fold with respect to the environmental conditions (Fig.31c), whereas, at the levels further from the bells, the displacement increase is lower (levels two, six, seven, as shown in Fig.31d).

Fig.31. Graphs of the effects of bells at different hours at various levels: a) peak acceleration at each level for three bell ringing times; b) displacement at each level for three bell ringing times; c) displacement at each level before, during and after bell ringing at 12 noon; d) displacement at second, sixth, and seventh levels before, during, and after bell ringing at 12 noon

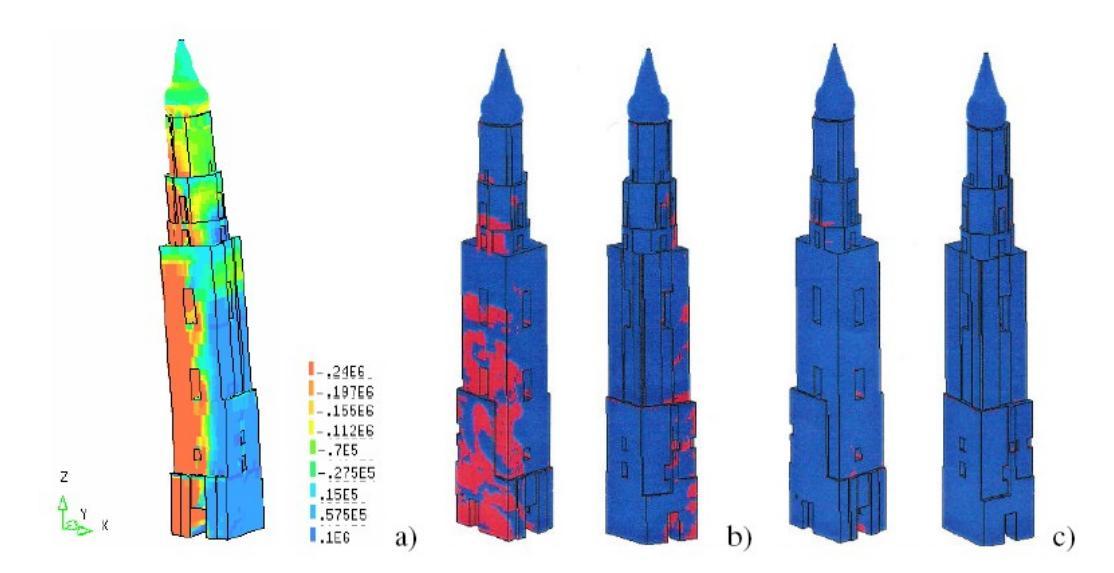
Fig.12. a) Distribution of principal stresses along the Tower for the maximum shear force in +X direction (stress in N/m²=10,6MPa); b) Distribution of tensile stresses greater than 0.07MPa; c)Distribution of tensile stresses greater than 0.1MPa

In Figs.12b-c, the distributions of tensile stresses exceeding the tensile strength of tuff (0.070MPa) and clay brick (0.120MPa) masonry are red coloured to evidence the most critical fields. The figures indicate that the tension stresses correspondent to the maximum applicable shear force overcome the value of the peak resistance of the material in the part of the Bell Tower from +0.00 up to +30.00m, correspondent to the part made with tuff. No particular emergency situation appears to exist for the brick part.

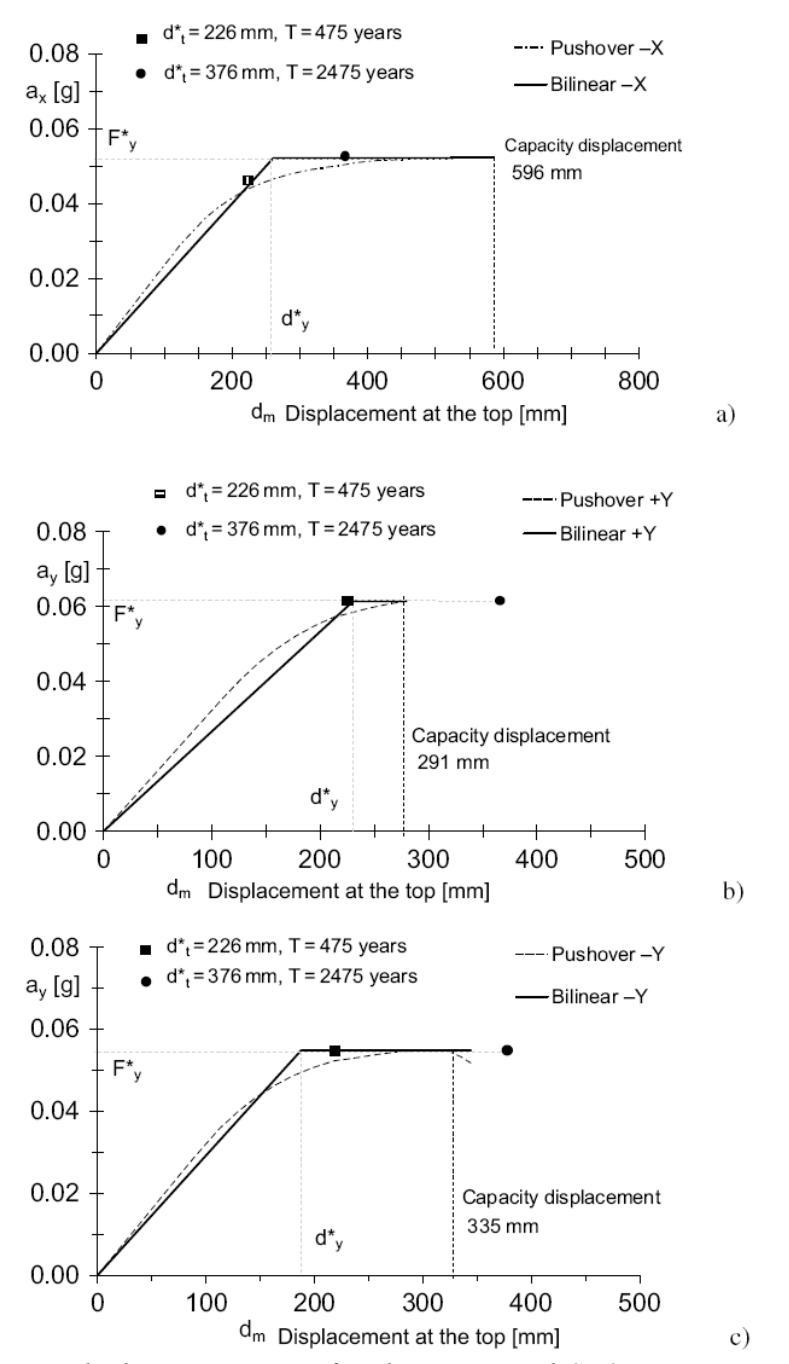
Fig.14. Capacity displacement curves of real structure and SDOF system normalized to Γ =1.71: a) Direction -X; b) Direction +Y; c) Direction -Y.

years) the minimum safety factor is 1.29 (+Y direction) and the maximum is 2.91 (+X direction), therefore the structure is verified; on the contrary with reference to the Limit State of Near Collapse (return period 2475 years), the tower is verified for both ±X directions (safety factors 1.75 and 1.59), while it is not verified for either ±Y directions (safety factors 0.77 for +Y and 0.89 for -Y).

In Fig.14 the capacity displacement curves of the SDOF system and of the real structure, normalized to Γ , are shown for the directions with the lowest safety factors (-X, +Y, -Y).

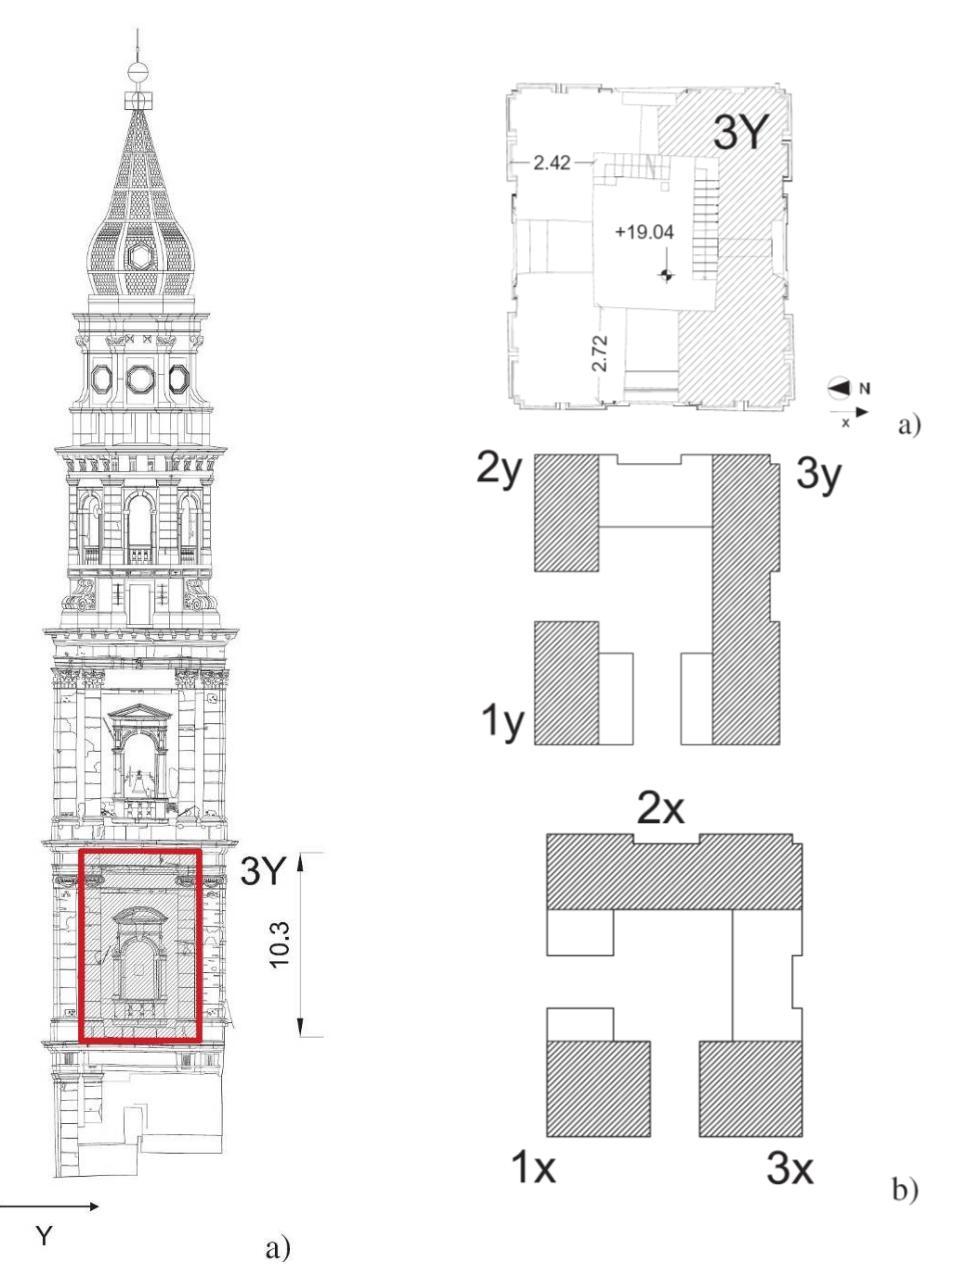
Fig.25. Tuff panels between +19.0-+29.0 m:
1) original plan view; 2) schematic reproduction of resistant panels in X and Y directions.

If the peak ground acceleration, a_g , with an occurrence probability of 2% in 50 years with return period of 2475 years ($a_{g,2475} = 0.28g$, Limit State NC) is assumed, the equilibrium is not verified at any analyzed level and in particular the worst condition is attained in panels between levels +19.0m-+29.0m (especially panel 3Y shown in the lateral view of Fig.24a and in the plan view of Fig.25a). In Fig.25b the regularized geometry of panels between +19.0m and +29.0m is reported. Panel 3Y shows the lowest ratio of stabilizing to destabilizing moment (0.60), so that, in order to achieve safety, additional horizontal forces $\Delta F_{hor} = 1100$ kN in the X direction and $\Delta F_{hor} = 880$ kN in the Y direction are needed. Contribution of existing undamaged steel tie rods has been taken into account considering a maximum working tensile stress of 250MPa.

At the upper levels, following a similar approach, lower forces are required. The safety condition deteriorates on the assumption that all the chains and steel tie rods used in the walls are ineffective; under this hypothesis the maximum total tensile force required between +19.0m-+29.0m becomes $F_{hor} = 1830$ kN.

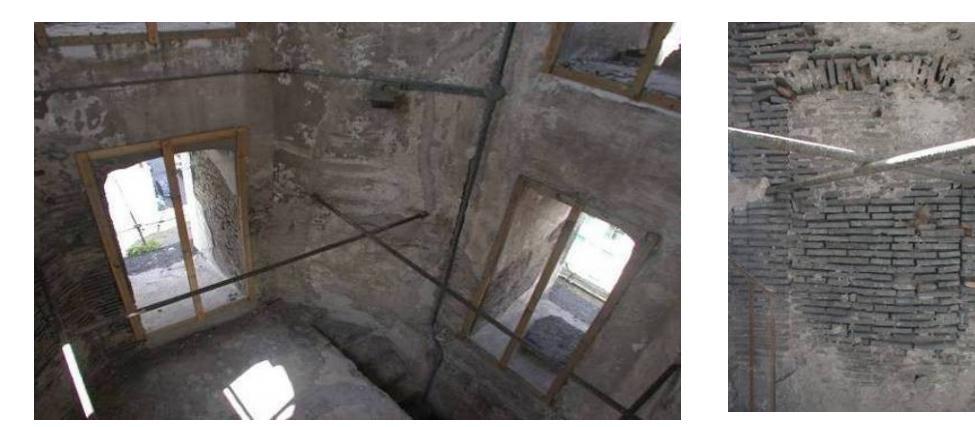
Fig.2. Steel tie bar system +41.7m

Walls between levels +40.0m and +49.0m are presently connected by two systems of four ties represented by steel bars (diameter of 40mm). The first four bars are positioned orthogonally to each other at +41.7m (Figs.1a-b, 2), have an external anchorage made of a vertical steel bar and show no significant corrosion problems, so that their contribution has been taken into account in the structural checks. Furthermore in situ tests highlighted that they are subjected to tensile stresses ranging between 41.5MPa and 71.5MPa.

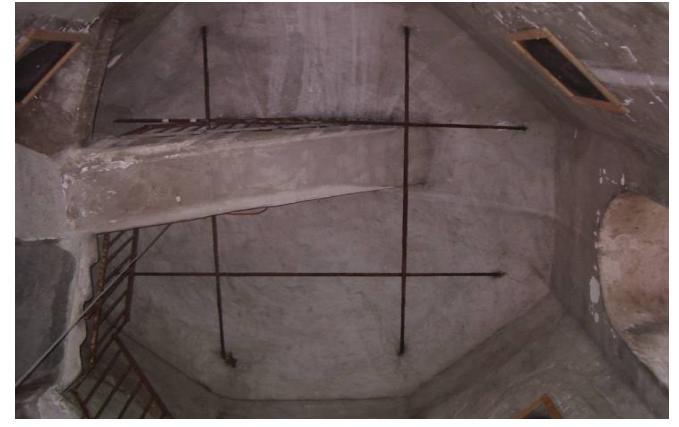
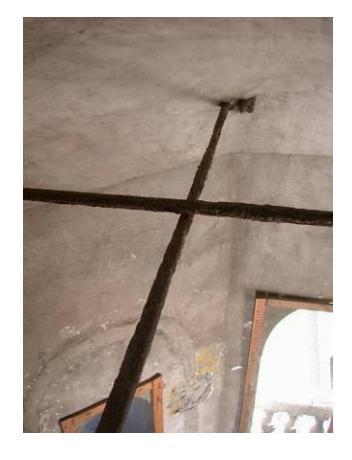
Fig.3. Steel tie bar system +48.3m

At +48.3m the second system is made of four steel bars (diameter 40mm) placed orthogonally (Figs.1a-b and 2). They have an external anchorage made of a horizontal steel bar. As previously described, those ties are characterized by evident corrosion phenomena and don't seem to bear any load as confirmed by tensile stresses measured in two of them; therefore their contribution has not been considered in the checks. At a level of +55.6m there is only one system of six orthogonal steel bars (average diameter of 35mm) (Figs.1a-b,3) characterized by evident corrosion phenomena and damaged conditions of the anchorage; therefore these ties have not been considered in the checks.

- To connect panels between +40.0m-+49.0m a minimum tensile load of 10t is required for each new tie rod (Table 1), a system of four orthogonal elements, each of them made of three GFRP laminates with a design load of 25t, has been planned to replace the existing ones just below the fifth floor(Fig.9, Fig.10).
- Analogously between +49.0m-+56.0m the minimum required load for each panel is 8t (Table 1), so that four orthogonal elements made of two GFRP laminates (design load 16t) will substitute the existing six ones just below the sixth floor. (Fig.9, Fig.11).

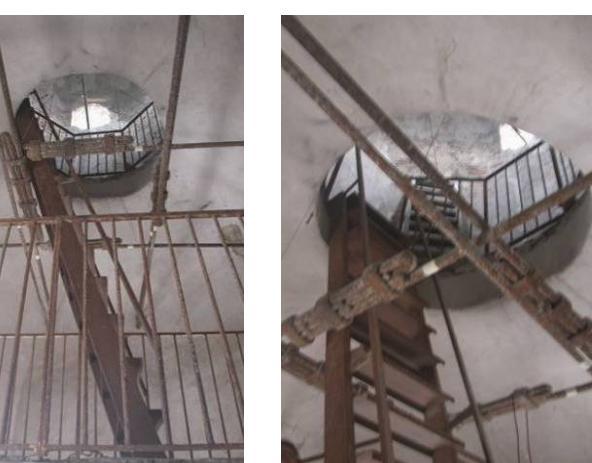
Fig.4. Steel tie bar system +55.6m

The four tie rods in a west-east direction (along Y axis) are coupled two by two. Each group of two has an external anchorage made of a steel squared plate (side 400mm). In the other direction, two single rods with a similar anchorage are present. All these ties have an intermediate blocking system used in the past probably to preload them (Fig.5). In situ tests evidenced that: the two north-south ties detached from the walls are unloaded; those most corroded in a west-east direction bear a stress of about 100MPa; the others are subjected to tensile stresses ranging between 26MPa and 46MPa. Appendix X summarizes the distribution of the existing bars and the assessment of their functional status.
