SEISMIC VULNERABILITY OF MASONRY BUILDINGS DAMAGED AFTER L'AQUILA 2009 EARTHQUAKE ACCOUNTING FOR THE EFFECT OF CONSTRUCTION AGE

XXXIV Ph.D. Programme in Structural, Geotechnical Engineering and Seismic Risk

THESIS FOR THE DEGREE OF DOCTOR OF PHILOSOPHY

by
SANTA ANNA SCALA

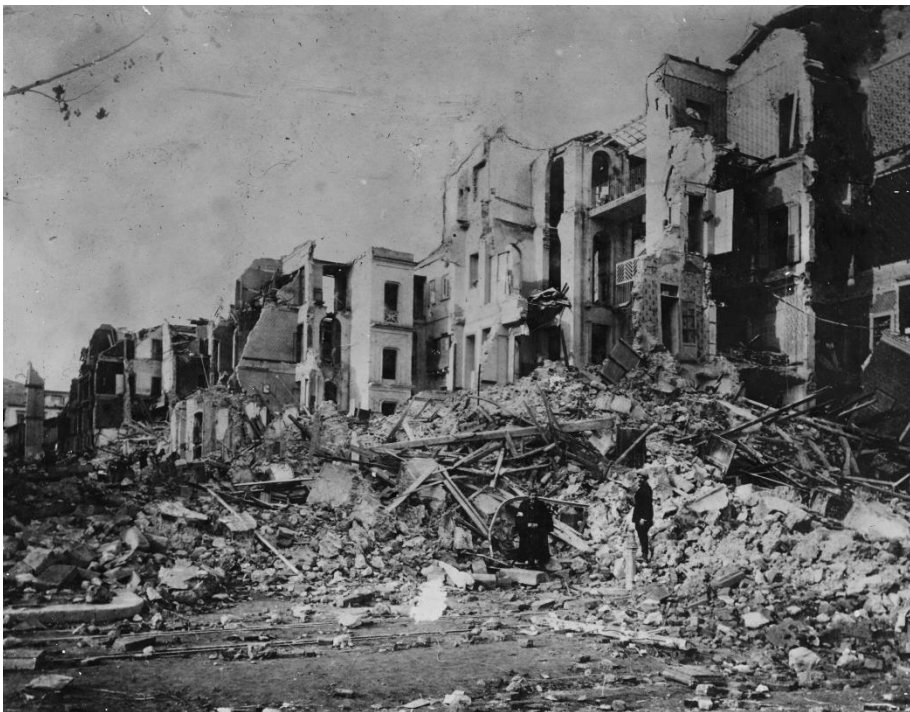
Figure 2. *Messina Earthquake, 28 December 1908*. Description: Street in Messina, Sicily, showing damage caused by the earthquake. Photographed in January 1909. Collection of Lieutenant Commander Richard Wainwright, 1928. U.S. Naval History and Heritage Command Photograph. (Catalog #: NH 1447)

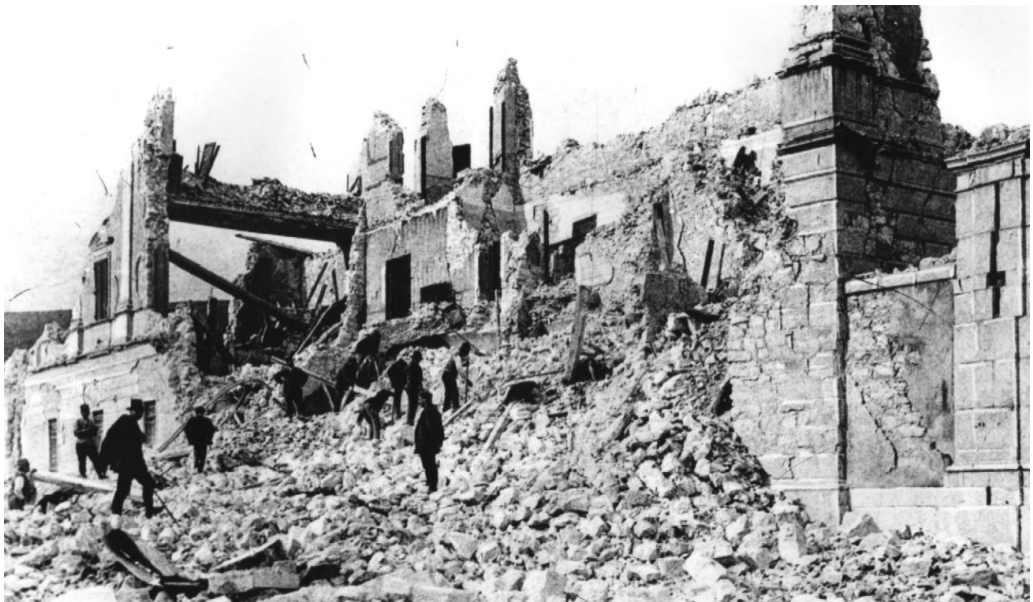
Figure 3. Avezzano 1915, Palazzo Torlonia after the earthquake. Photo retrieved from <http://marsica1915.rm.ingv.it/it/79/il-terremoto-del-1915>.

their lives (Cavasino, 1935). After the seismic event, several vulnerability factors were identified: namely, walls made of poor-quality sand, poor lime and smooth stones, insufficient foundations, cantilevered stairs, heavy vaults, heavy roofs pushing on the load-bearing walls, excessive height of buildings (Oddone, 1915). The awareness of these vulnerabilities in the building stock led to the enactment of the R.D. n.573 of 29 April 1915, to regulate the constructions in the municipalities hit by the earthquake.

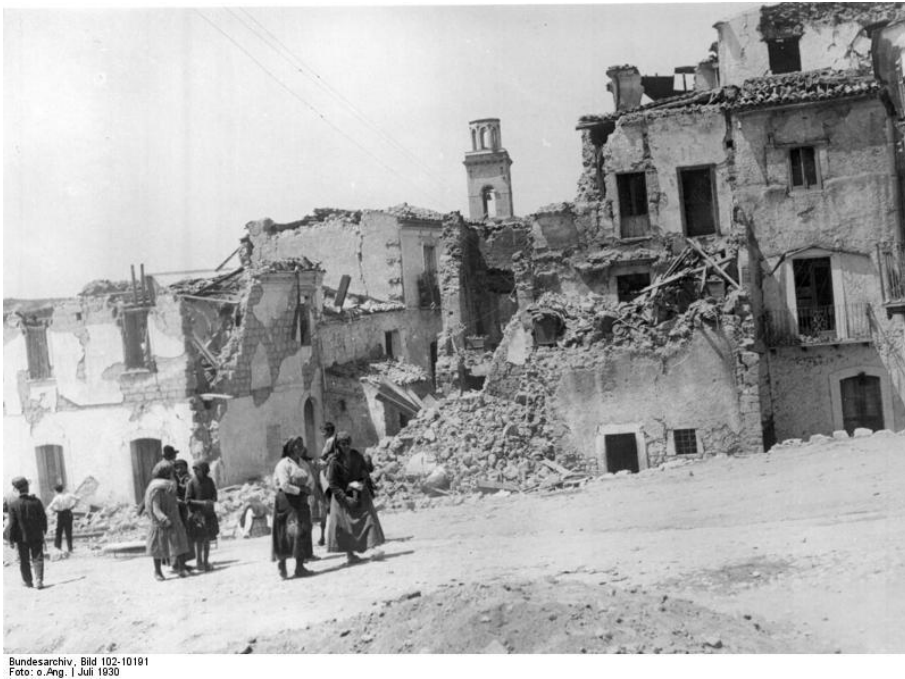
Figure 4. Italien, Erdbeben-Katastrophe. Description: houses collapsed due to the catastrophic earthquake of Vulture, 23 July 1930. This image was provided to Wikimedia Commons by the German Federal Archive (Deutsches Bundesarchiv).

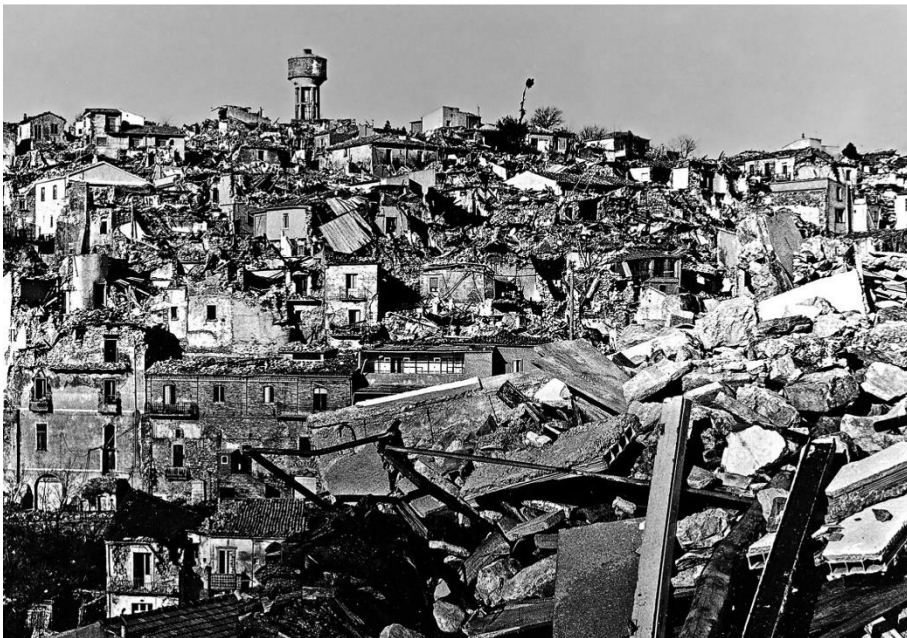
Figure 5. View of the destroyed city of Conza della Campania after the earthquake of November 1980. Photographed by Giuseppe Maria Galasso.

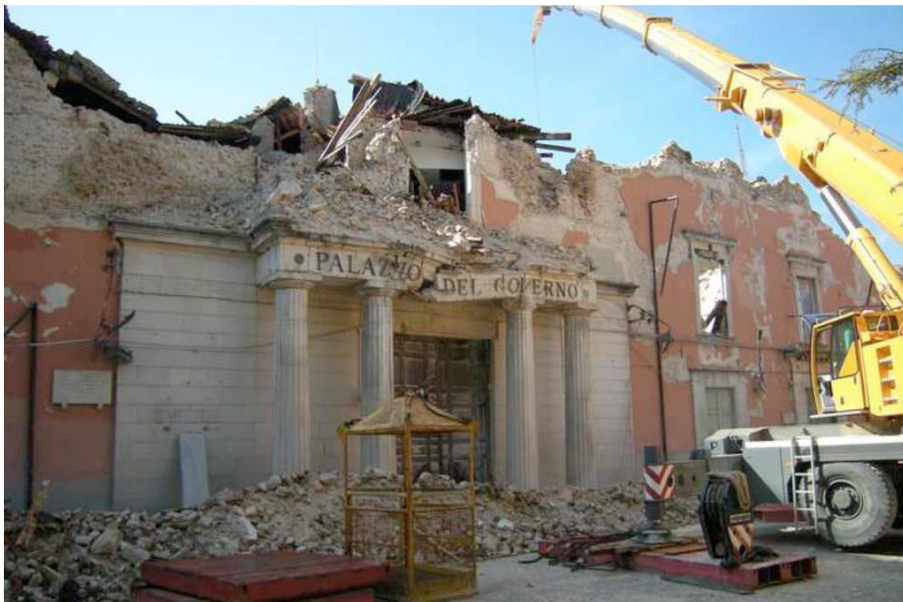
Figure 6. Global collapse of the L'Aquila's Prefecture.
Photo retrieved from Augenti and Parisi, 2010.

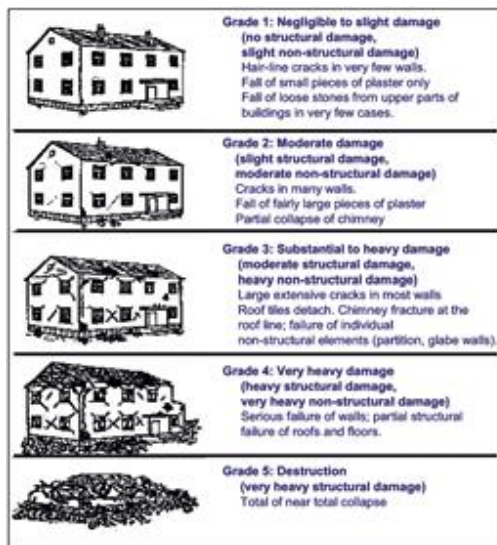
Chapter 3.

EVOLUTION OF THE ITALIAN SEISMIC CLASSIFICATION AND SEISMIC CODES
